## Annual Inspection

Dyffryn Ardudwy and Talybont Community Council

Pentre Uchaf Play Park

Annual Inspection - 21 November 2017 at 11:44 Inspector: Jon Dalton RPII Annual Inspector

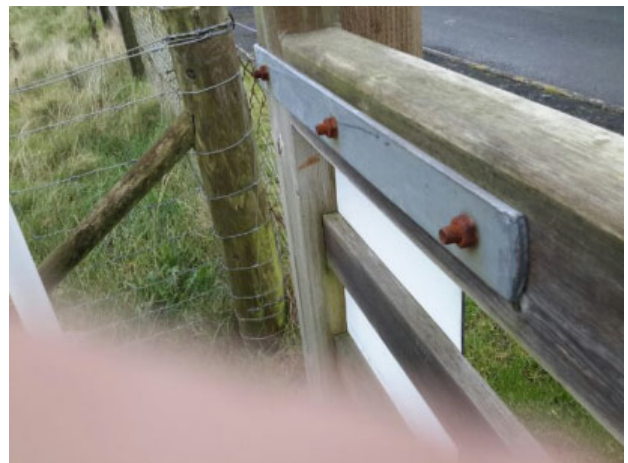
## 6 - Low Risk (Finding 2)

**Finding:** There are projecting bolt thread(s) present  
**Action:** Remove excess thread length and deburr or provide cap

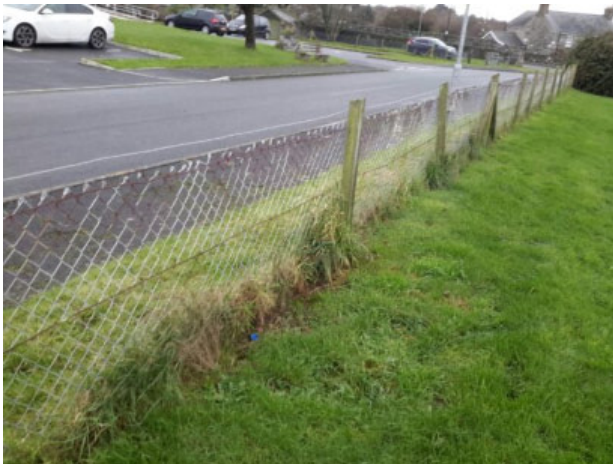
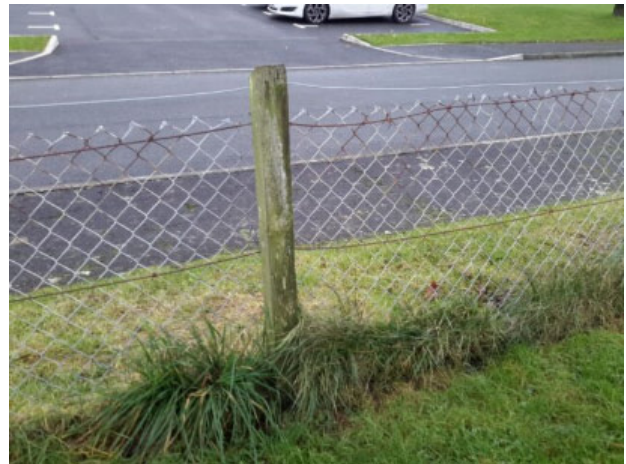
8 - Low Risk (Finding 1)

**Finding:** The timber on this item has severe rot **Action:** Remove and replace all affected timber sections

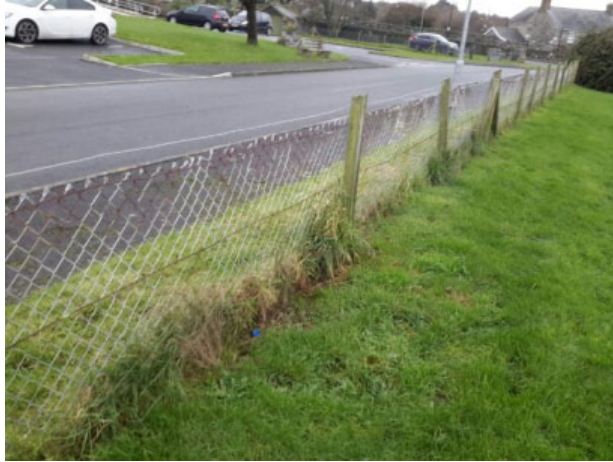
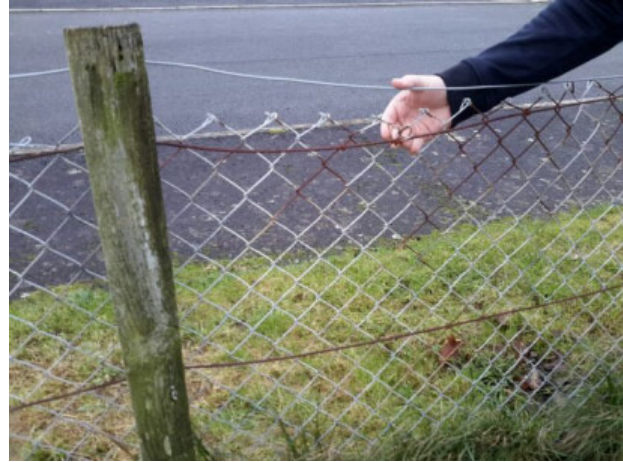
8 - Low Risk (Finding 2)

**Finding:** There are projecting wires

**Action:** repair

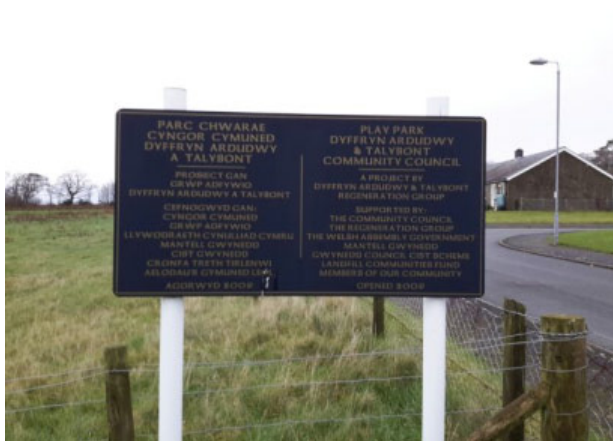
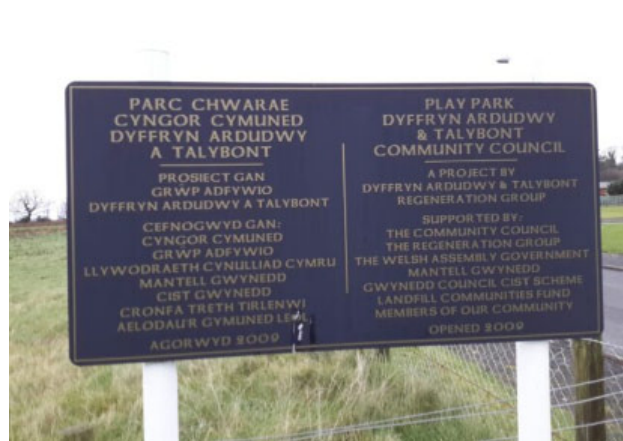
2 - Very Low Risk (Finding 1)

**Finding:** It is recommended that information signs with emergency contact details are installed at each entrance/exit point to the playground

**Action:** Provide in accordance with the recommendations set out in BS EN 1176

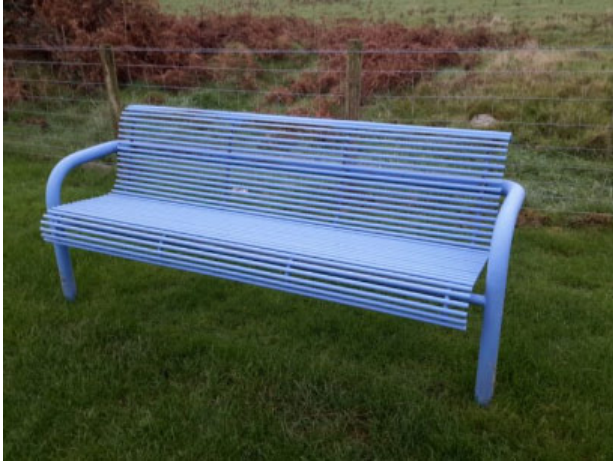
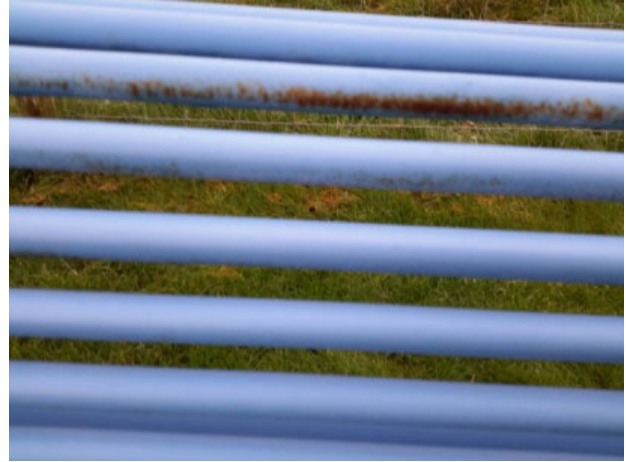
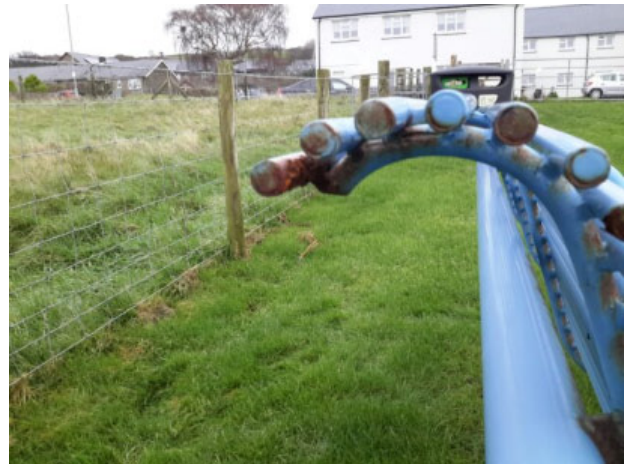
6 - Low Risk (Finding 1)

**Finding:** The paintwork on this item has been damaged or worn exposing the metal underneath which is rusting

**Action:** Treat any rusting components and repaint

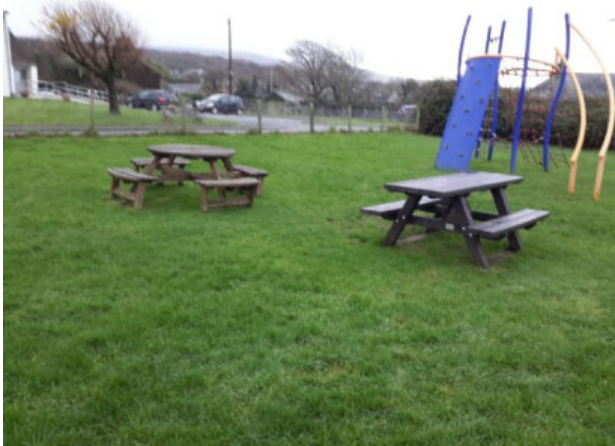
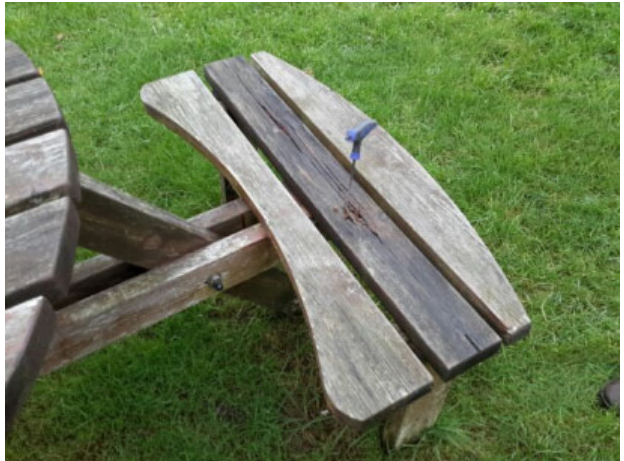
8 - Low Risk (Finding 2)

**Finding:** The timber on this item has severe rot

**Action:** Remove and replace all affected timber sections

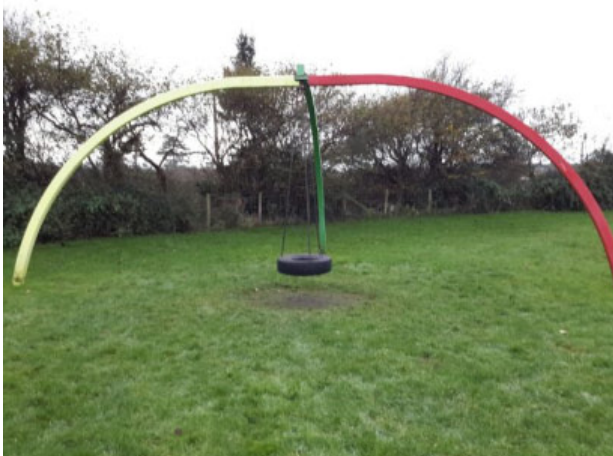
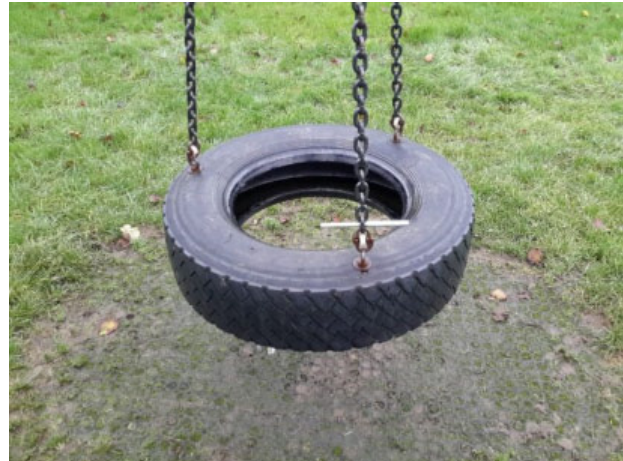
5 - Very Low Risk (Finding 2)

**Finding:** The chain openings are in excess of the 8.6mm as recommended by BS EN 1176

**Action:** Monitor use

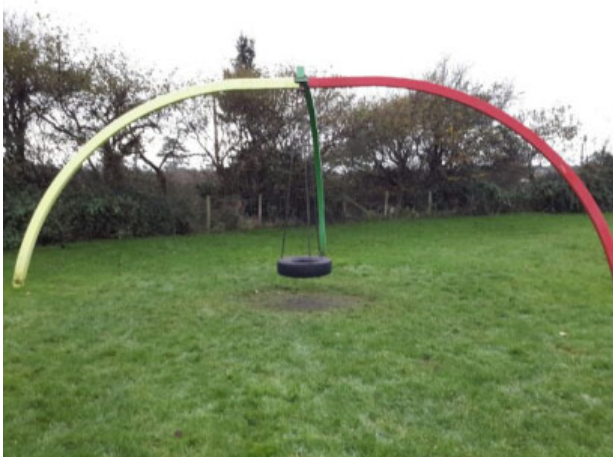
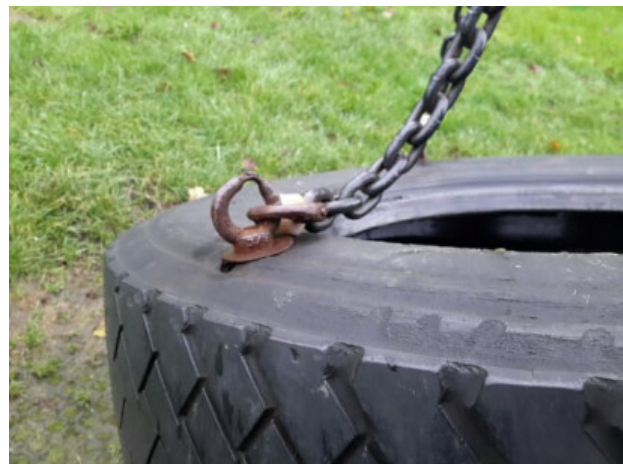
15 - Moderate Risk (Finding 3)

**Finding:** There is severe wear to the eyebolts

**Action:** Replace

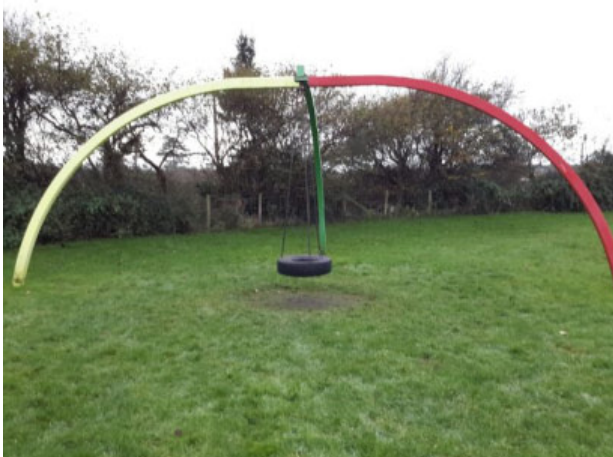
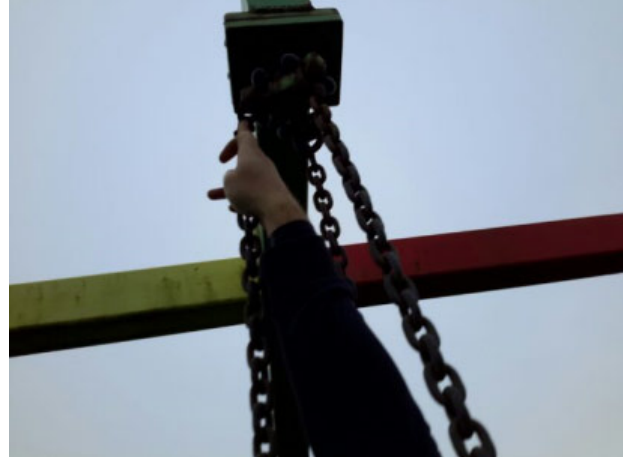
8 - Low Risk (Finding 5)

**Finding:** The shackles are worn in excess of 40% and require renewing

**Action:** Replace worn shackles

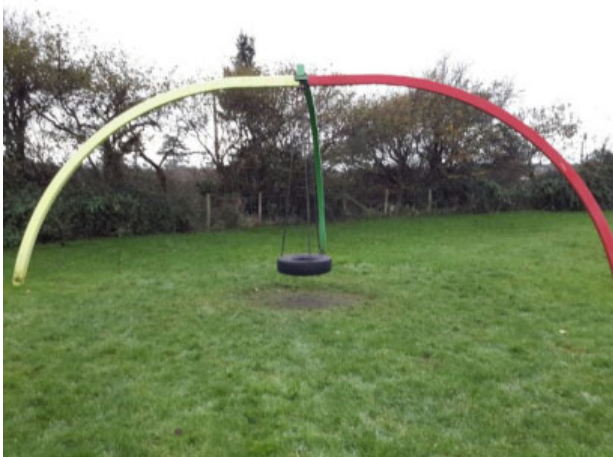
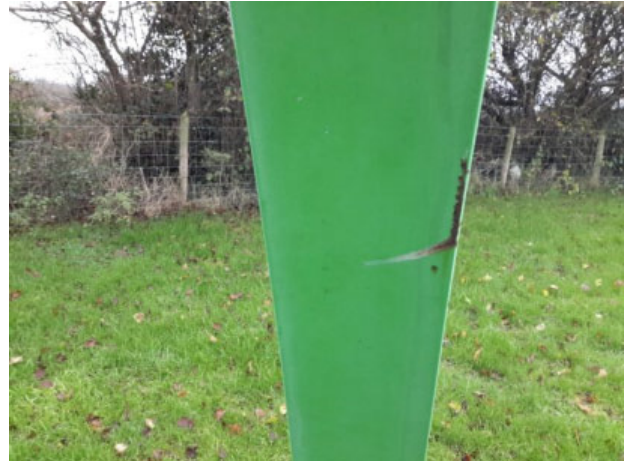
**Finding:** The paintwork on this item has been damaged or worn exposing the metal underneath which is rusting

**Action:** Treat any rusting components and repaint

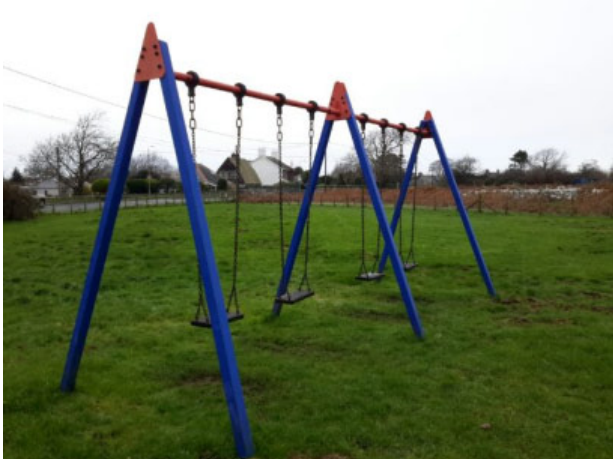
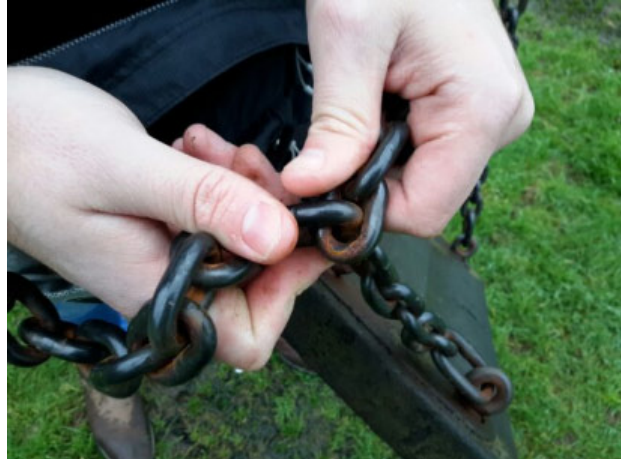
**Finding:** There is some notable evidence of chain wear

**Action:** Monitor for any further deterioration and replace when 40% worn

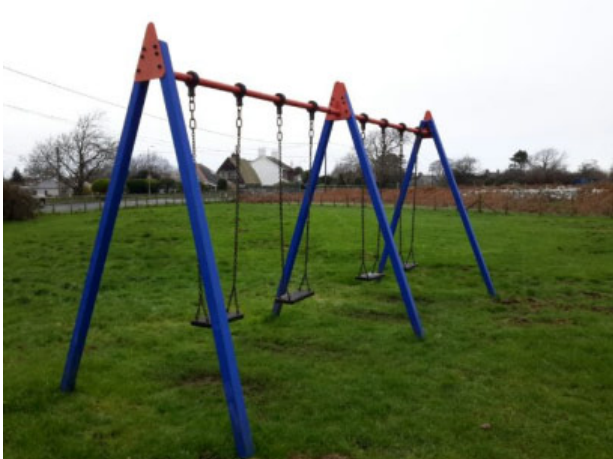
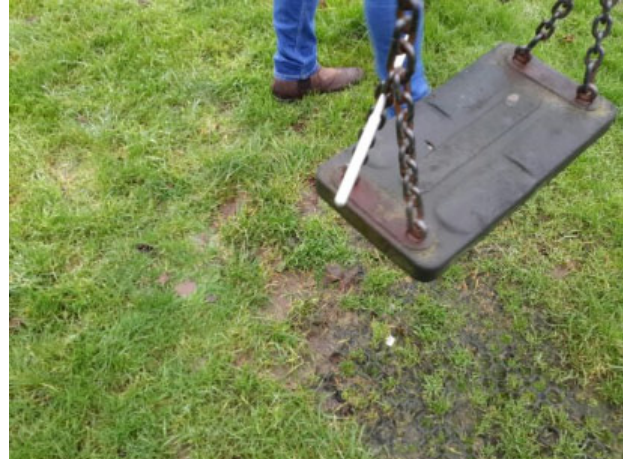
**Finding:** The chain openings are in excess of the 8.6mm as recommended by BS EN 1176

**Action:** Monitor use

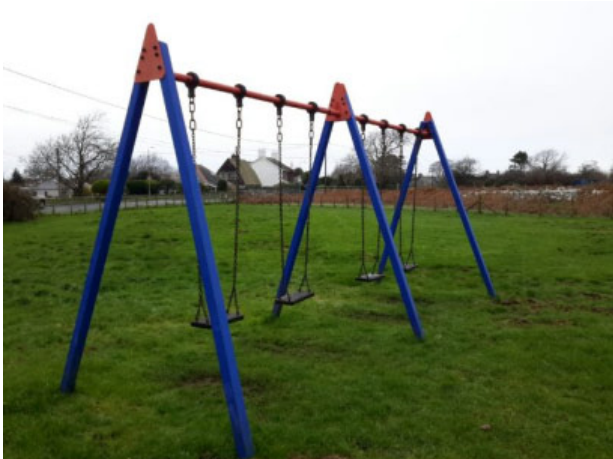
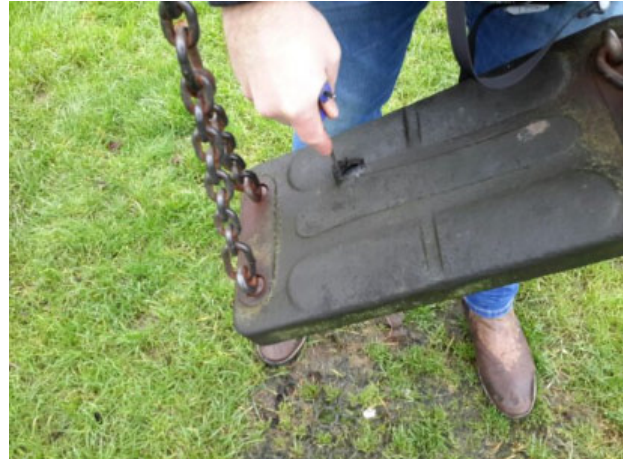
**Finding:** The seat is severely damaged and requires replacing

**Action:** Replace damaged seat

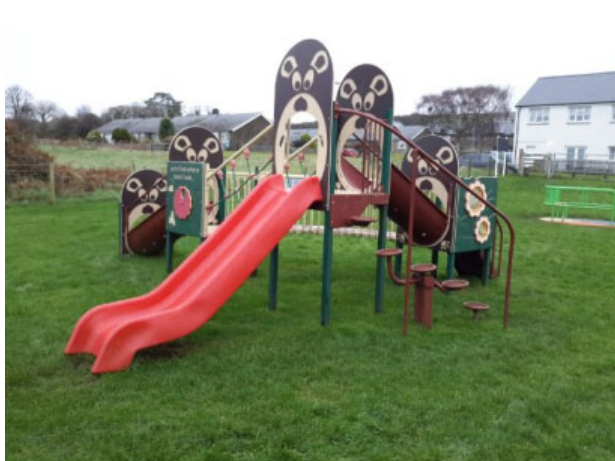
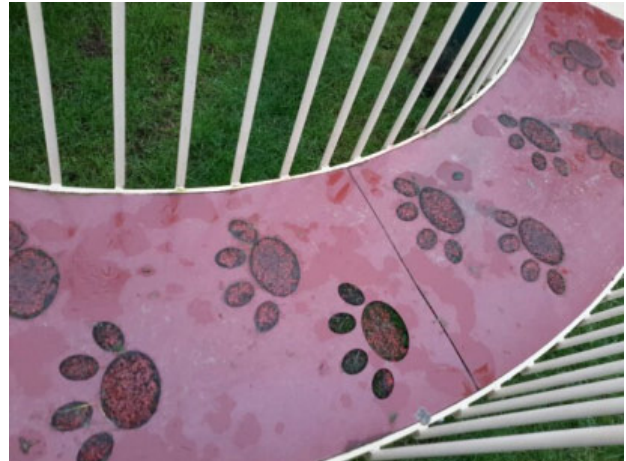
**Finding:** Wetpour inlays are worn

**Action:** Repair

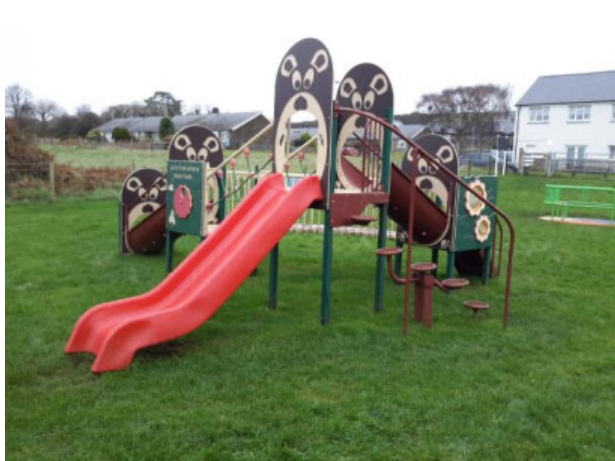
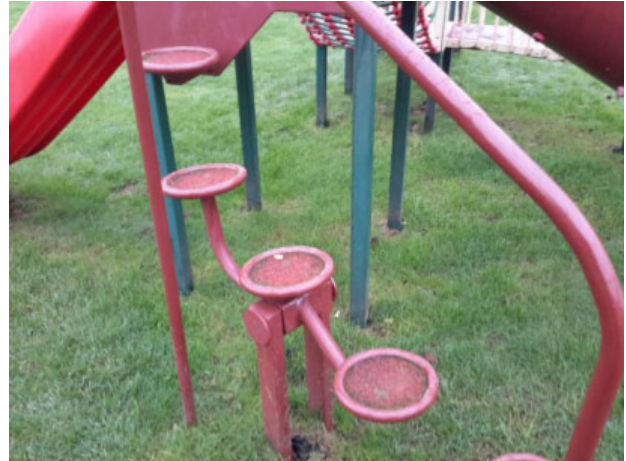
**Finding:** Rubber bearing worn on seesaw step

**Action:** Replace

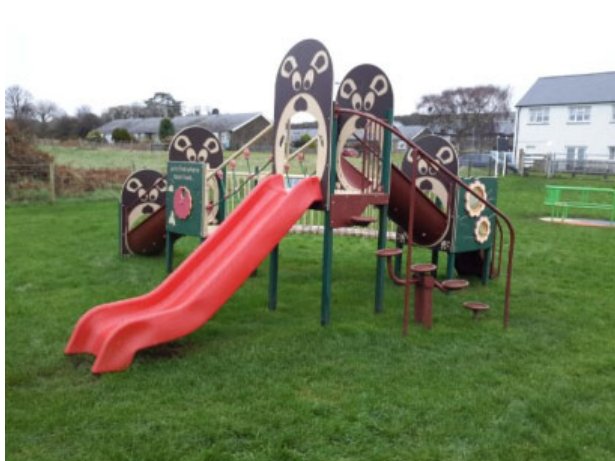
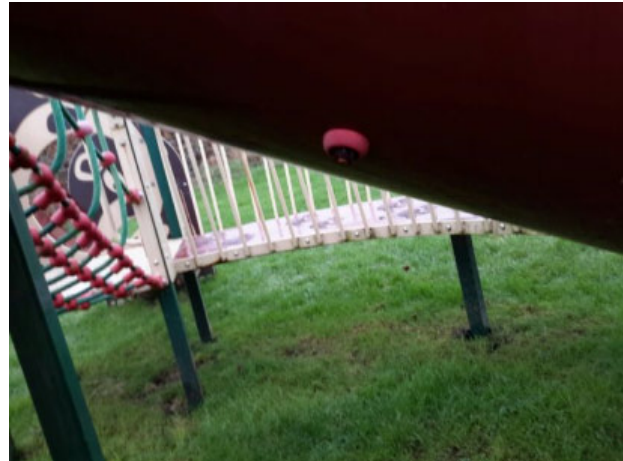
**Finding:** There is/are bolt cap covers missing or damaged on the item

**Action:** Replace missing or damaged bolt cap covers

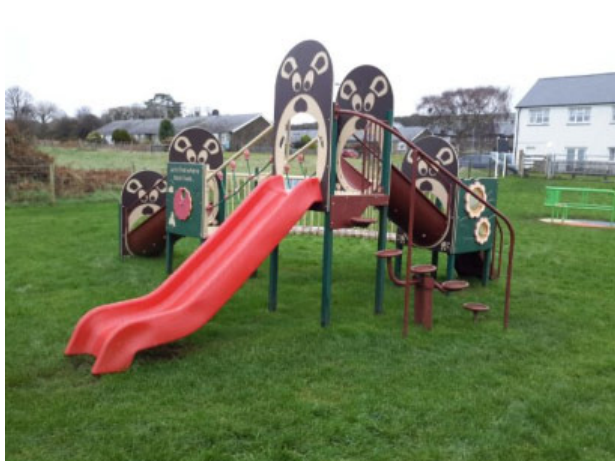
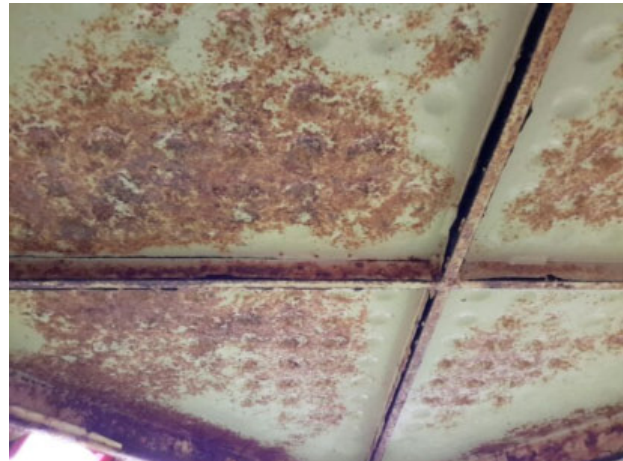
**Finding:** The paintwork on this item has been damaged or worn exposing the metal underneath which is rusting under the platforms

**Action:** Treat any rusting components and repaint

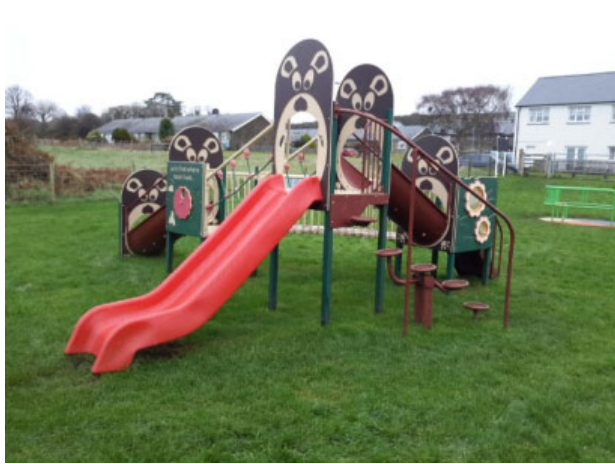
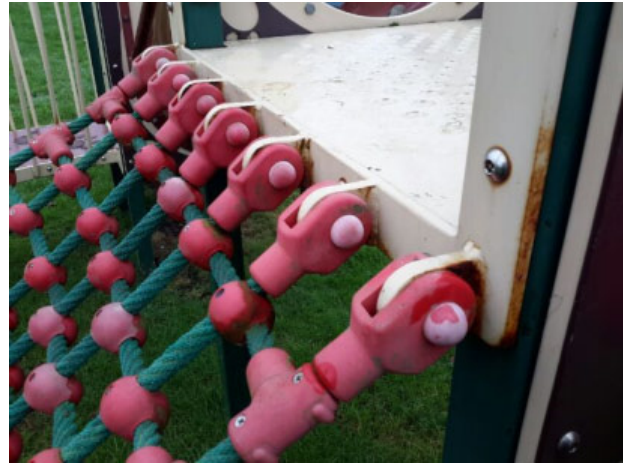
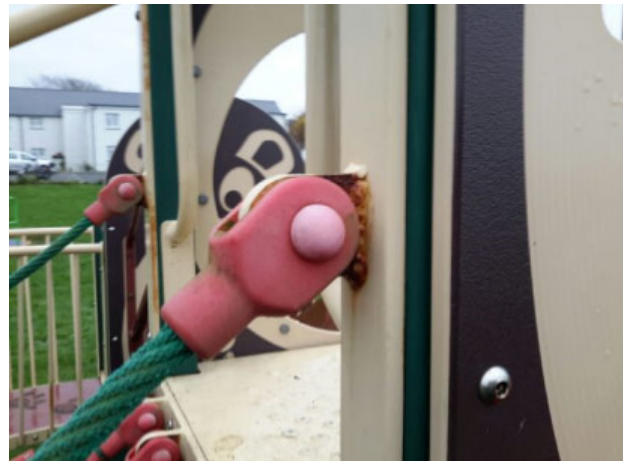
**Finding:** The paintwork on this item has been damaged or worn exposing the metal underneath which is rusting

**Action:** Treat any rusting components and repaint

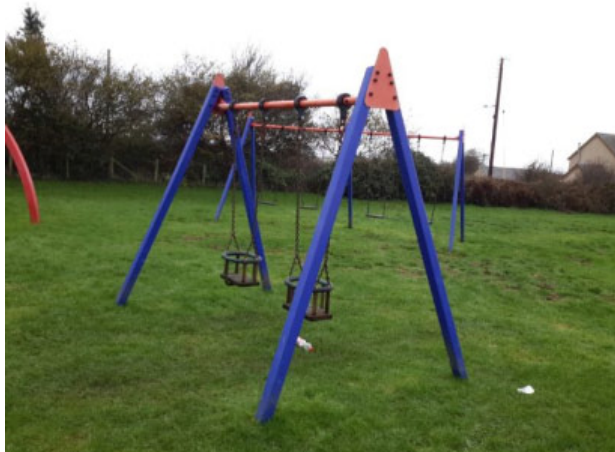
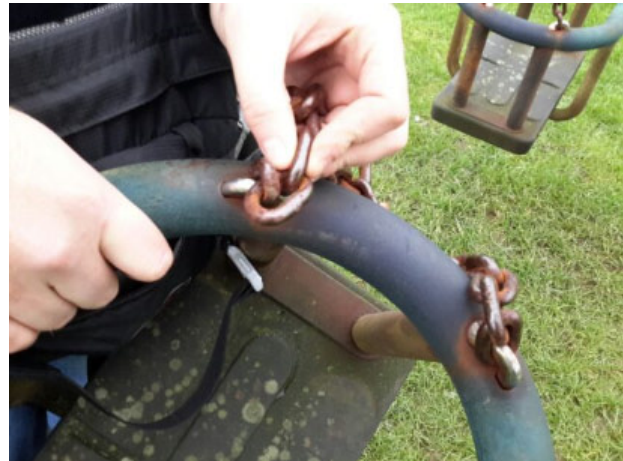
**Finding:** There is some notable evidence of chain wear

**Action:** Monitor for any further deterioration and replace when 40% worn

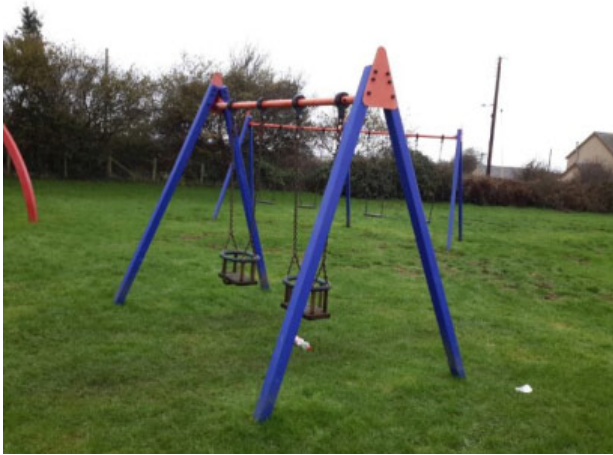
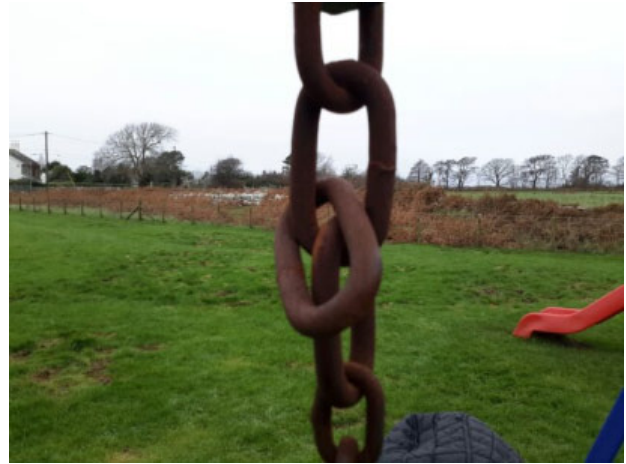
**Finding:** Chains have corroded

**Action:** Monitor and replace as required

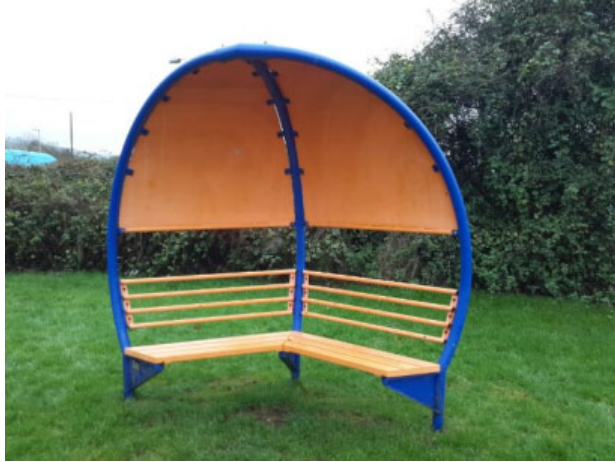
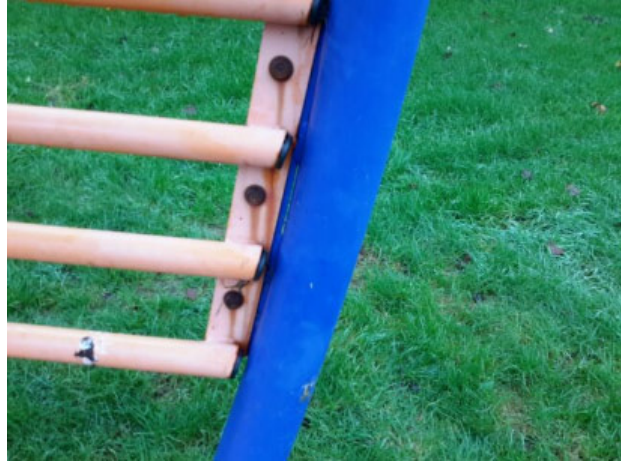
**Finding:** Fixings have corroded

**Action:** Replace

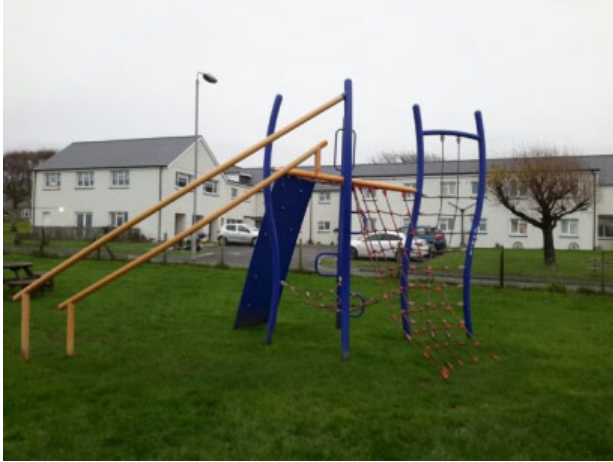
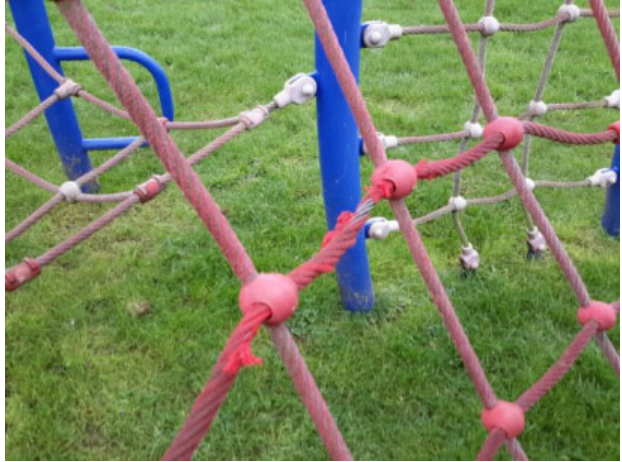
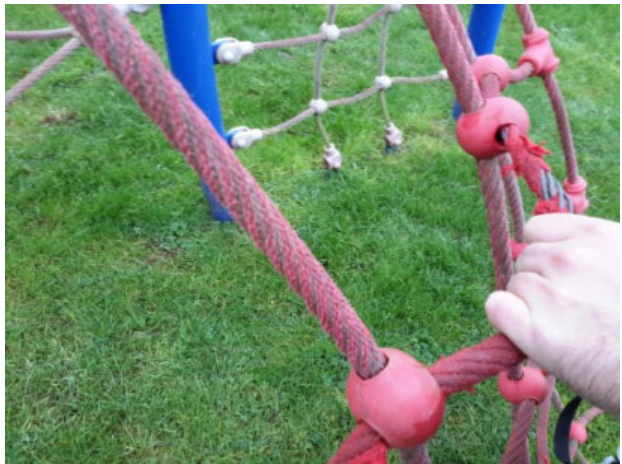
**Finding:** The ropes/nets are worn/damaged in places

**Action:** Monitor for any further deterioration and repair or replace as required

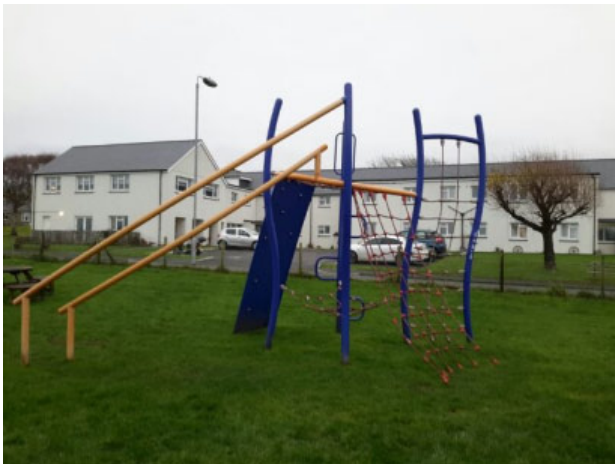
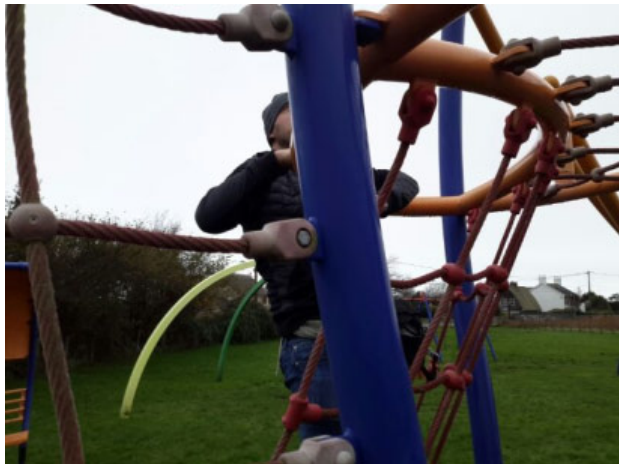
**Finding:** There is/are bolt cap covers missing or damaged on the item

**Action:** Replace missing or damaged bolt cap covers

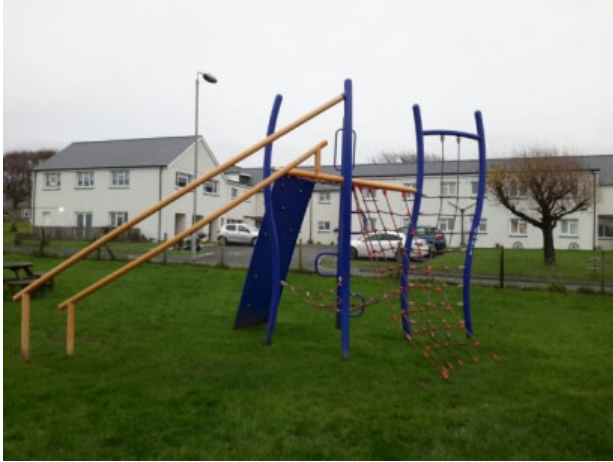
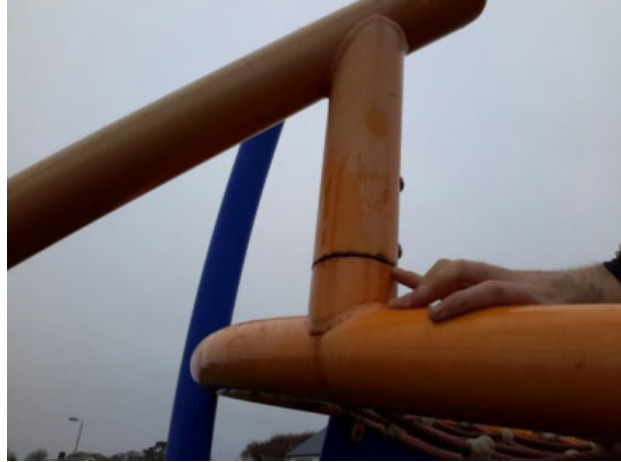
**Finding:** The paintwork on this item has been damaged or worn exposing the metal underneath which is rusting

**Action:** Treat any rusting components and repaint

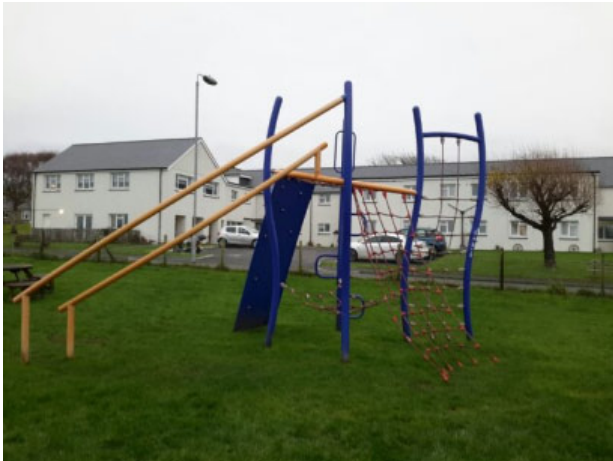
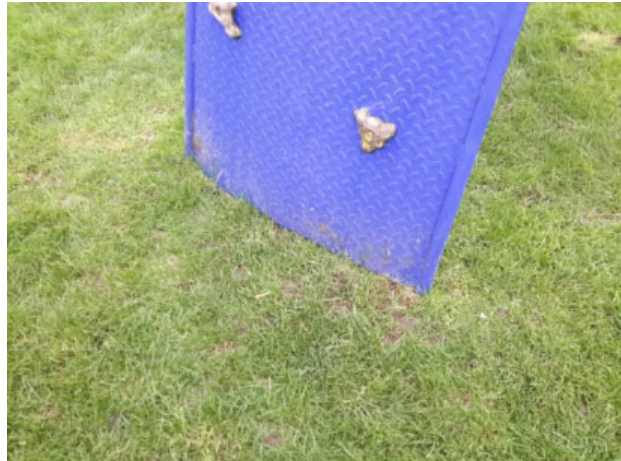
**Finding:** Climbing wall loose in ground at base

**Action:** Re concrete

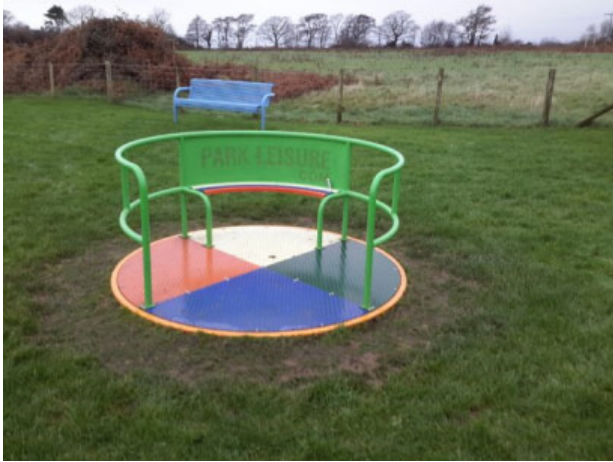
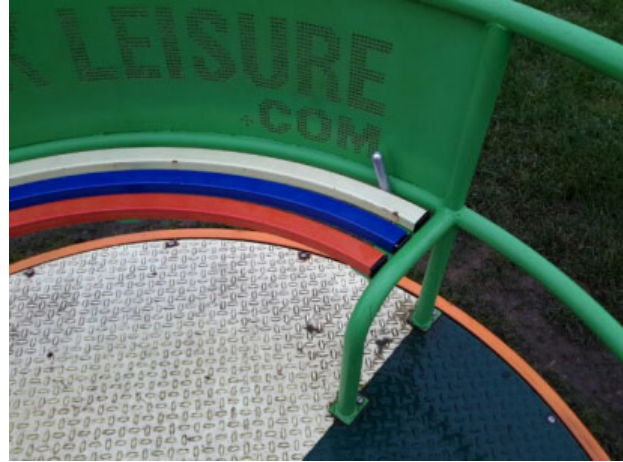
**Finding:** There is/are finger entrapment/s in the seat and the item fails to meet the requirements of BS EN 1176:2008 Part 1 4.2.7.6 Entrapment of fingers

**Action:** Monitor use

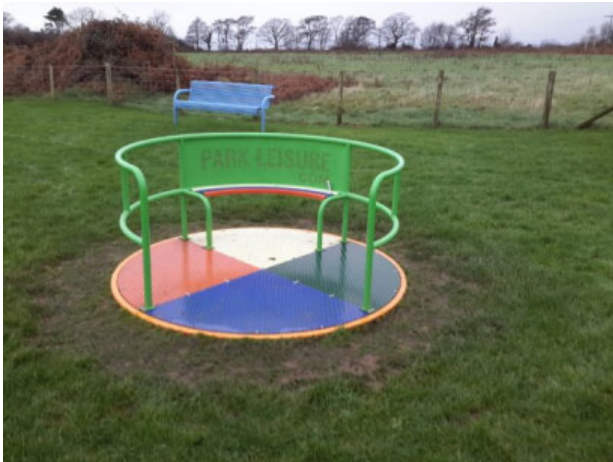
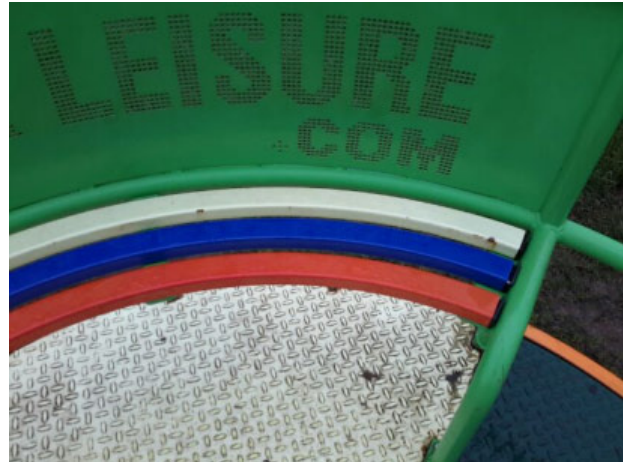
**Finding:** The paintwork on this item has been damaged or worn exposing the metal underneath which is rusting

**Action:** Treat any rusting components and repaint

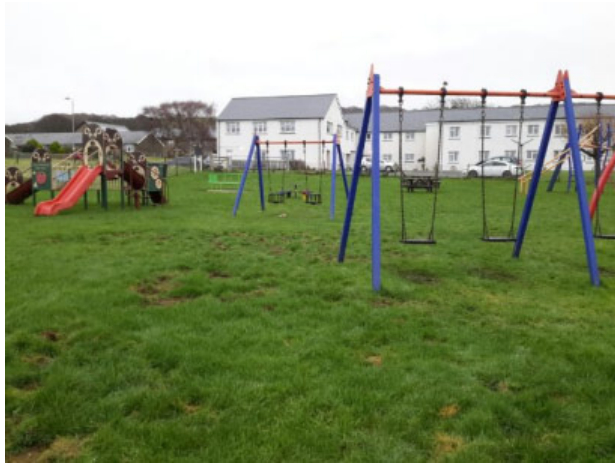
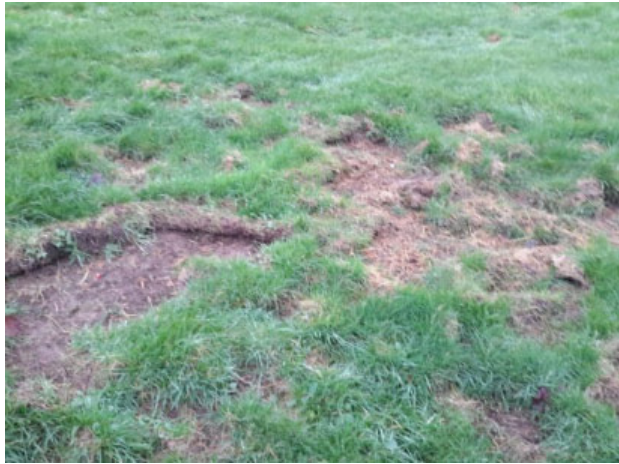
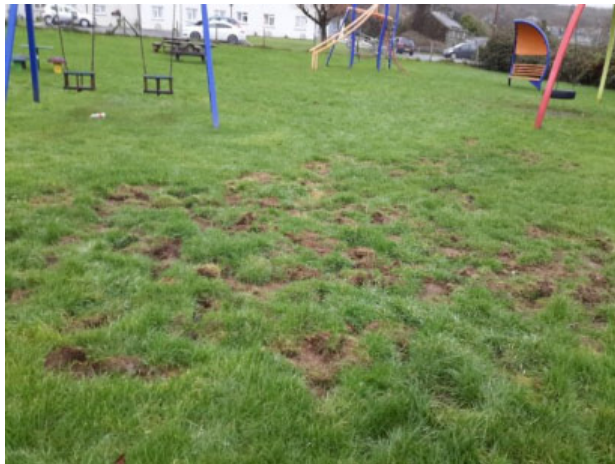
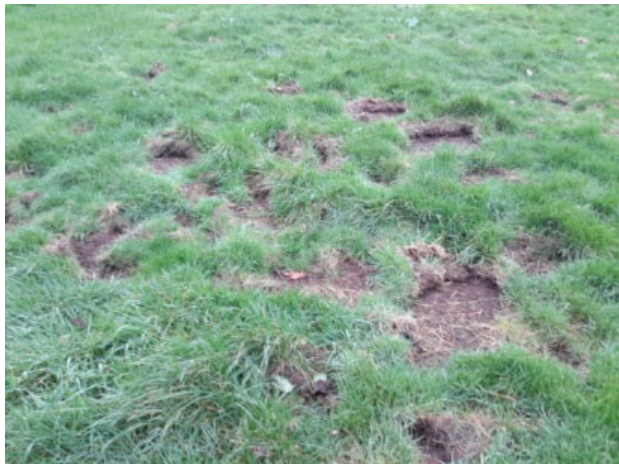
**Finding:** The ground is rutted and in poor condition

**Action:** Reinstate to level
