## Annual Inspection

Dyffryn Ardudwy and Talybont Community Council

Old Swings

Talybont, LL44 2HT

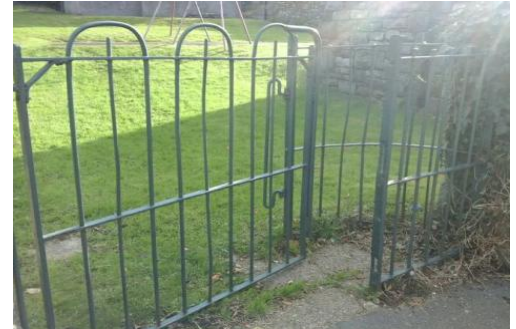
**Item:** Gate - Pedestrian  
**Manufacturer:** Owner/Operator  
**Surface Type:** N/A  
**Equipment Compliance:** N/A  
**Surface Area Compliance:** N/A

The opening between the gate and the post or the double gate leafs is less than 12mm and could trap users fingers - Where possible a 12mm gap should be maintained on both sides or between the gate leafs of the gate

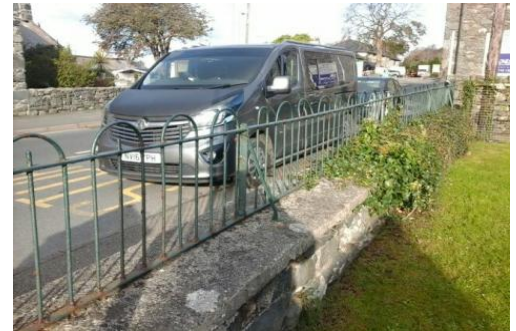
**Item:** Fence - Bow Top  
**Manufacturer:** Owner/Operator  
**Surface Type:** N/A  
**Equipment Compliance:** N/A  
**Surface Area Compliance:** N/A

There are a number of slats missing from the fence - Replace missing slats

There is surface corrosion present on the item - Consider treating and repainting the item

There is some damage to the fence sections - Monitor for any further deterioration and repair as required

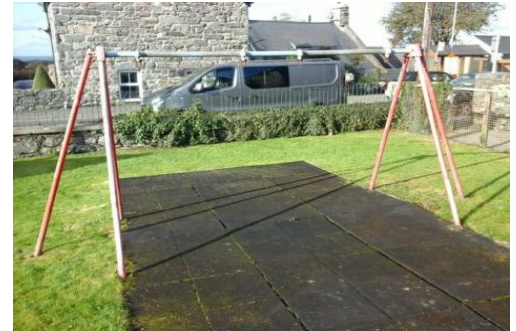
**Item:** 1 Bay 2 Seat (Cradle)  
**Manufacturer:** GL Jones  
**Surface Type:** Rubber Tiles  
**Equipment Compliance:** N/A  
**Surface Area Compliance:** N/A

There are significant gaps (over 30mm) between the surface and the edging or between the joints in the surface; these are large enough for a small foot to enter - Repair surfacing

There is some wear to the shackles. - Monitor for any further deterioration and replace when 40% worn

The shackles are corroding - Monitor for any further deterioration and replace as required

There are trip hazards at the edges of the surface - Reinstate surrounding surface levels to remove the trip points

The seat(s) and suspension were missing at the time of inspection and the inspector was unable to make a full compliance assessment - Replace missing seat(s) and suspension

The bushes are showing signs of wear - Monitor for any further deterioration and replace as required

The tiles can easily be lifted or are lifting along the edges of the area - Lift and re-glue tiles to secure

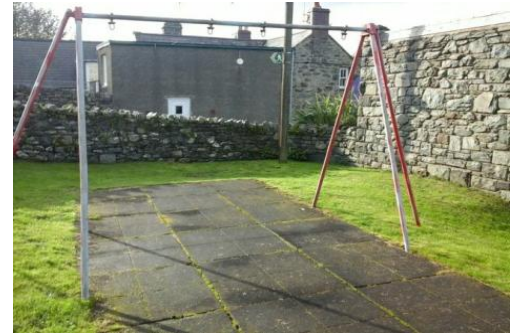
**Item:** 1 Bay 2 Seat (Flat)  
**Manufacturer:** GL Jones  
**Surface Type:** Rubber Tiles  
**Equipment Compliance:** N/A  
**Surface Area Compliance:** N/A

The seat(s) and suspension were missing at the time of inspection and the inspector was unable to make a full compliance assessment - Replace missing seat(s) and suspension

There are gaps opening in between the tiles - Monitor for any further deterioration and repair as required

The bushes are showing signs of wear - Monitor for any further deterioration and replace as required

There is some wear to the shackles. - Monitor for any further deterioration and replace when 40% worn

The shackles are corroding - Monitor for any further deterioration and replace as required

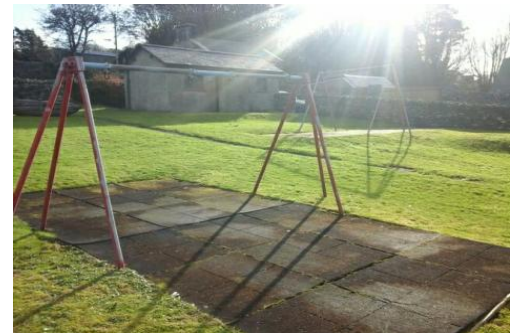
**Item:** Site General  
**Manufacturer:** Owner/Operator  
**Surface Type:** N/A  
**Equipment Compliance:** N/A  
**Surface Area Compliance:** N/A

There is algae or moss growth on the surface resulting in slippery conditions - Clean and treat appropriately

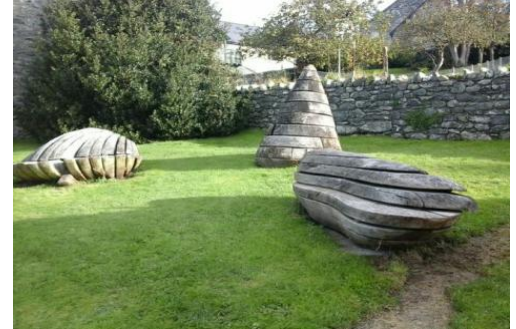
**Item:** Sculpture  
**Manufacturer:** Not Identified  
**Surface Type:** Grass  
**Equipment Compliance:** N/A  
**Surface Area Compliance:** N/A

The top section is loose - Secure top section

There is some evidence of rot in the timber - Monitor for any further deterioration and replace as required

A timber is loose producing a projecting fixing - Re secure timber

A timber section has dropped allowing a foot entrapment - Repair

The item has started to separate resulting in potential entrapments - Repair

There is a potential crush point between the rotating sections - Adjust item to remove crush point

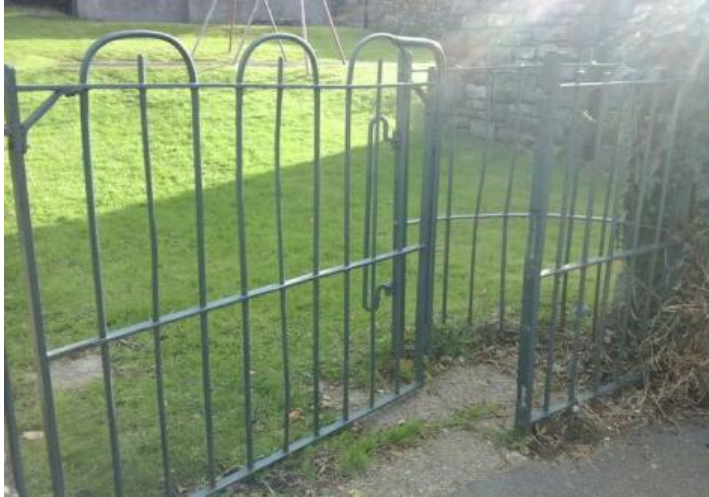
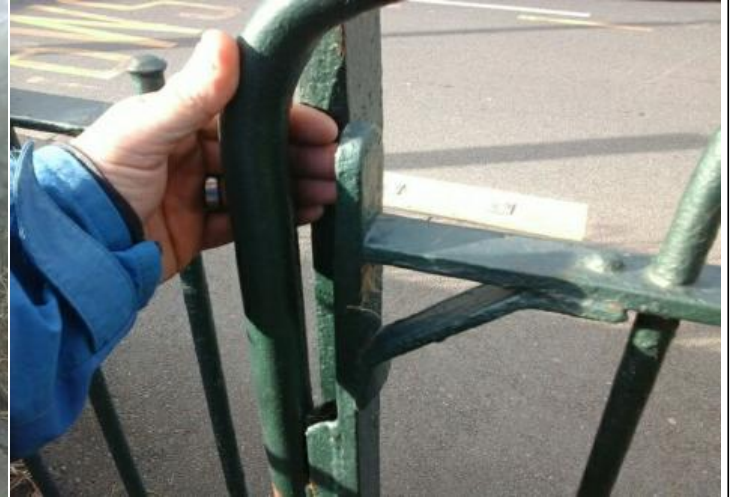
**Item:** Ancillary Items - Gate - Pedestrian  
**Manufacturer:** Owner/Operator

**Finding:** The opening between the gate and the post or the double gate leafs is less than 12mm and could trap users fingers

**Action:** Where possible a 12mm gap should be maintained on both sides or between the gate leafs of the gate

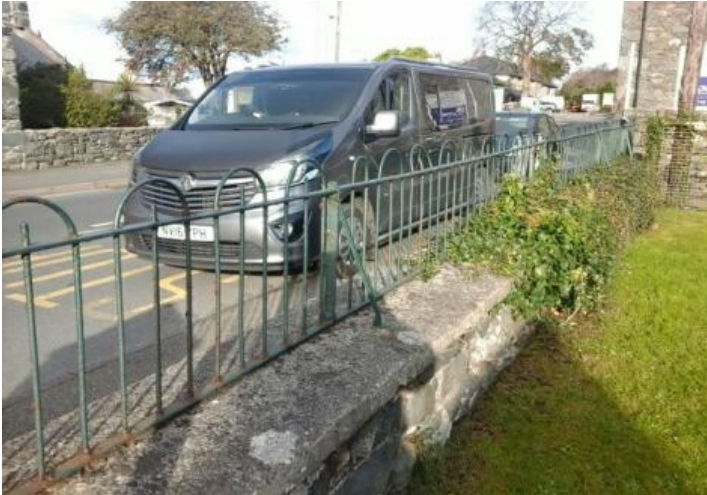
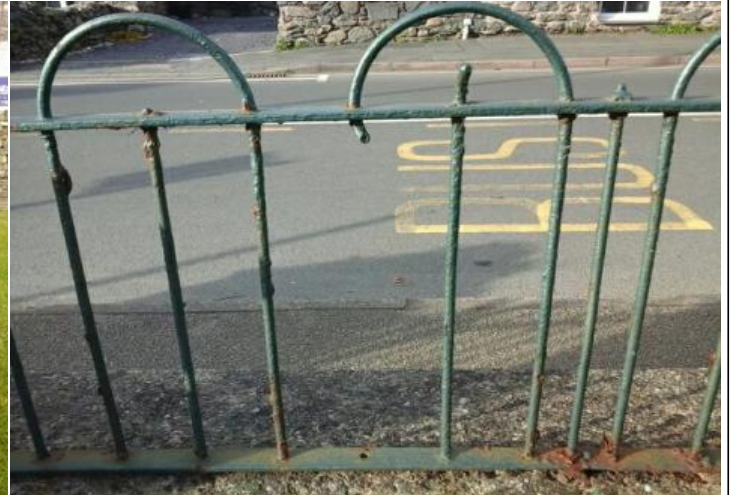
**Item:** Ancillary Items - Fence - Bow Top  
**Manufacturer:** Owner/Operator

**Finding:** There are a number of slats missing from the fence

**Action:** Replace missing slats

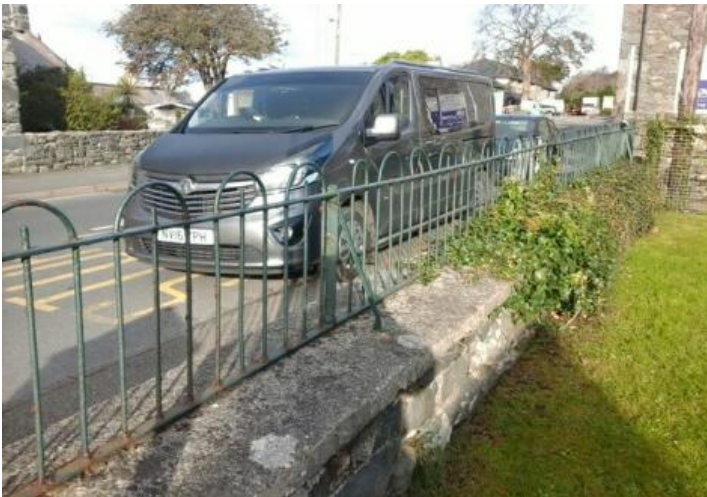
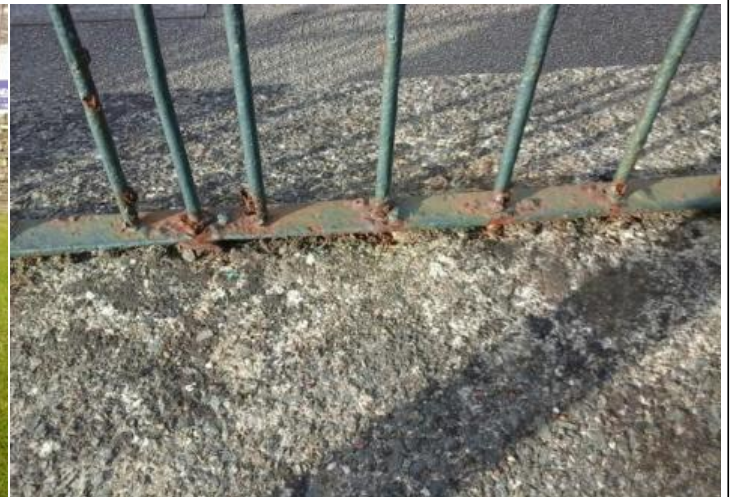
**Item:** Ancillary Items - Fence - Bow Top  
**Manufacturer:** Owner/Operator

**Finding:** There is surface corrosion present on the item

**Action:** Consider treating and repainting the item

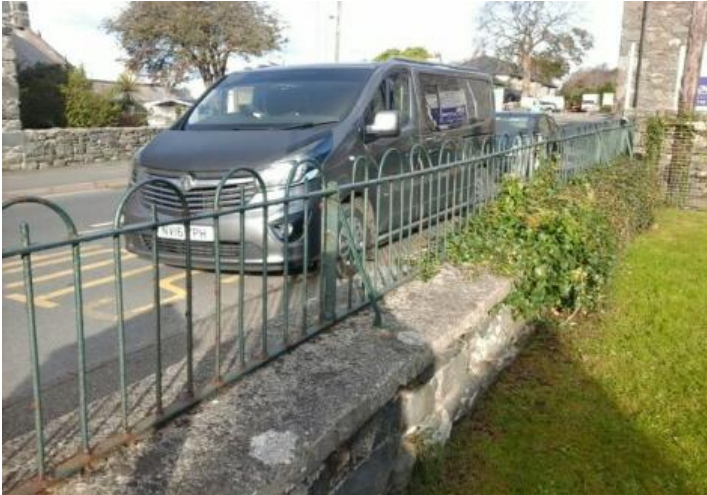
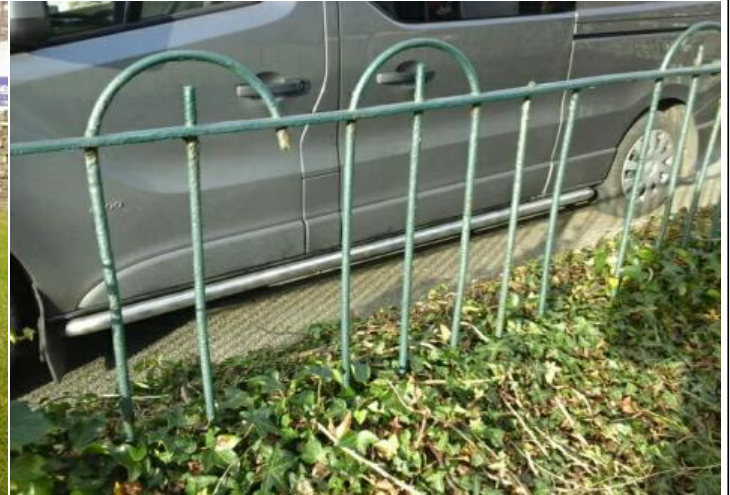
**Item:** Ancillary Items - Fence - Bow Top  
**Manufacturer:** Owner/Operator

**Finding:** There is some damage to the fence sections

**Action:** Monitor for any further deterioration and repair as required

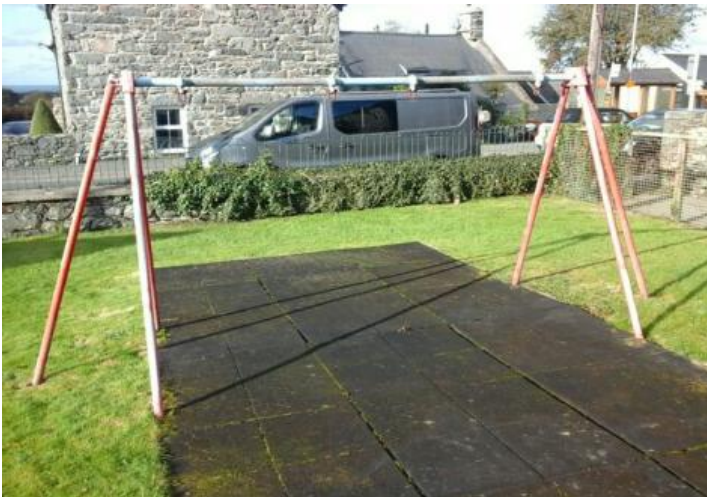
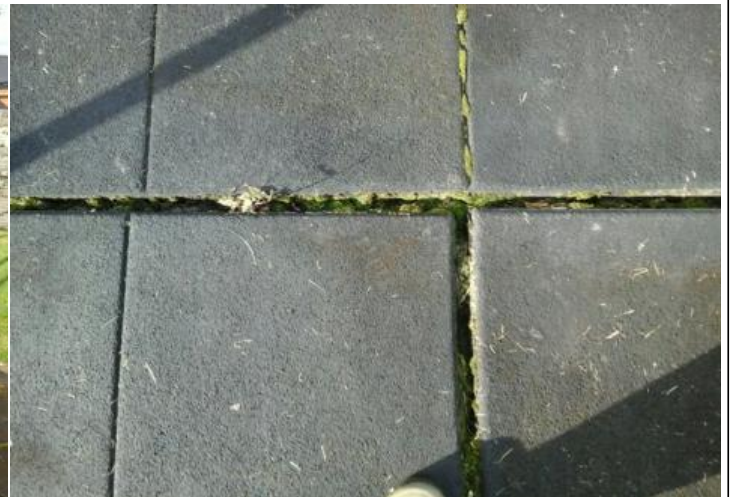
**Item:** Swings - 1 Bay 2 Seat (Cradle)  
**Manufacturer:** GL Jones

**Finding:** There are significant gaps (over 30mm) between the surface and the edging or between the joints in the surface; these are large enough for a small foot to enter

**Action:** Repair surfacing

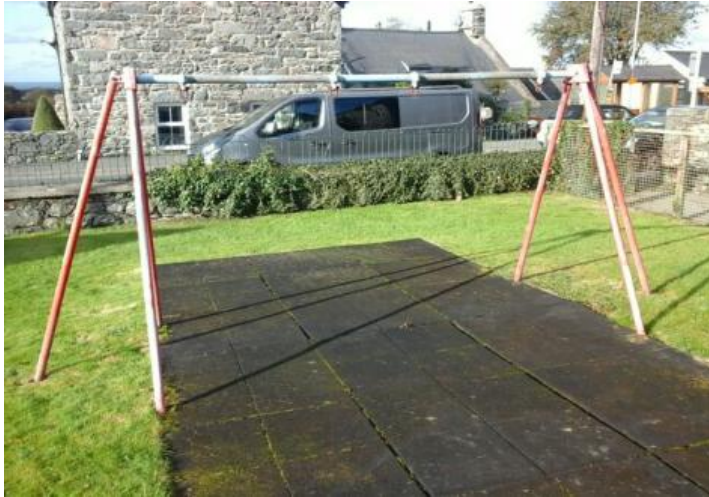
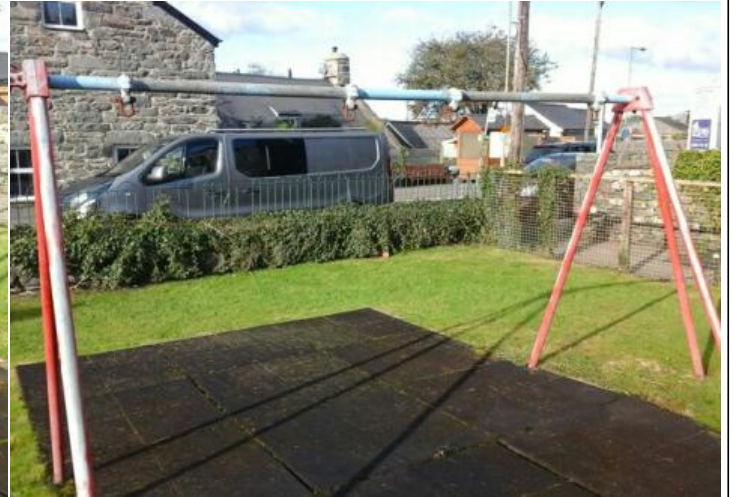
**Item:** Swings - 1 Bay 2 Seat (Cradle)  
**Manufacturer:** GL Jones

**Finding:** The seat(s) and suspension were missing at the time of inspection and the inspector was unable to make a full compliance assessment

**Action:** Replace missing seat(s) and suspension

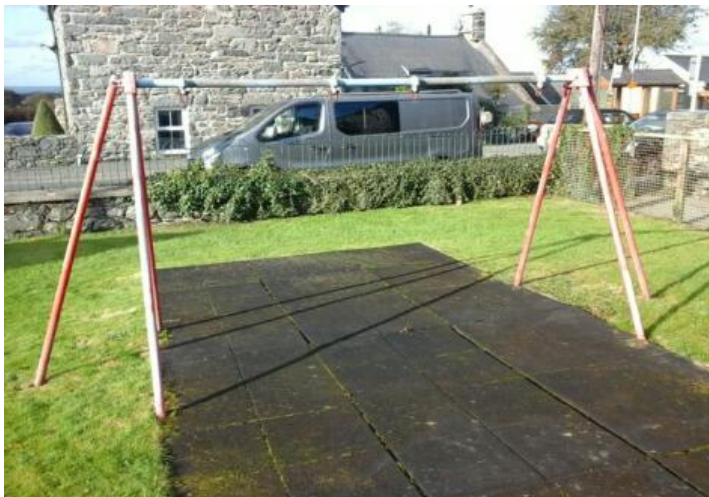
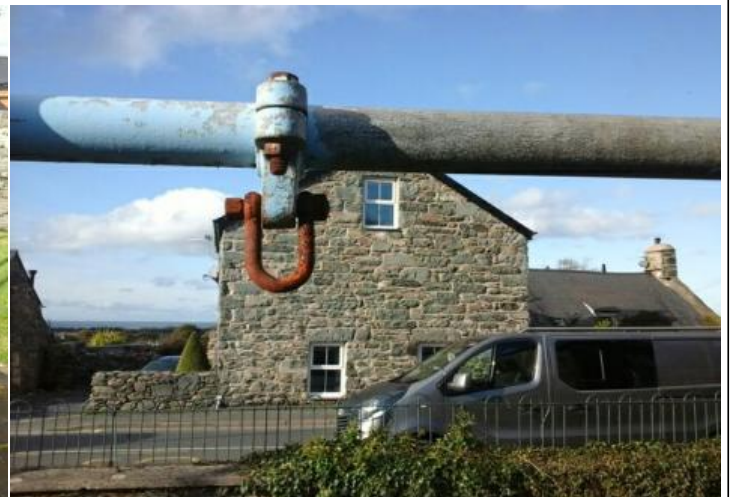
**Item:** Swings - 1 Bay 2 Seat (Cradle)  
**Manufacturer:** GL Jones

**Finding:** There is some wear to the shackles.

**Action:** Monitor for any further deterioration and replace when 40% worn

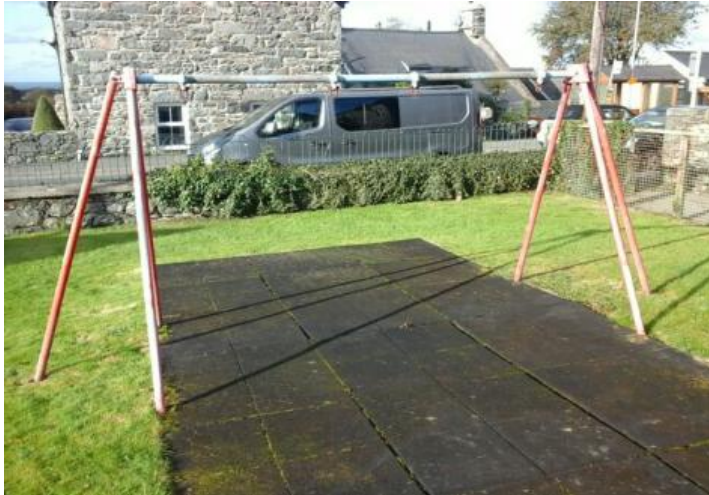
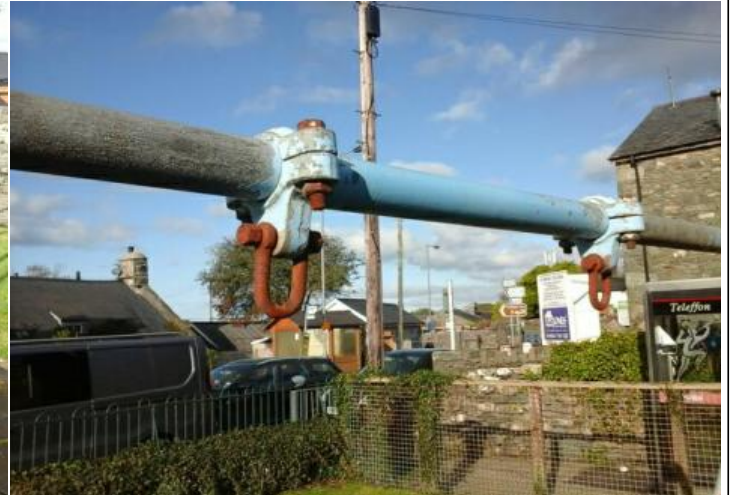
**Item:** Swings - 1 Bay 2 Seat (Cradle)  
**Manufacturer:** GL Jones

**Finding:** The bushes are showing signs of wear

**Action:** Monitor for any further deterioration and replace as required

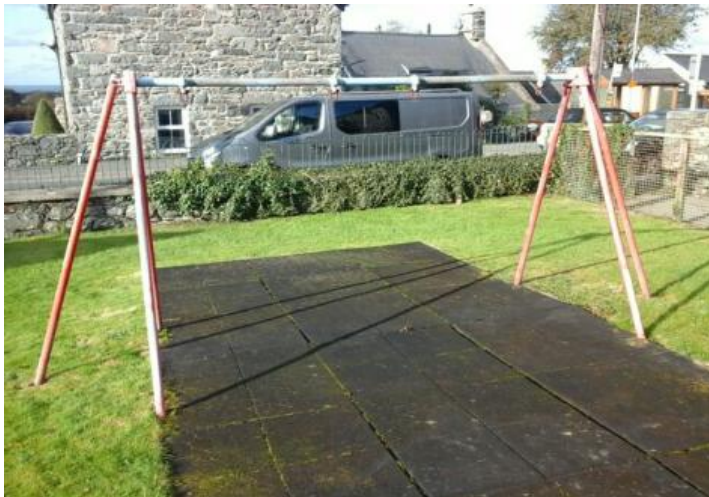
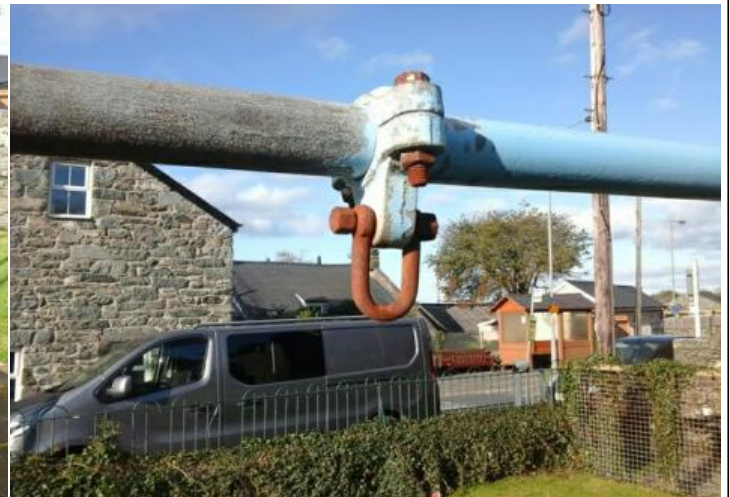
**Item:** Swings - 1 Bay 2 Seat (Cradle)  
**Manufacturer:** GL Jones

**Finding:** The shackles are corroding

**Action:** Monitor for any further deterioration and replace as required

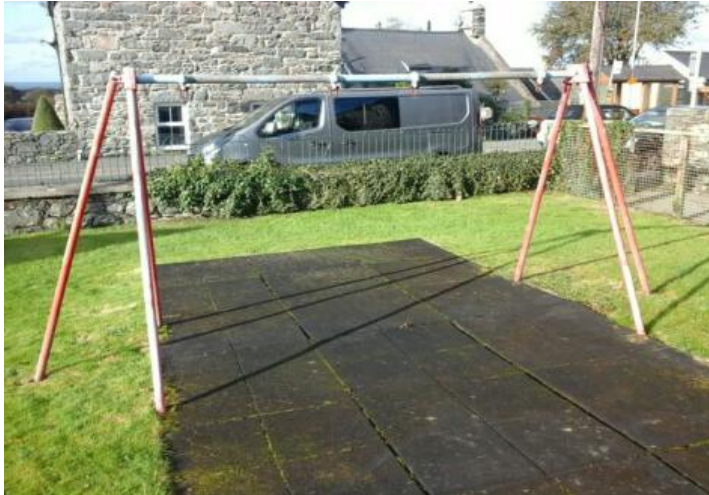
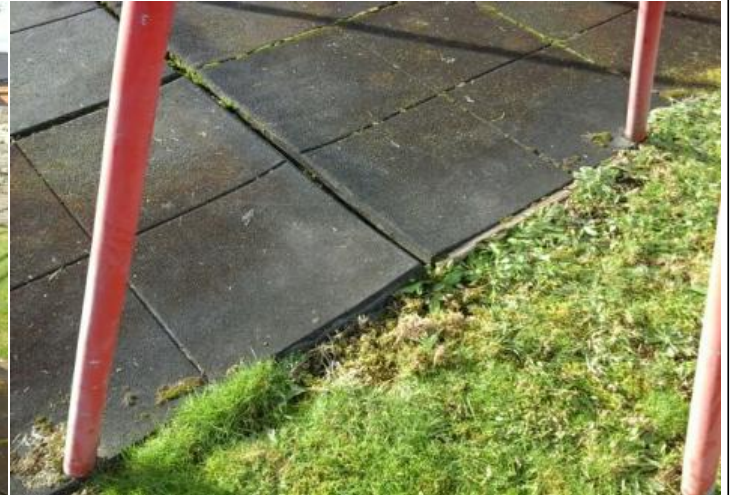
**Item:** Swings - 1 Bay 2 Seat (Cradle)  
**Manufacturer:** GL Jones

**Finding:** The tiles can easily be lifted or are lifting along the edges of the area  
**Action:** Lift and re-glue tiles to secure

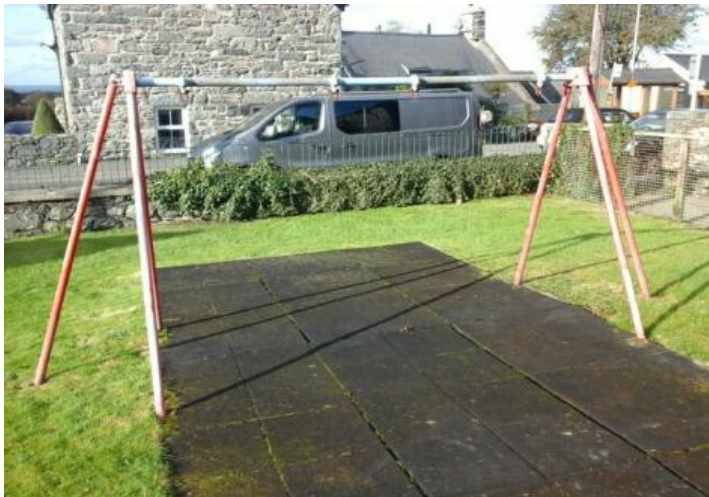
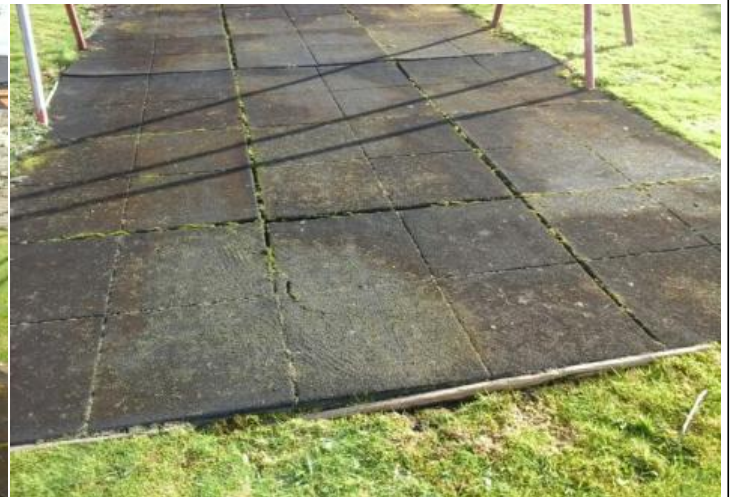
**Item:** Swings - 1 Bay 2 Seat (Cradle)  
**Manufacturer:** GL Jones

**Finding:** There are trip hazards at the edges of the surface  
**Action:** Reinstate surrounding surface levels to remove the trip points

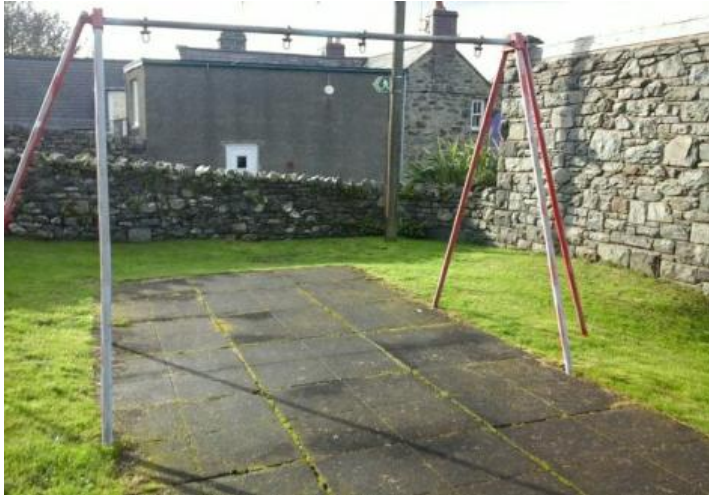
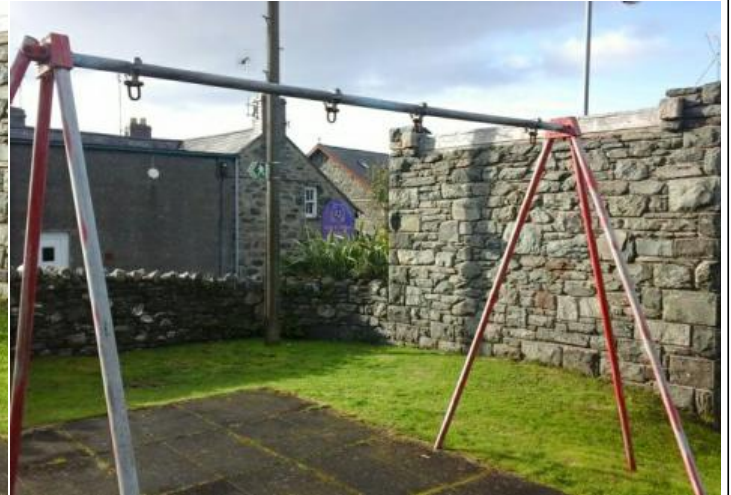
**Item:** Swings - 1 Bay 2 Seat (Flat)  
**Manufacturer:** GL Jones

**Finding:** The seat(s) and suspension were missing at the time of inspection and the inspector was unable to make a full compliance assessment

**Action:** Replace missing seat(s) and suspension

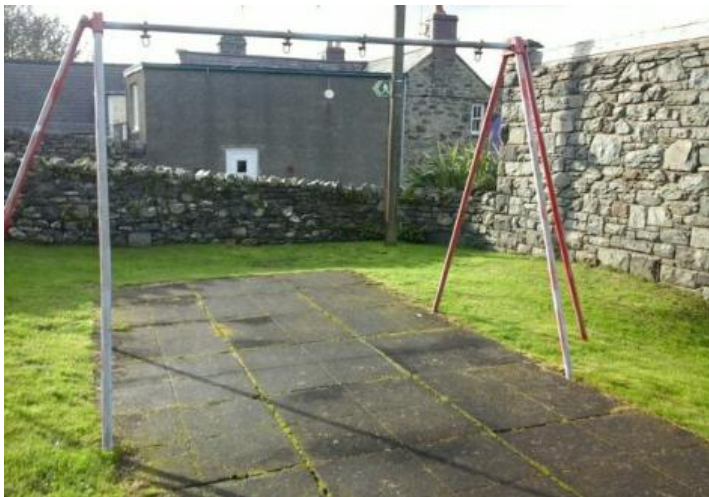
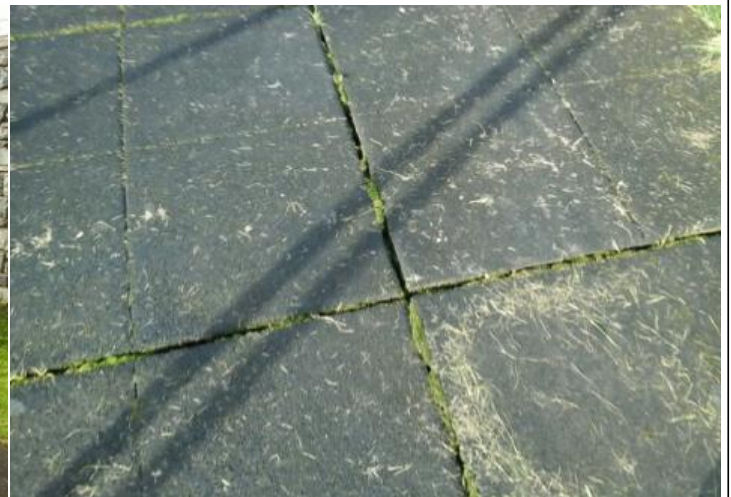
**Item:** Swings - 1 Bay 2 Seat (Flat)  
**Manufacturer:** GL Jones

**Finding:** There are gaps opening in between the tiles

**Action:** Monitor for any further deterioration and repair as required

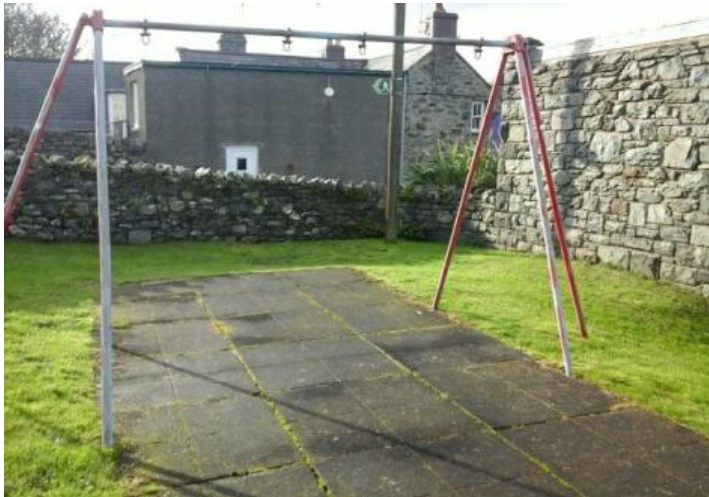
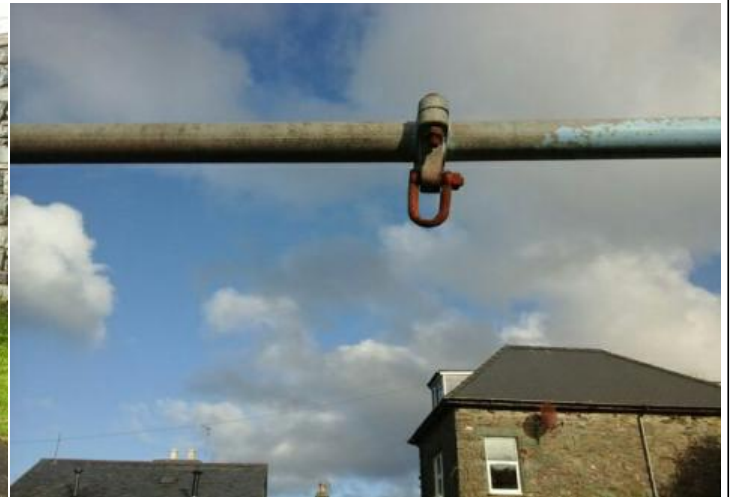
**Item:** Swings - 1 Bay 2 Seat (Flat)  
**Manufacturer:** GL Jones

**Finding:** The bushes are showing signs of wear

**Action:** Monitor for any further deterioration and replace as required

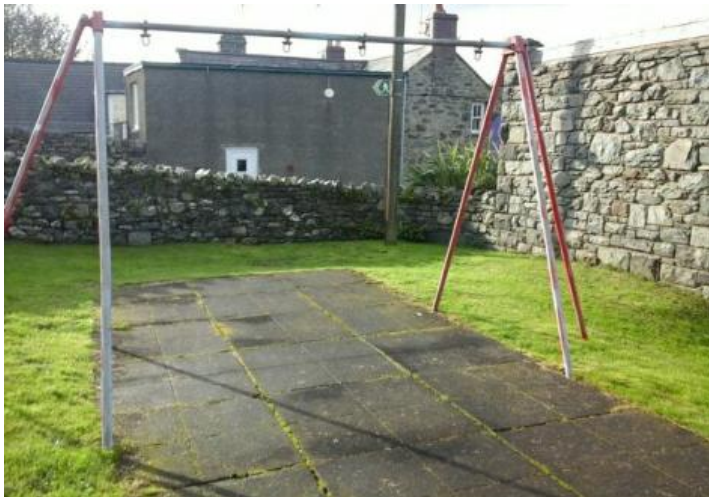
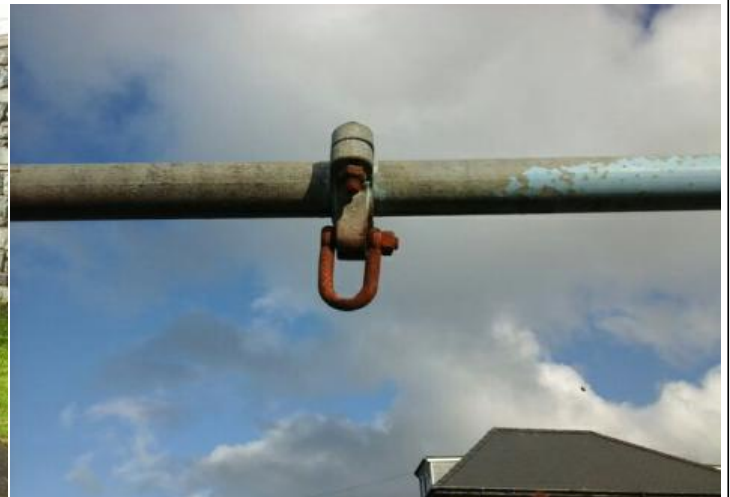
**Item:** Swings - 1 Bay 2 Seat (Flat)  
**Manufacturer:** GL Jones

**Finding:** There is some wear to the shackles.

**Action:** Monitor for any further deterioration and replace when 40% worn

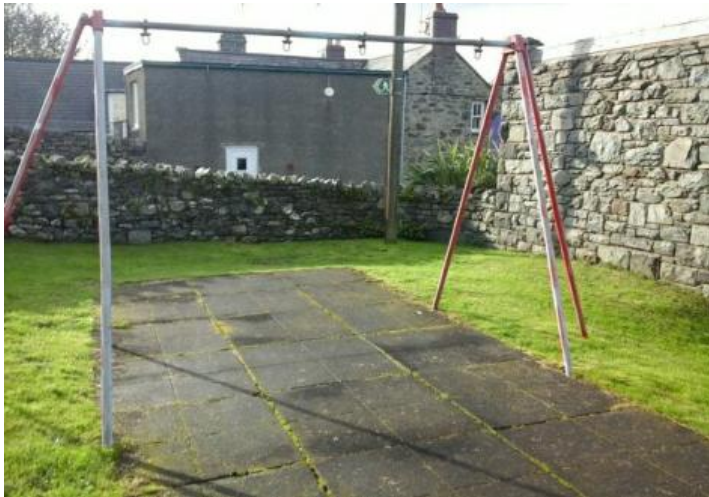
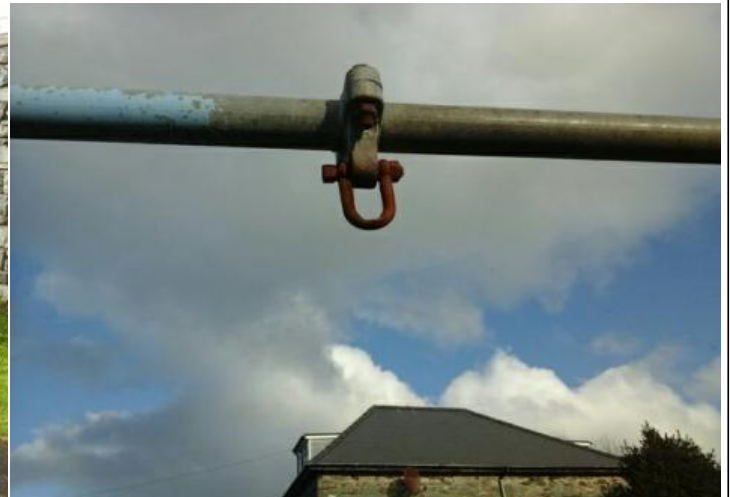
**Item:** Swings - 1 Bay 2 Seat (Flat)  
**Manufacturer:** GL Jones

**Finding:** The shackles are corroding

**Action:** Monitor for any further deterioration and replace as required

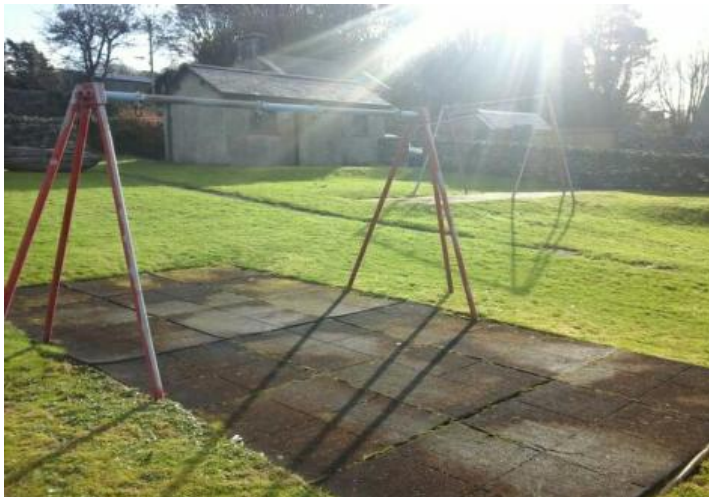
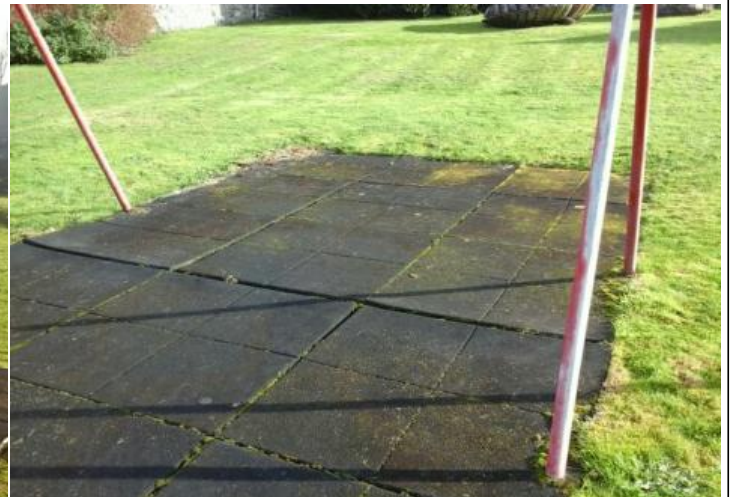
**Item:** Ancillary Items - Site General  
**Manufacturer:** Owner/Operator

**Finding:** There is algae or moss growth on the surface resulting in slippery conditions

**Action:** Clean and treat appropriately

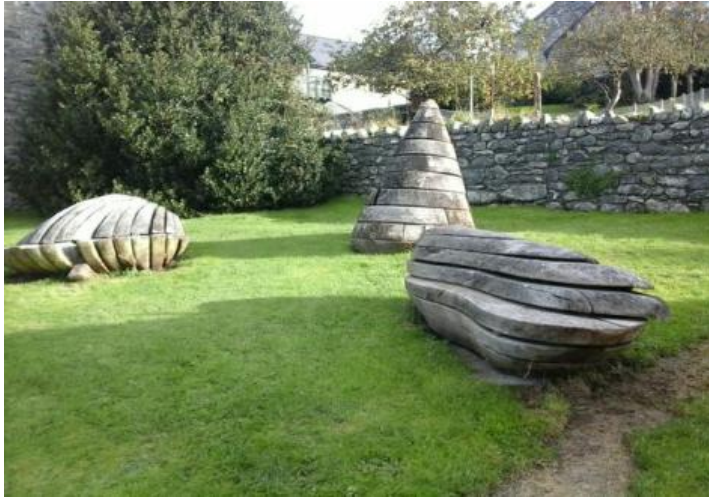
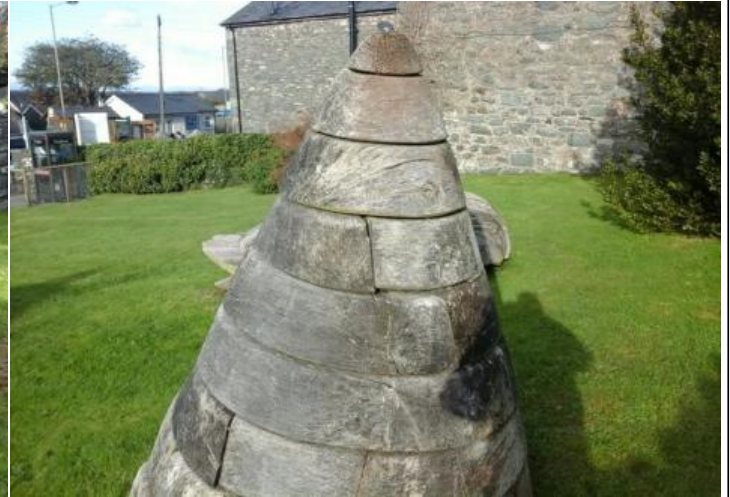
**Item:** Other - Sculpture  
**Manufacturer:** Not Identified

**Finding:** The top section is loose

**Action:** Secure top section

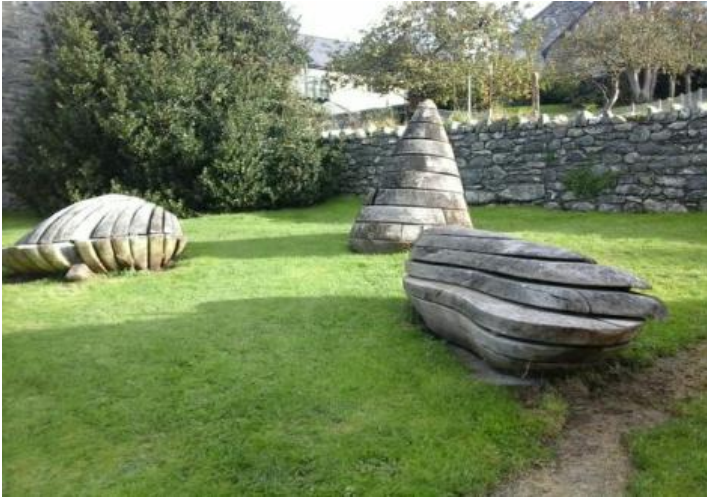
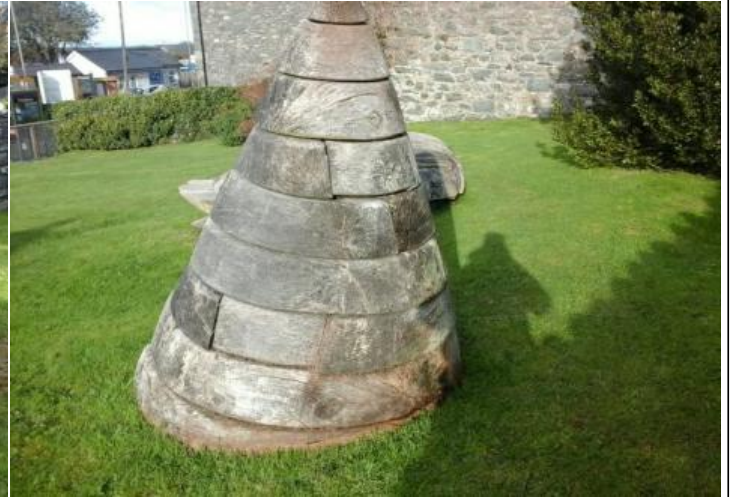
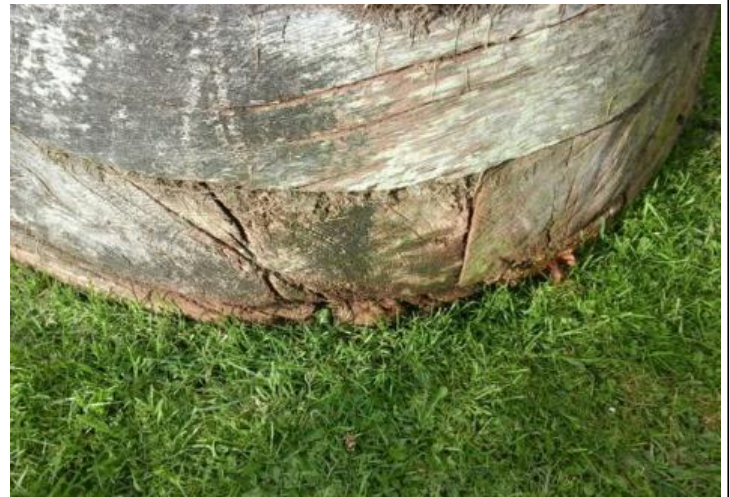
**Item:** Other - Sculpture  
**Manufacturer:** Not Identified

**Finding:** There is some evidence of rot in the timber

**Action:** Monitor for any further deterioration and replace as required

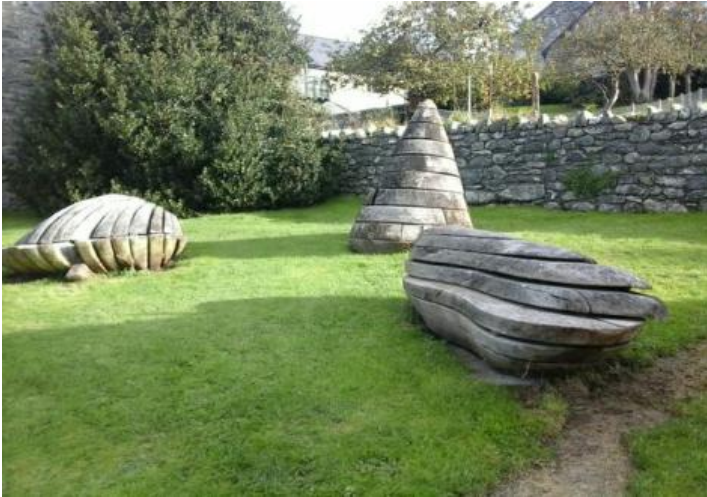
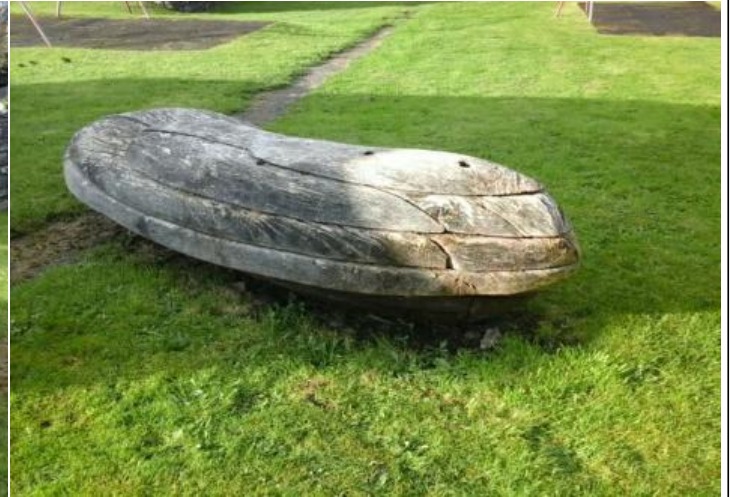
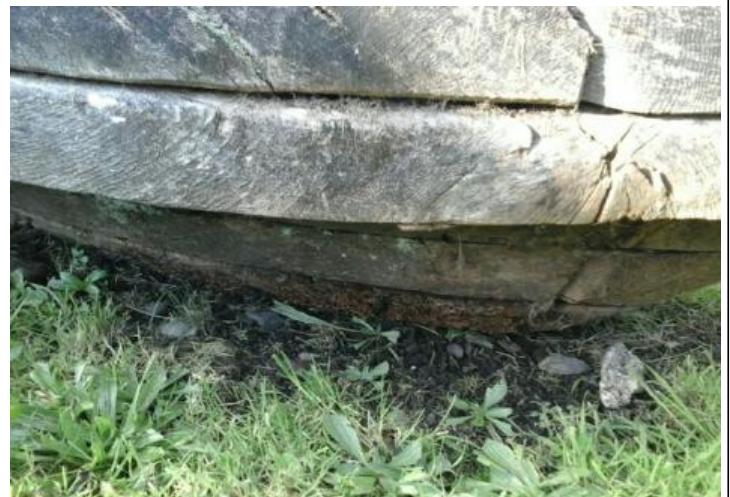
**Item:** Other - Sculpture  
**Manufacturer:** Not Identified

**Finding:** There is some evidence of rot in the timber

**Action:** Monitor for any further deterioration and replace as required

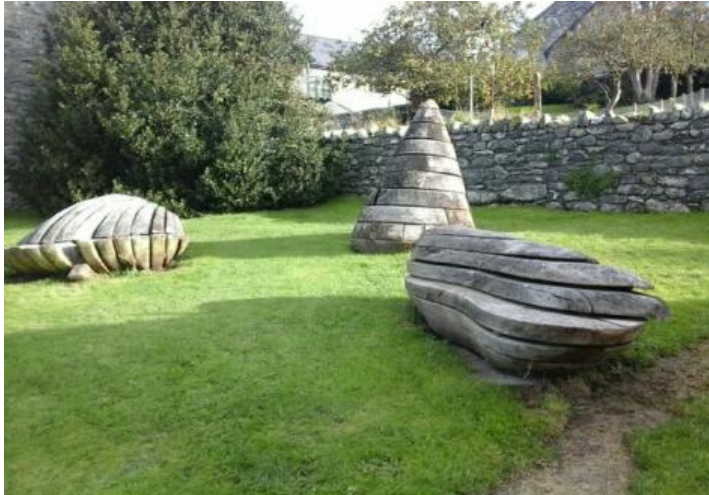
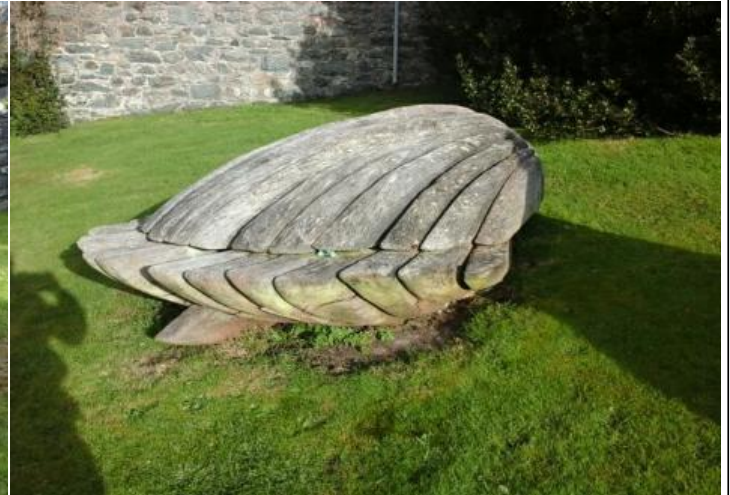
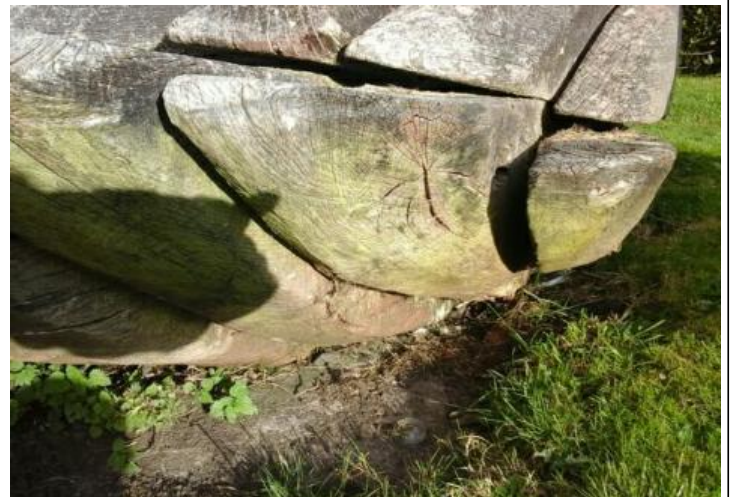
**Item:** Other - Sculpture  
**Manufacturer:** Not Identified

**Finding:** There is some evidence of rot in the timber

**Action:** Monitor for any further deterioration and replace as required

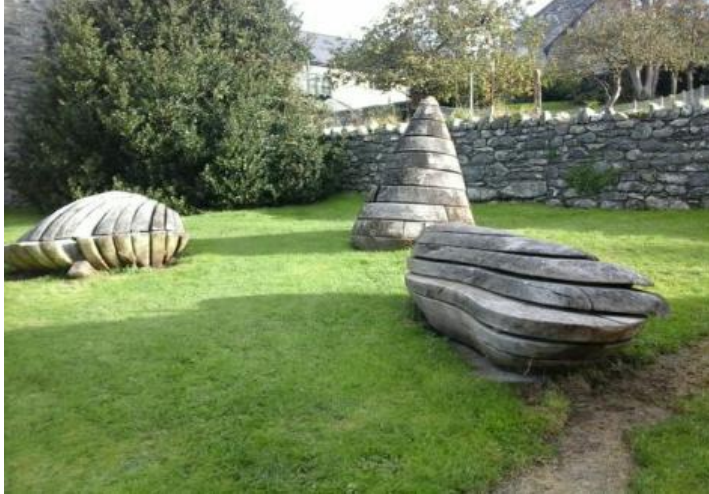
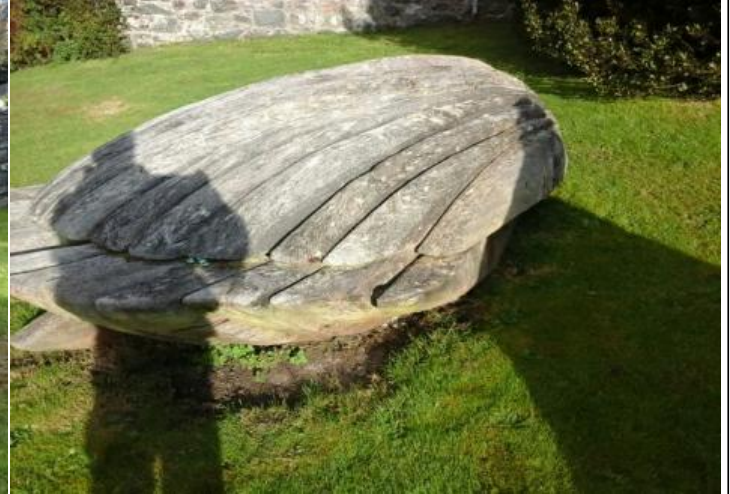
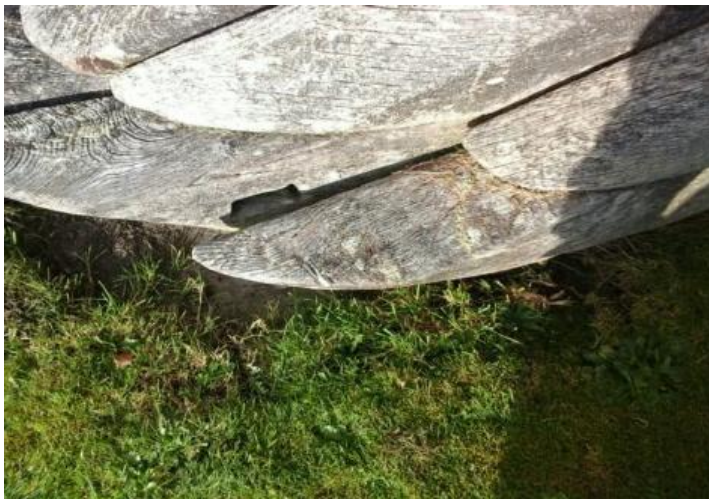
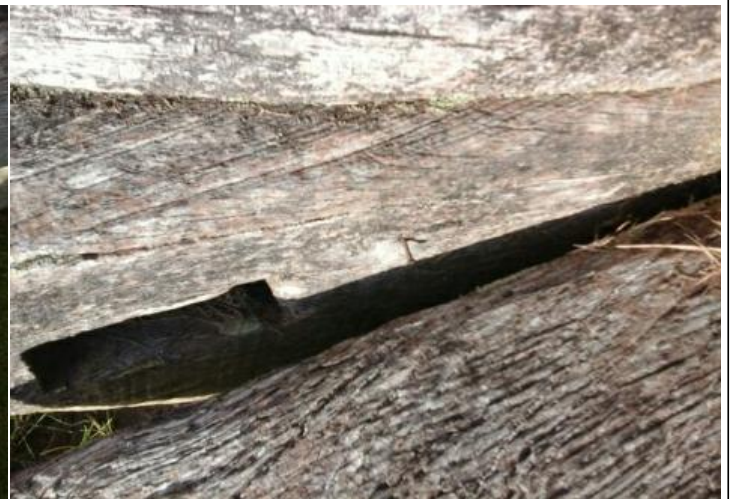
**Item:** Other - Sculpture  
**Manufacturer:** Not Identified

**Finding:** A timber is loose producing a projecting fixing

**Action:** Re secure timber

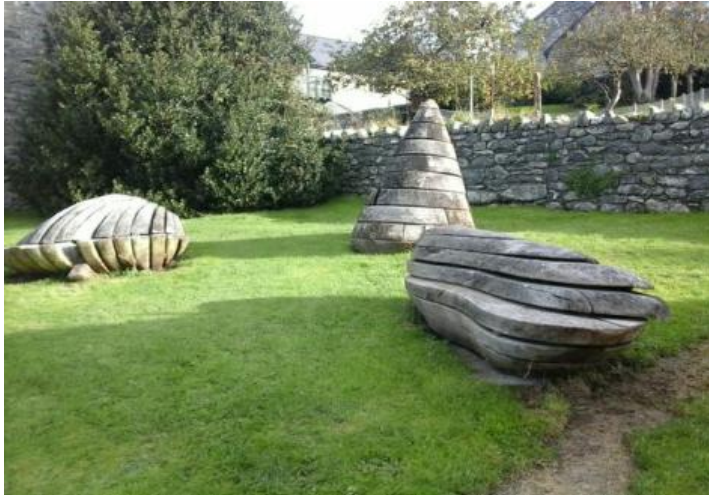
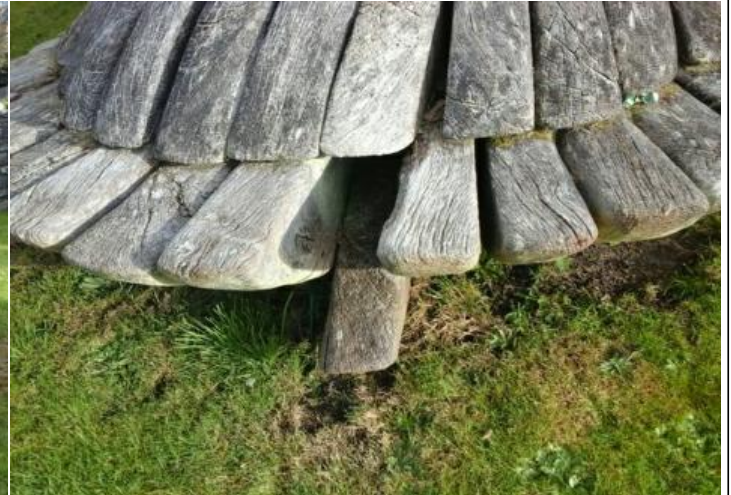
**Item:** Other - Sculpture  
**Manufacturer:** Not Identified

**Finding:** A timber section has dropped allowing a foot entrapment

**Action:** Repair

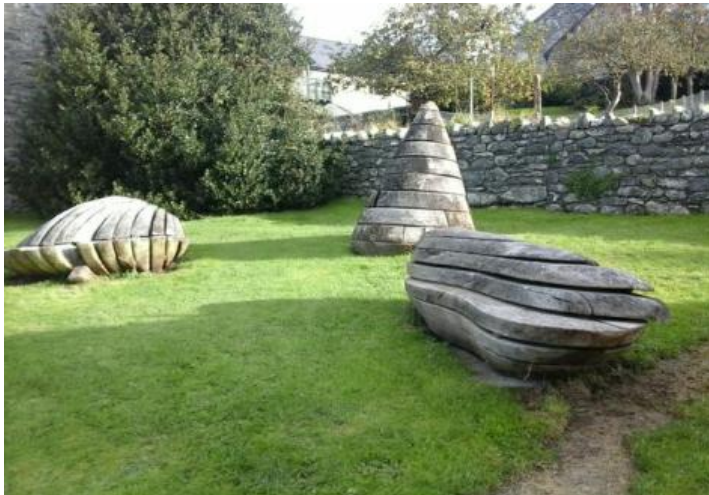
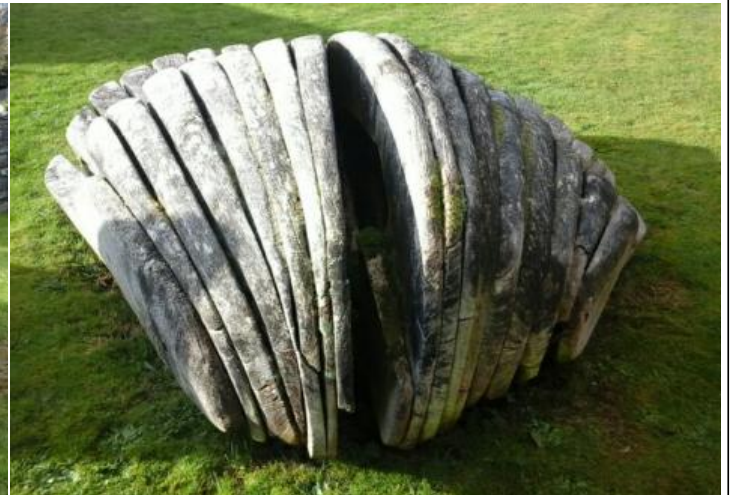
**Item:** Other - Sculpture  
**Manufacturer:** Not Identified

**Finding:** The item has started to separate resulting in potential entrapments

**Action:** Repair

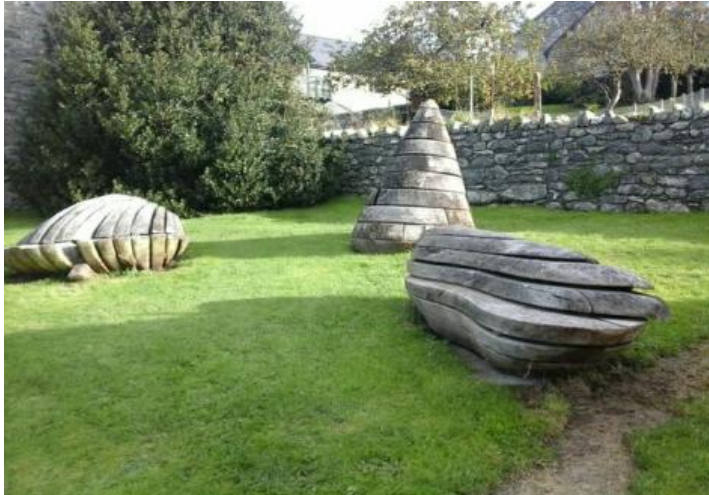
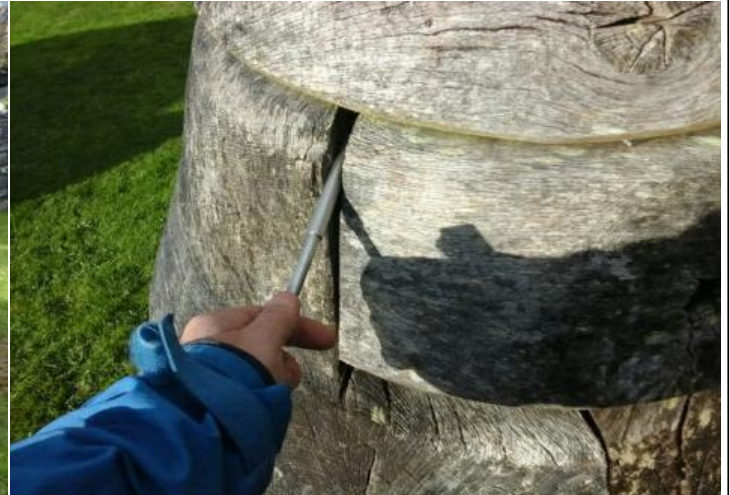
**Item:** Other - Sculpture  
**Manufacturer:** Not Identified

**Finding:** There is a potential crush point between the rotating sections

**Action:** Adjust item to remove crush point
