## Annual Inspection

Dyffryn Ardudwy and Talybont Community Council

Old Swings

Talybont, LL44 2HT

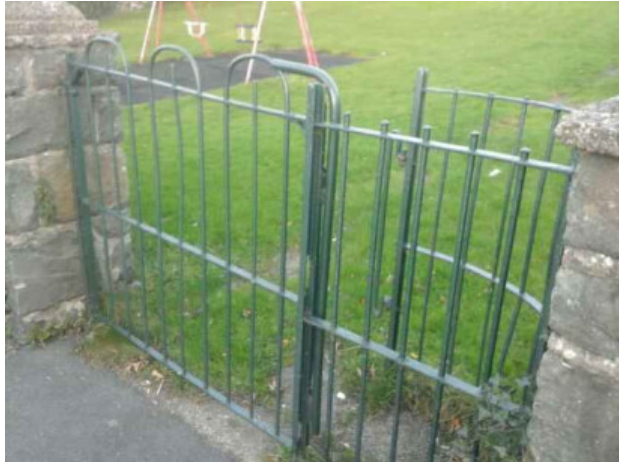
**Item:** Ancillary Items - Gate - Self Closing  
**Manufacturer:** Owner/Operator  
**Surface Type:** N/A  
**Equipment Compliance:** N/A  
**Surface Area Compliance:** N/A  
**Ref/Part Number:**  
**Total Findings:** 2

The opening between the gate and the post is less than 12mm and could trap users fingers - Adjust gate to ensure a 12mm opening all around

The paintwork on this item has been damaged or worn exposing the metal underneath which is rusting - Treat any rusting components and repaint

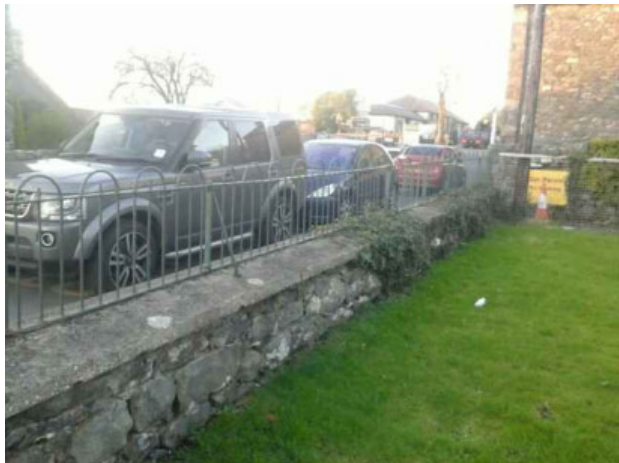
**Item:** Ancillary Items - Fence - Bow Top  
**Manufacturer:** Owner/Operator  
**Surface Type:** N/A  
**Equipment Compliance:** N/A  
**Surface Area Compliance:** N/A  
**Ref/Part Number:**  
**Total Findings:** 2

There is some damage to the fence sections - Monitor for any further deterioration and repair as required

The paintwork on this item has been damaged or worn exposing the metal underneath which is rusting - Treat any rusting components and repaint

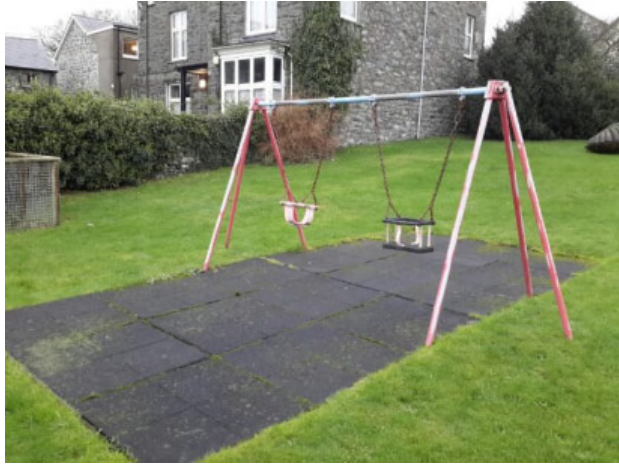
**Item:** Swings - 1 Bay 2 Seat (Cradle)  
**Manufacturer:** GL Jones  
**Surface Type:** Rubber Tiles  
**Equipment Compliance:** No  
**Surface Area Compliance:** No  
**Ref/Part Number:**  
**Total Findings:** 10

There is algae or moss growth on the surface resulting in slippery conditions - Clean and treat appropriately

There are gaps opening in between the tiles - Monitor for any further deterioration and repair as required

There are weeds/vegetation growth between or around the edges of the surfacing - Remove weeds/vegetation growth

The chain openings are in excess of the 8.6mm as recommended by BS EN 1176 - Monitor use

The seat is severely damaged and requires replacing - Replace damaged seat

The chain links are worn in excess of 40% and require renewing - Replace worn chains

The seat has minor damage or wear - Monitor for any further deterioration and replace as required

There are caps missing from the underside of the seats - Replace missing caps under the seats

Chains have corroded - Replace

The surfacing width under each seat is less than 1.75 metres and fails the requirements of BS EN 1176 Part 2 - Monitor use

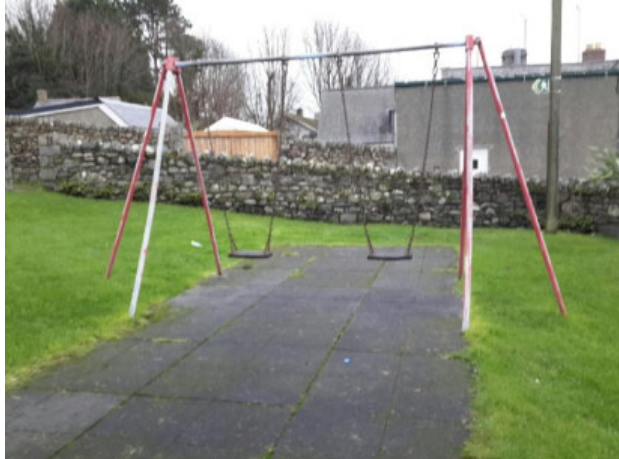
**Item:** Swings - 1 Bay 2 Seat (Flat)  
**Manufacturer:** GL Jones  
**Surface Type:** Rubber Tiles  
**Equipment Compliance:** No  
**Surface Area Compliance:** No  
**Ref/Part Number:**  
**Total Findings:** 8

There are gaps opening in between the tiles - Monitor for any further deterioration and repair as required

There are weeds/vegetation growth between or around the edges of the surfacing - Remove weeds/vegetation growth

Chains have corroded - Replace

The seat is severely damaged and requires replacing - Replace damaged seat

The chain links are worn in excess of 40% and require renewing - Replace worn chains

The eyebolts are worn in excess of 40% and require renewing - Replace worn eyebolts

The seats are too close to the frame as defined in BS EN 1176 Part 2; this is a low risk failure and no remedial action is required - Monitor use

There is algae or moss growth on the surface resulting in slippery conditions - Clean and treat appropriately

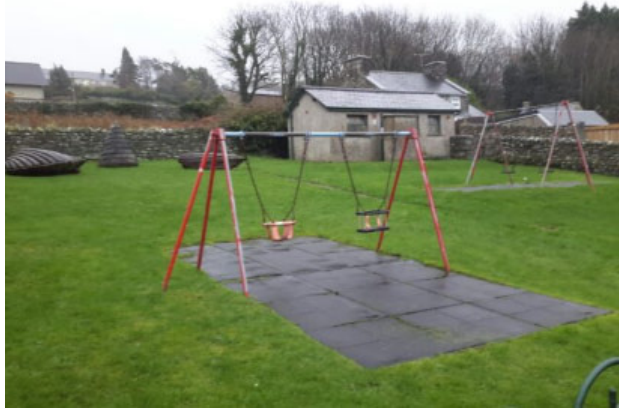
It is recommended that information signs with emergency contact details are installed at each entrance/exit point to the playground - Provide in accordance with the recommendations set out in BS EN 1176

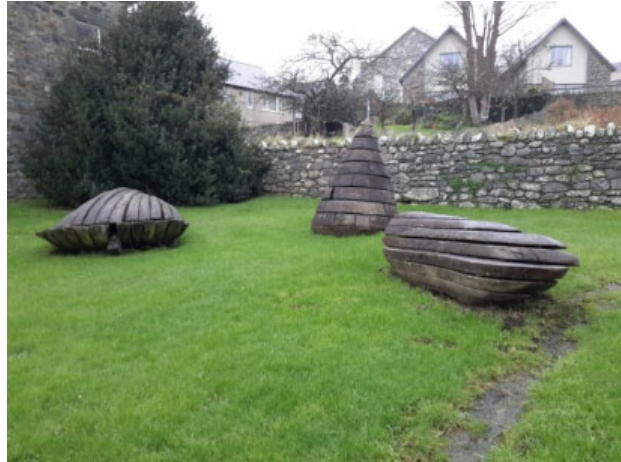
**Item:** Other - Sculpture  
**Manufacturer:** Not Identified  
**Surface Type:** Grass  
**Equipment Compliance:** No  
**Surface Area Compliance:** Yes  
**Ref/Part Number:**  
**Total Findings:** 8

There is algae or moss on the surface of the equipment - Clean and treat appropriately

Fungus was found on site (see photos) - Identify fungus type and remove if poisonous; if classified as non-harmful leave on site

There is/are foot entrapment/s in the xxx - Remove foot entrapment

The timber on this item has severe rot - Remove and replace all affected timber sections

A number of fixing(s) have worked loose - Secure all loose fixings

Parts of the timber are rough or splintered - Remove all rough or sharp edges

There is/are finger entrapment/s in the openings and the item fails to meet the requirements of BS EN 1176:2008 Part 1 4.2.7.6 Entrapment of fingers - Monitor use

There is a potential crush point between the rotating sections - Adjust item to remove crush point

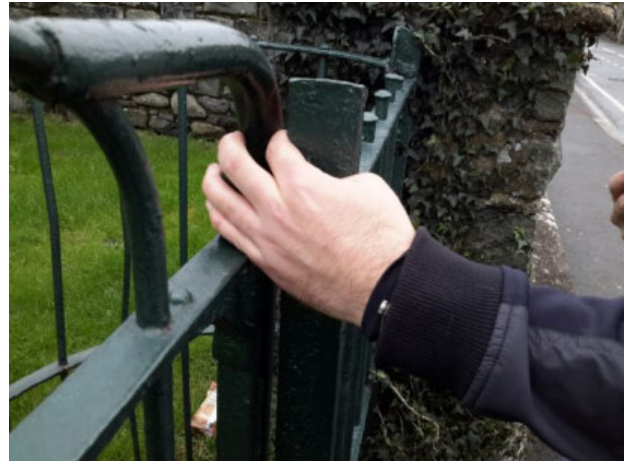
### 8 - Low Risk (Finding 1)

**Finding:** The opening between the gate and the post is less than 12mm and could trap users fingers  
**Action:** Adjust gate to ensure a 12mm opening all around

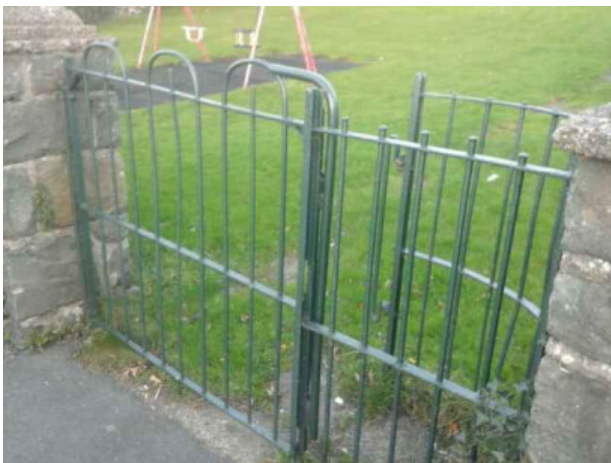
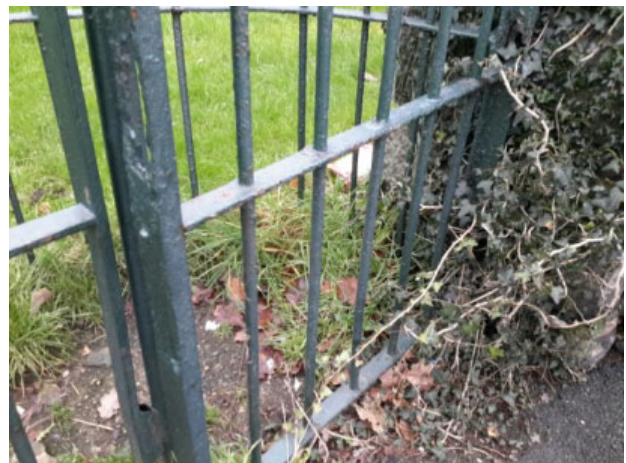
### 6 - Low Risk (Finding 2)

**Finding:** The paintwork on this item has been damaged or worn exposing the metal underneath which is rusting  
**Action:** Treat any rusting components and repaint

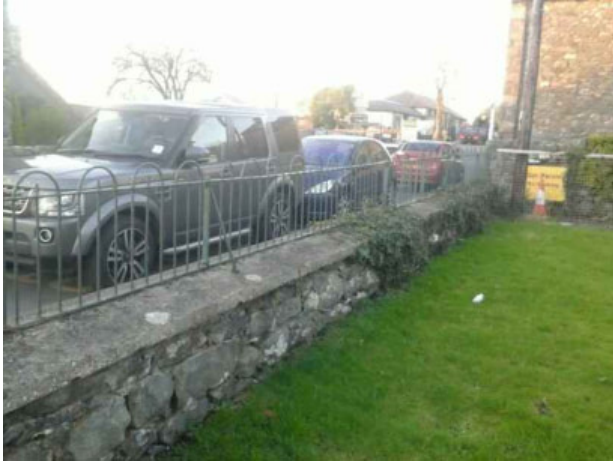
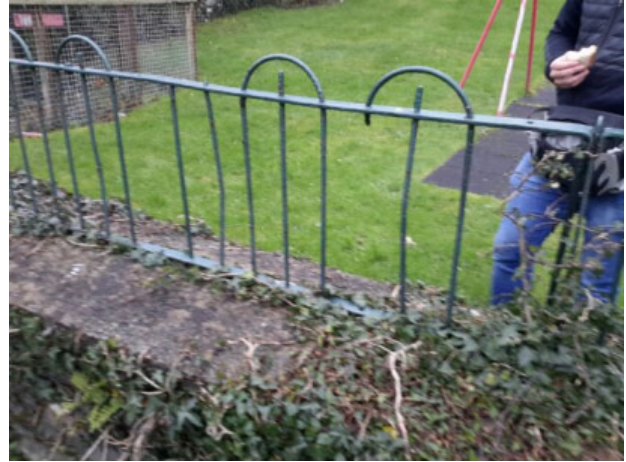
6 - Low Risk (Finding 1)

**Finding:** There is some damage to the fence sections

**Action:** Monitor for any further deterioration and repair as required

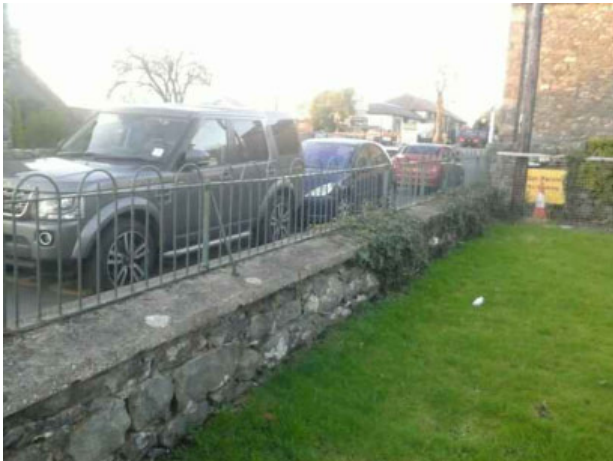
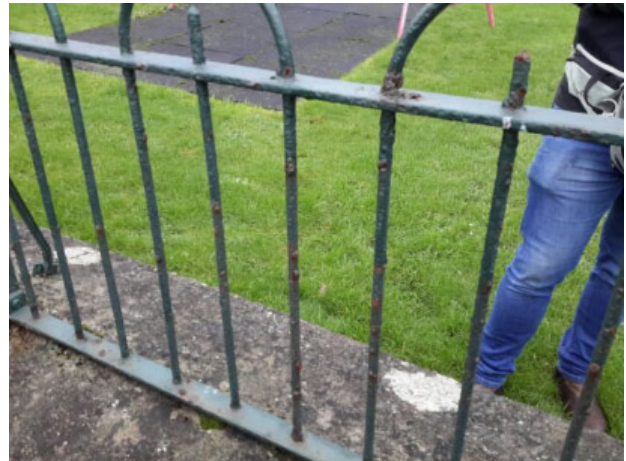
6 - Low Risk (Finding 2)

**Finding:** The paintwork on this item has been damaged or worn exposing the metal underneath which is rusting

**Action:** Treat any rusting components and repaint

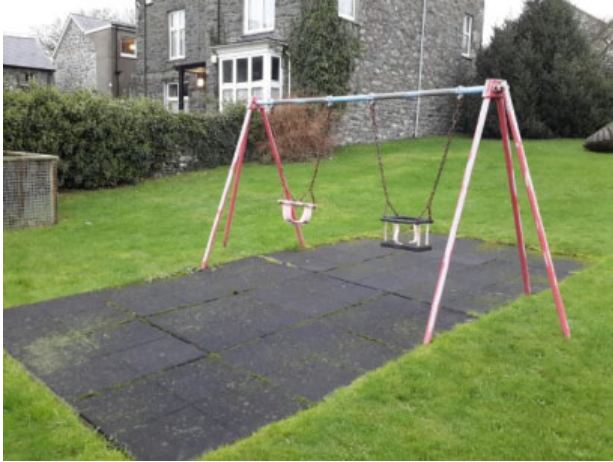
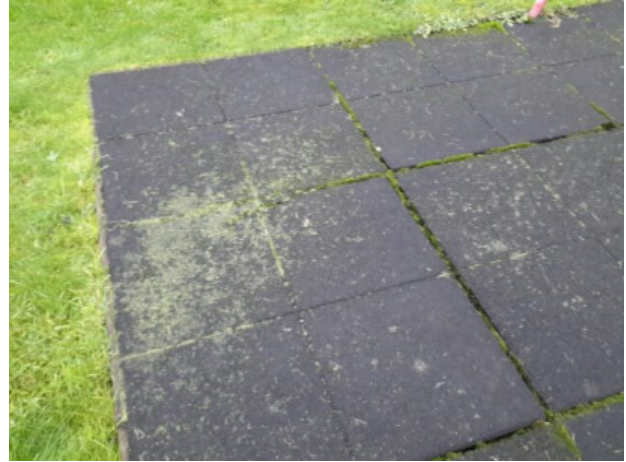
9 - Low Risk (Finding 1)

**Finding:** There is algae or moss growth on the surface resulting in slippery conditions  
**Action:** Clean and treat appropriately

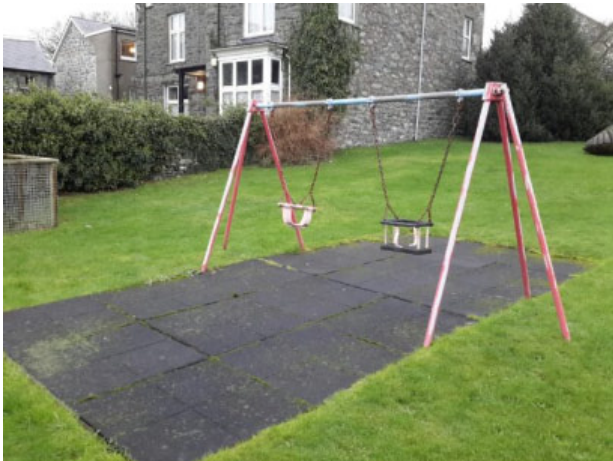
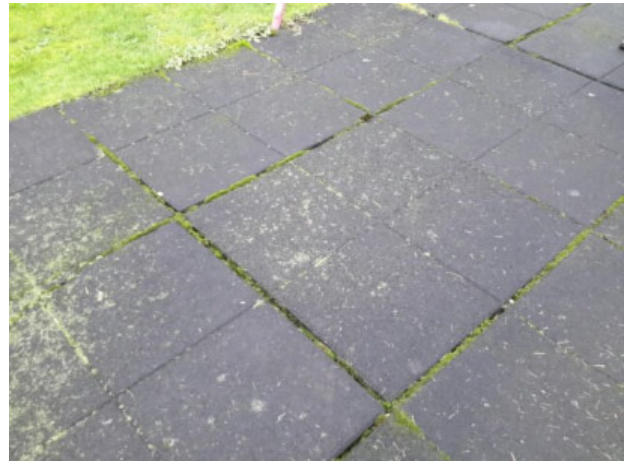
6 - Low Risk (Finding 2)

**Finding:** There are gaps opening in between the tiles  
**Action:** Monitor for any further deterioration and repair as required

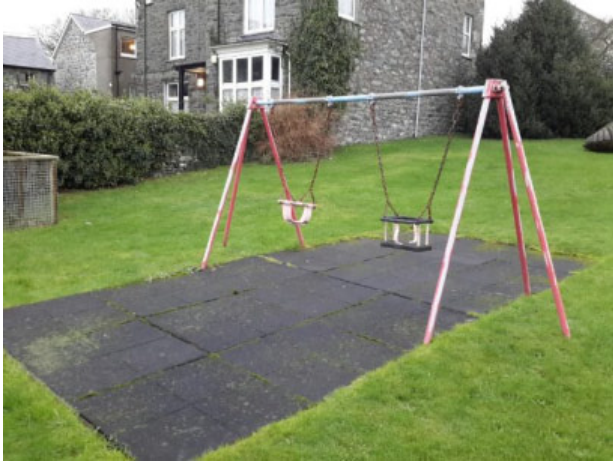
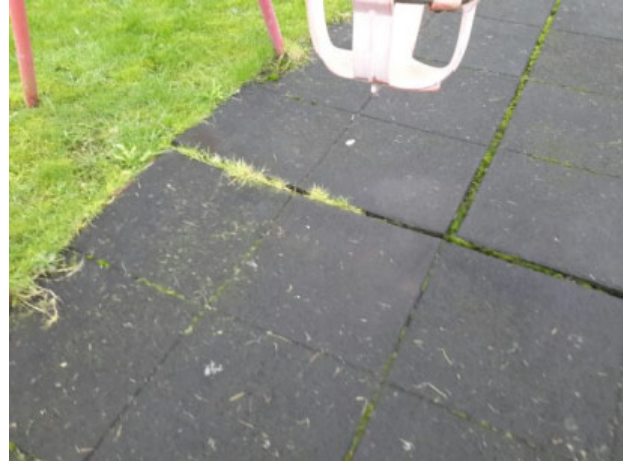
6 - Low Risk (Finding 3)

**Finding:** There are weeds/vegetation growth between or around the edges of the surfacing

**Action:** Remove weeds/vegetation growth

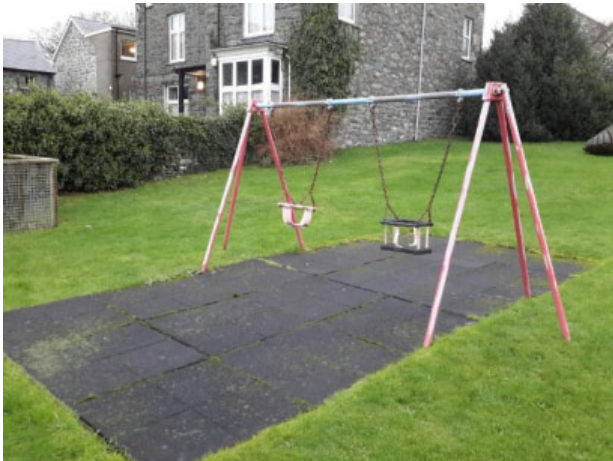
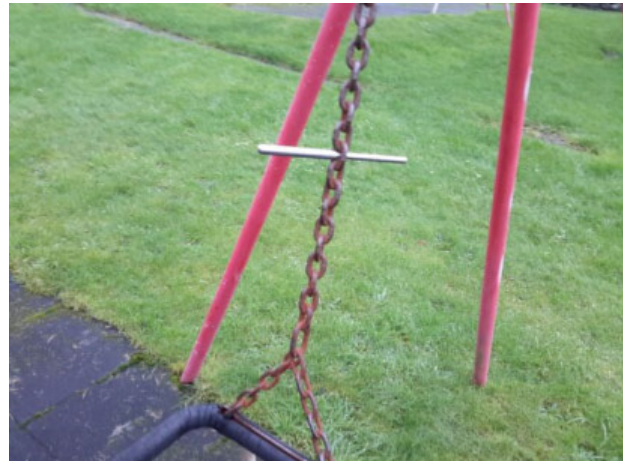
5 - Very Low Risk (Finding 4)

**Finding:** The chain openings are in excess of the 8.6mm as recommended by BS EN 1176

**Action:** Monitor use

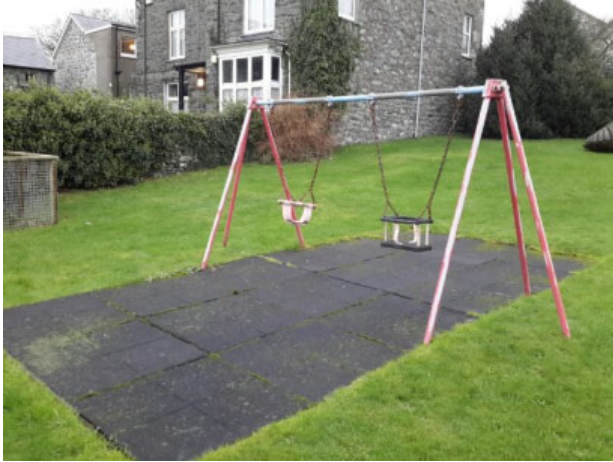
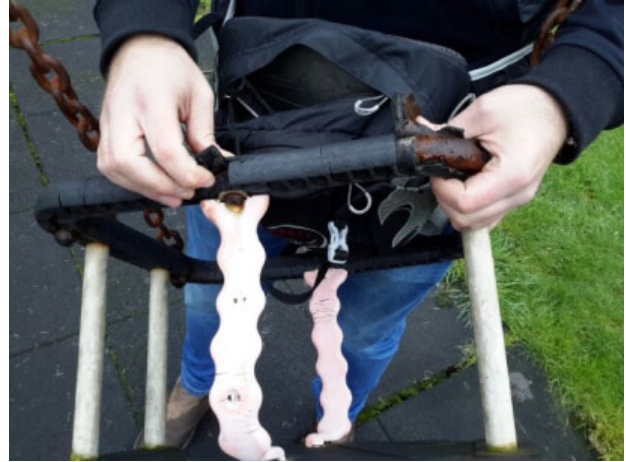
8 - Low Risk (Finding 5)

**Finding:** The seat is severely damaged and requires replacing

**Action:** Replace damaged seat

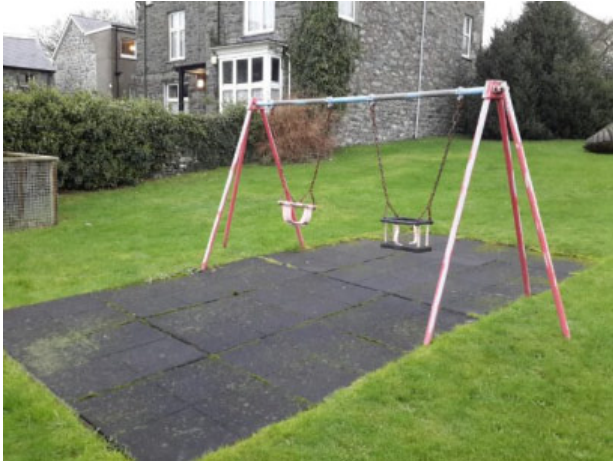
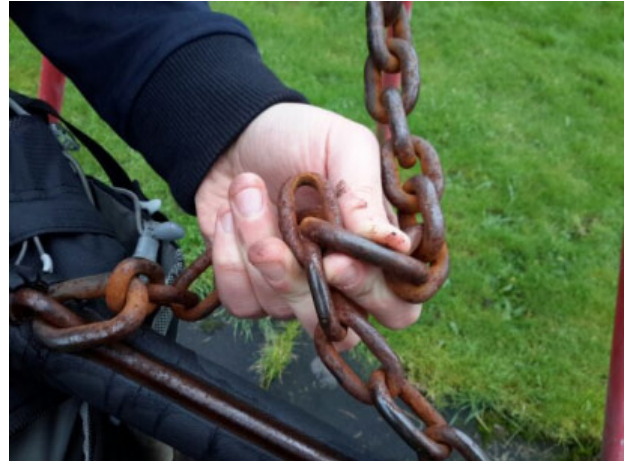
12 - Moderate Risk (Finding 6)

**Finding:** The chain links are worn in excess of 40% and require renewing

**Action:** Replace worn chains

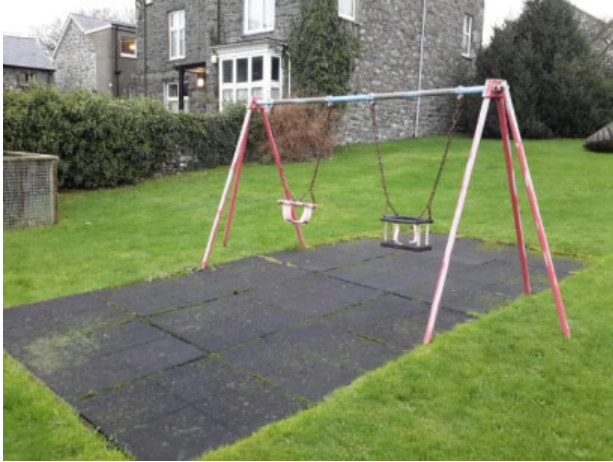
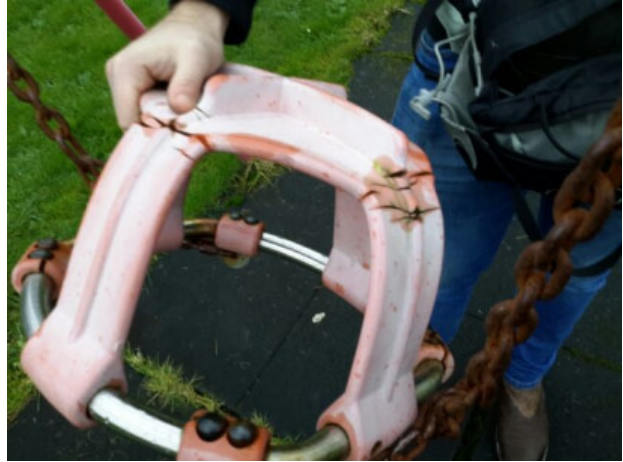
6 - Low Risk (Finding 7)

**Finding:** The seat has minor damage or wear

**Action:** Monitor for any further deterioration and replace as required

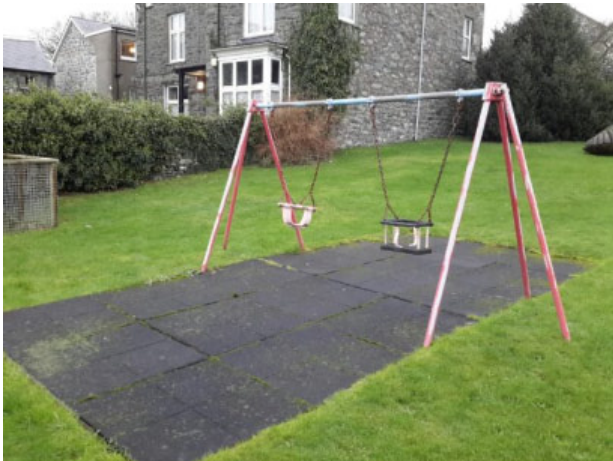
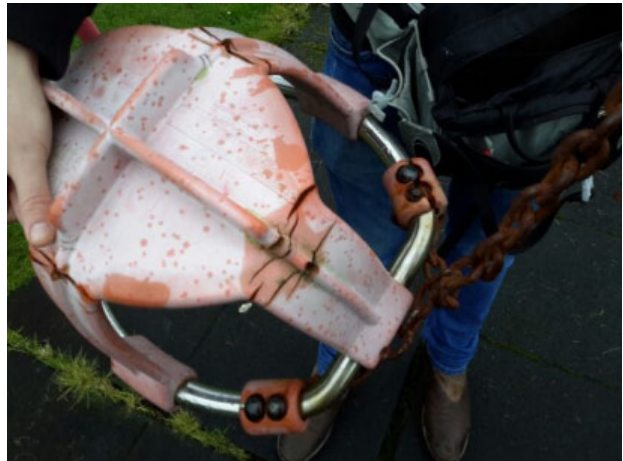
6 - Low Risk (Finding 8)

**Finding:** There are caps missing from the underside of the seats

**Action:** Replace missing caps under the seats

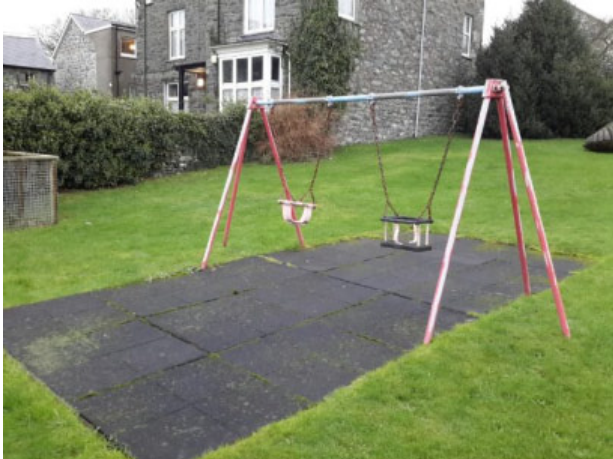
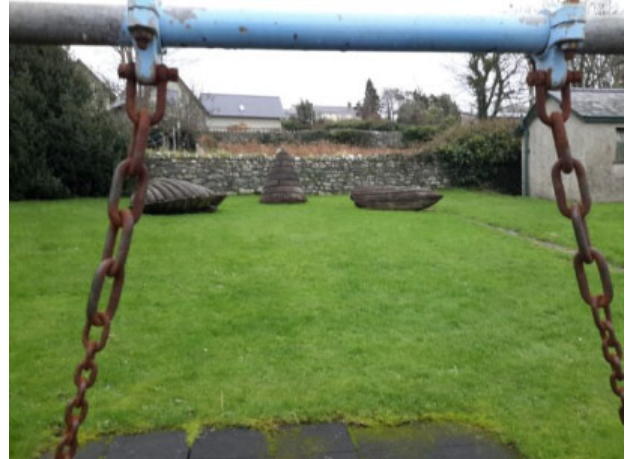
8 - Low Risk (Finding 9)

**Finding:** Chains have corroded

**Action:** Replace

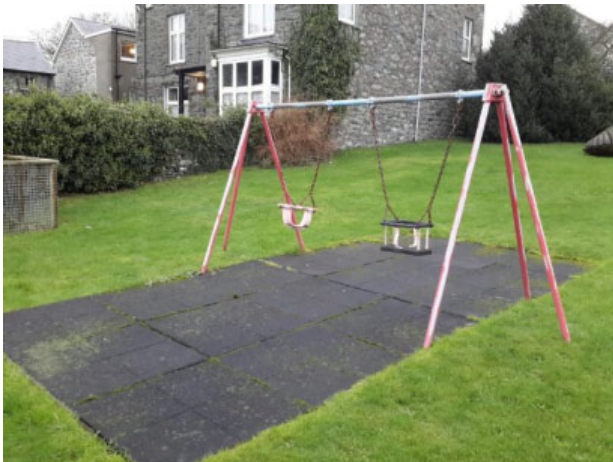
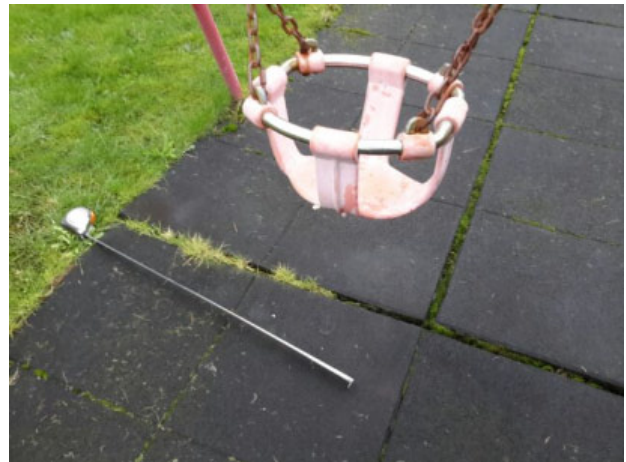
5 - Very Low Risk (Finding 10)

**Finding:** The surfacing width under each seat is less than 1.75 metres and fails the requirements of BS EN 1176 Part 2

**Action:** Monitor use

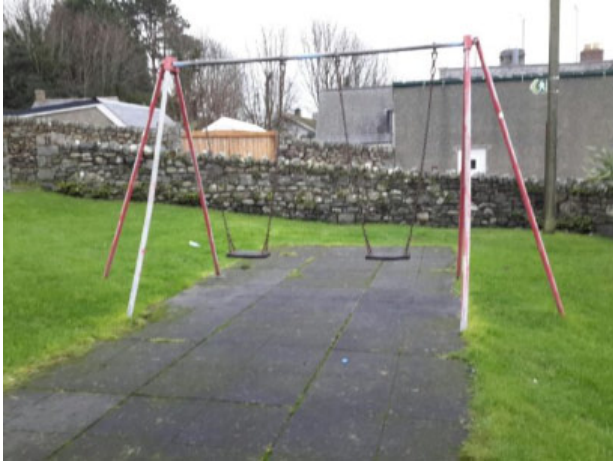
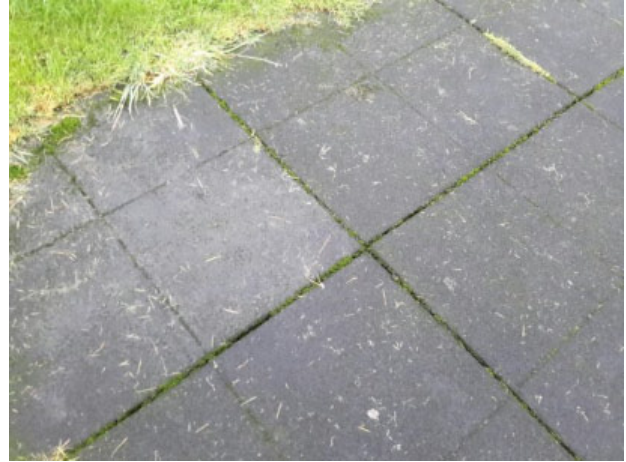
6 - Low Risk (Finding 1)

**Finding:** There are gaps opening in between the tiles

**Action:** Monitor for any further deterioration and repair as required

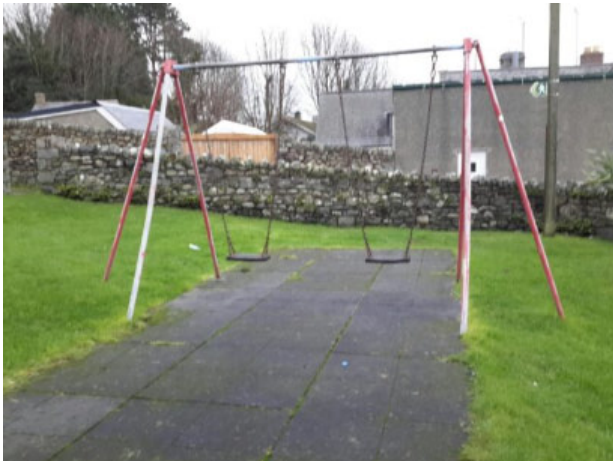
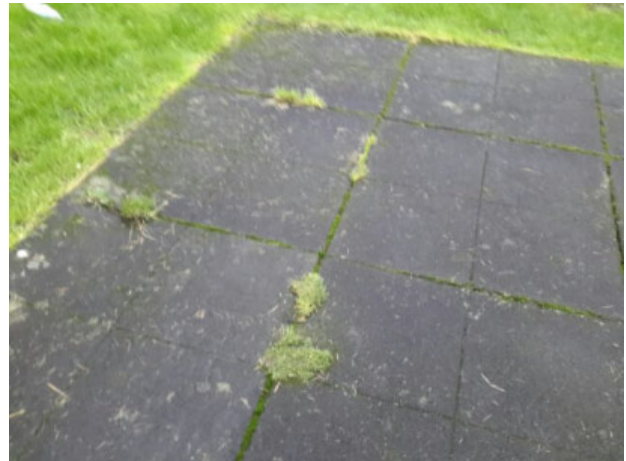
6 - Low Risk (Finding 2)

**Finding:** There are weeds/vegetation growth between or around the edges of the surfacing

**Action:** Remove weeds/vegetation growth

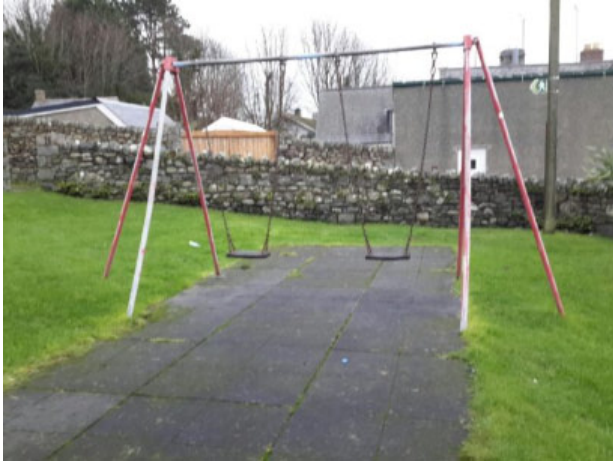
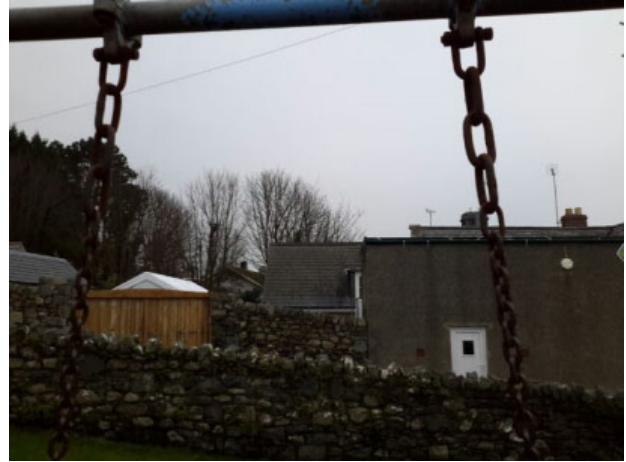
8 - Low Risk (Finding 3)

**Finding:** Chains have corroded

**Action:** Replace

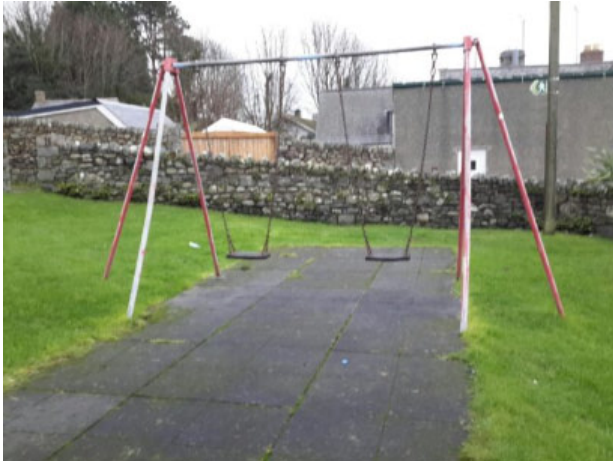
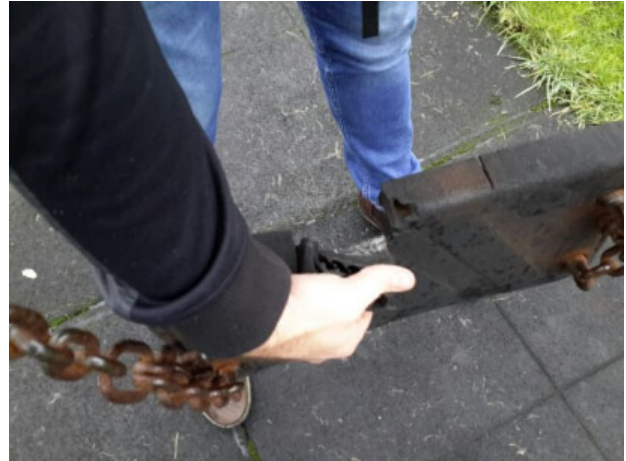
8 - Low Risk (Finding 4)

**Finding:** The seat is severely damaged and requires replacing

**Action:** Replace damaged seat

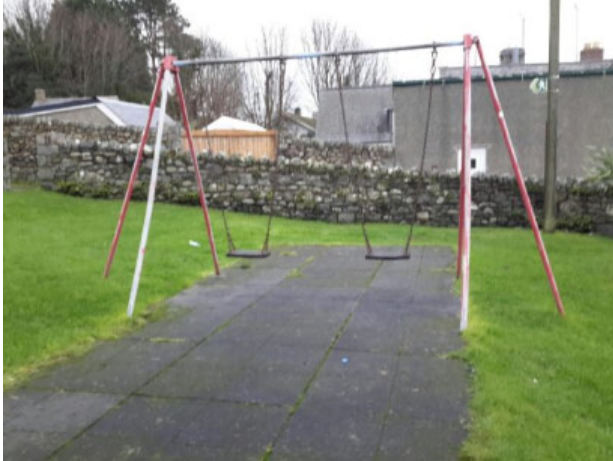
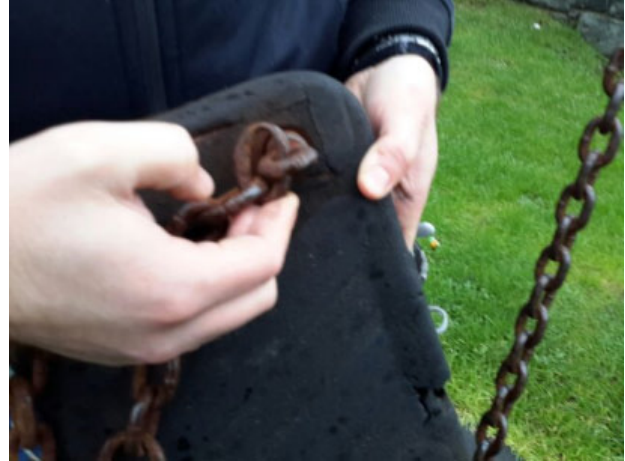
12 - Moderate Risk (Finding 5)

**Finding:** The chain links are worn in excess of 40% and require renewing

**Action:** Replace worn chains

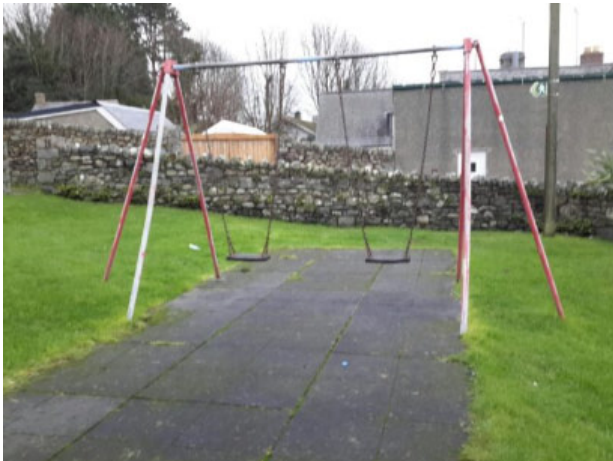
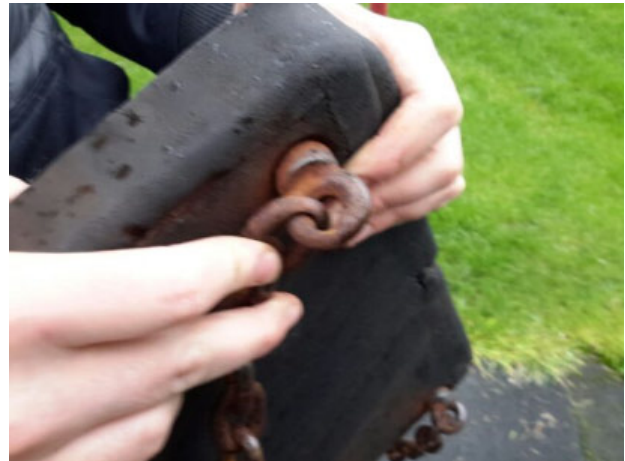
12 - Moderate Risk (Finding 6)

**Finding:** The eyebolts are worn in excess of 40% and require renewing

**Action:** Replace worn eyebolts

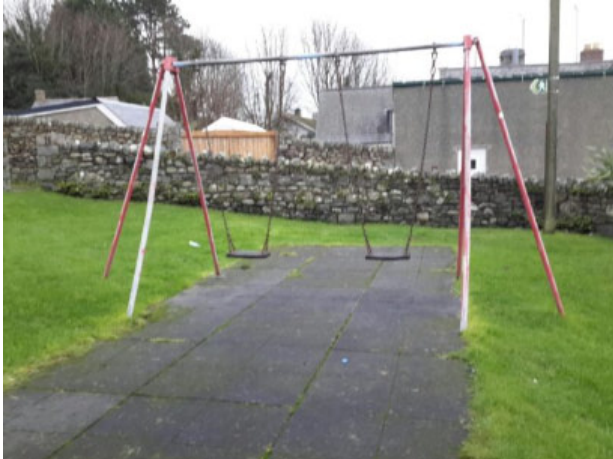
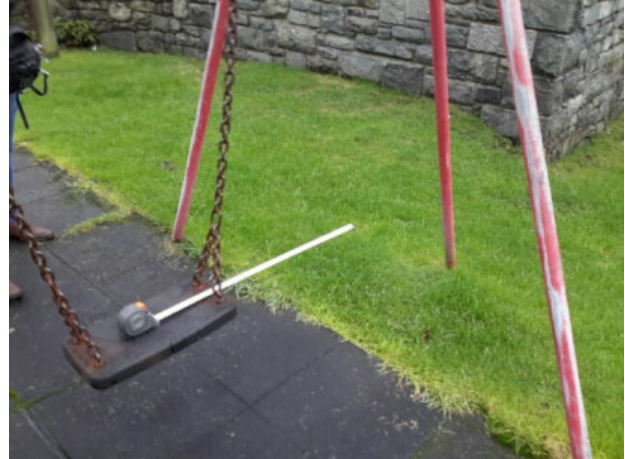
4 - Very Low Risk (Finding 7)

**Finding:** The seats are too close to the frame as defined in BS EN 1176 Part 2; this is a low risk failure and no remedial action is required

**Action:** Monitor use

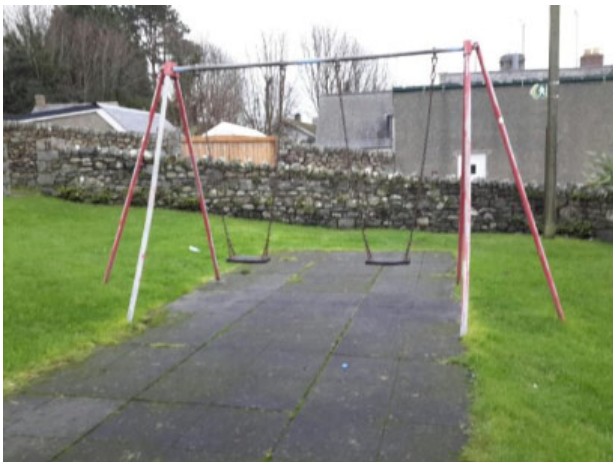
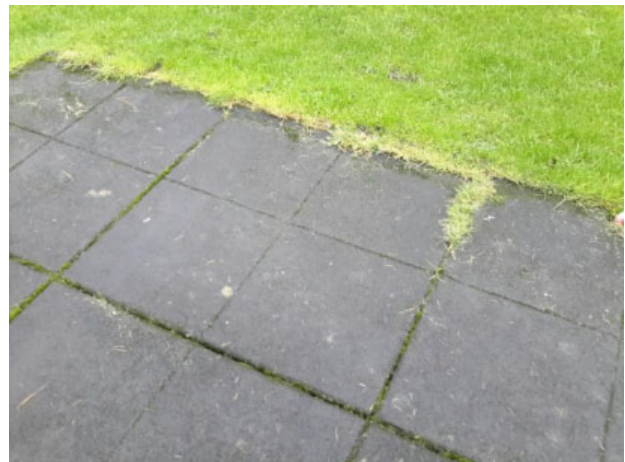
8 - Low Risk (Finding 8)

**Finding:** There is algae or moss growth on the surface resulting in slippery conditions

**Action:** Clean and treat appropriately

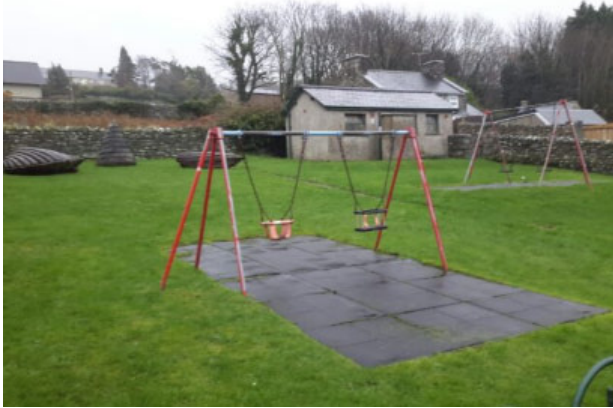
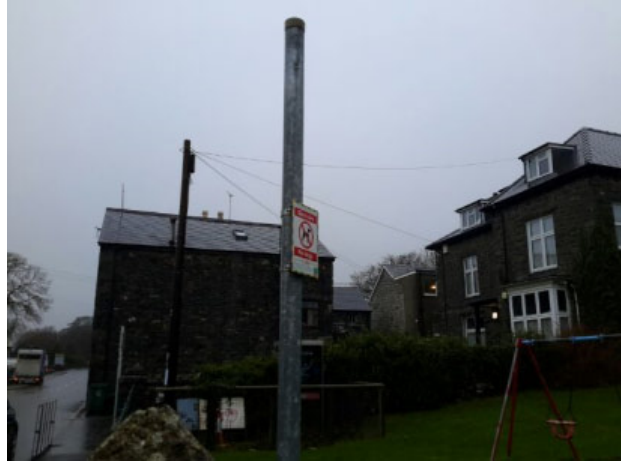
2 - Very Low Risk (Finding 1)

**Finding:** It is recommended that information signs with emergency contact details are installed at each entrance/exit point to the playground

**Action:** Provide in accordance with the recommendations set out in BS EN 1176

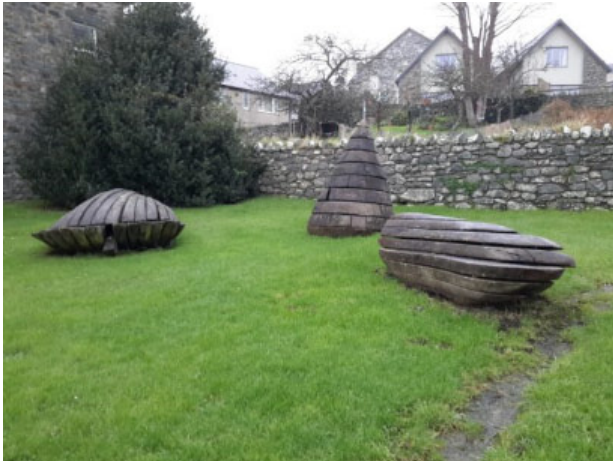
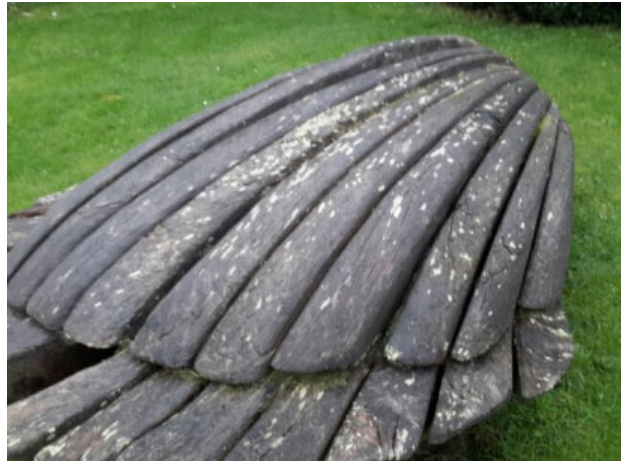
8 - Low Risk (Finding 1)

**Finding:** There is algae or moss on the surface of the equipment

**Action:** Clean and treat appropriately

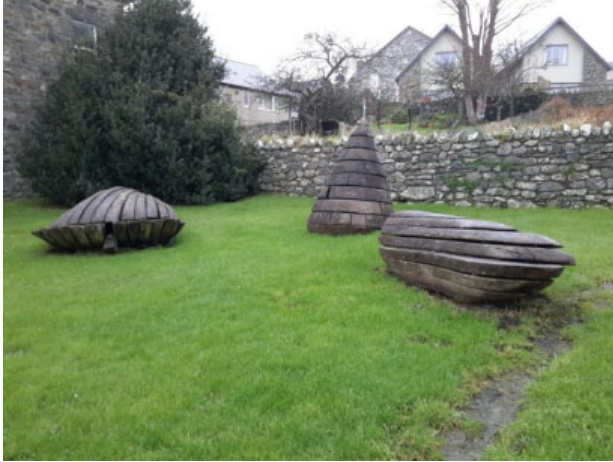
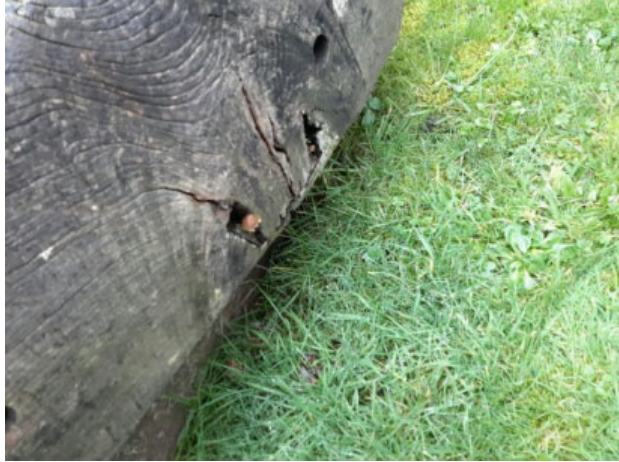
5 - Very Low Risk (Finding 2)

**Finding:** Fungus was found on site (see photos)

**Action:** Identify fungus type and remove if poisonous; if classified as non-harmful leave on site

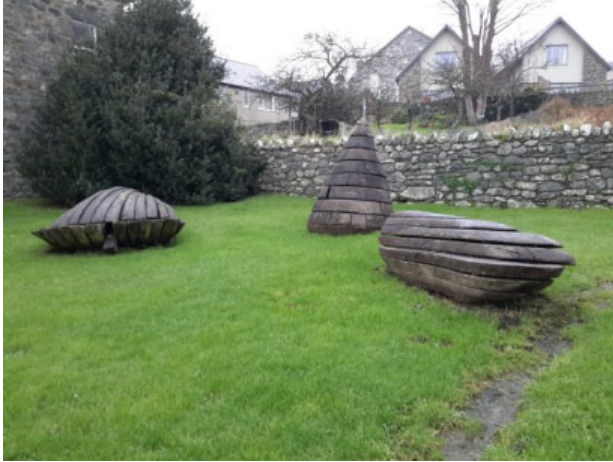
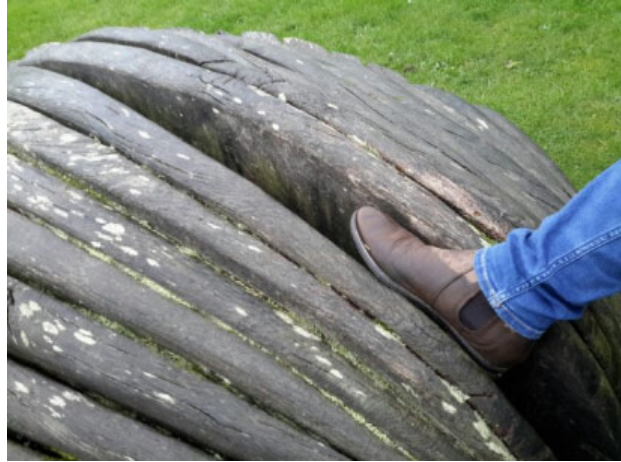
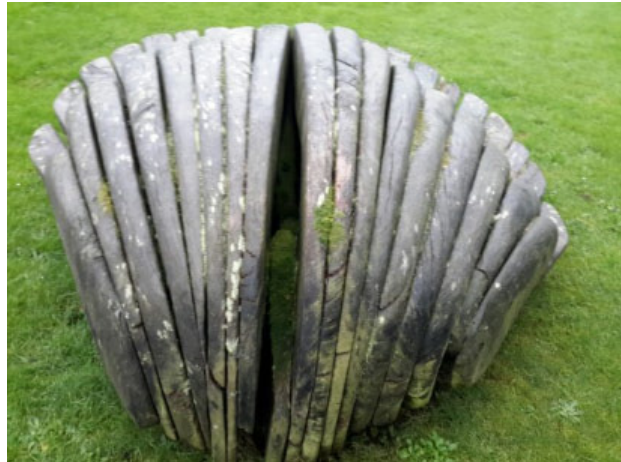
8 - Low Risk (Finding 3)

**Finding:** There is/are foot entrapment/s in the xxx

**Action:** Remove foot entrapment

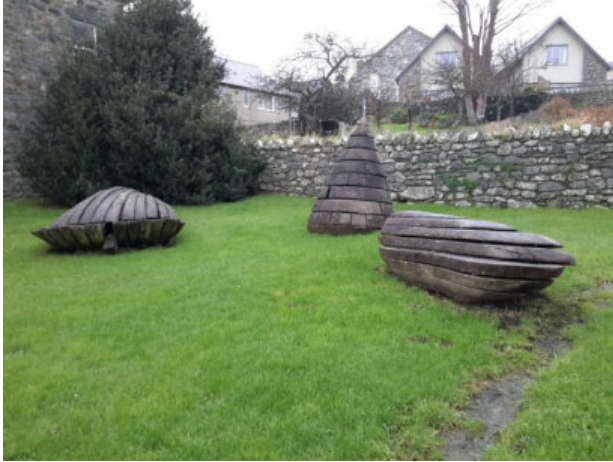
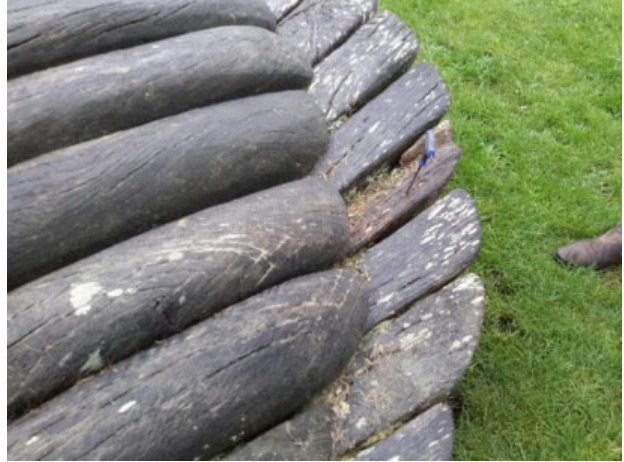
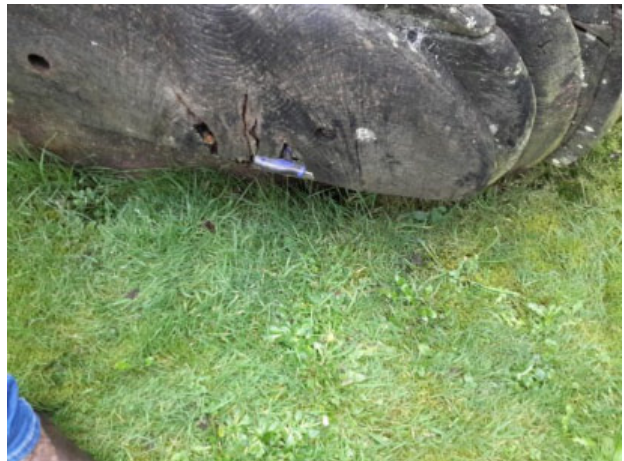
9 - Low Risk (Finding 4)

**Finding:** The timber on this item has severe rot

**Action:** Remove and replace all affected timber sections

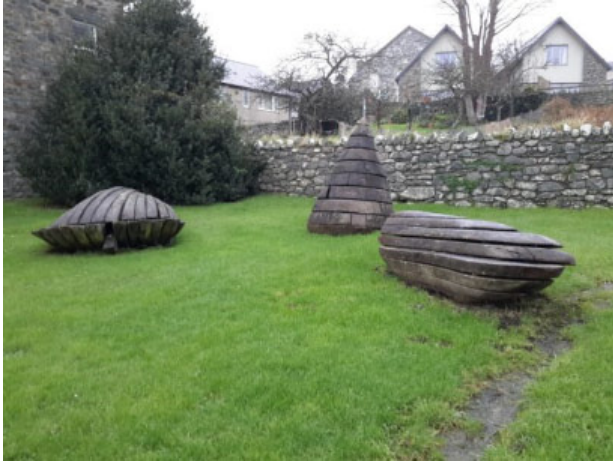
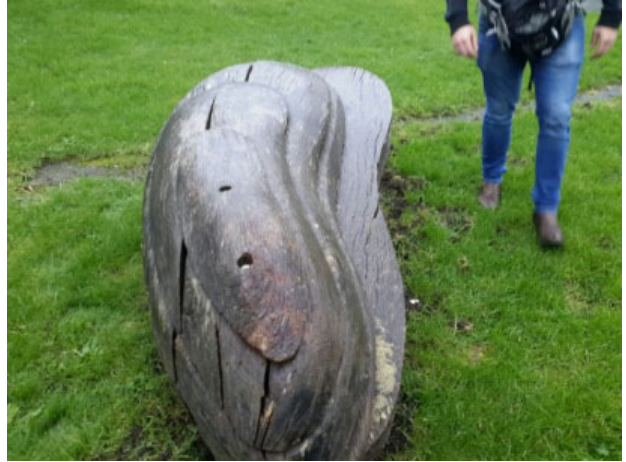
6 - Low Risk (Finding 5)

**Finding:** A number of fixing(s) have worked loose

**Action:** Secure all loose fixings

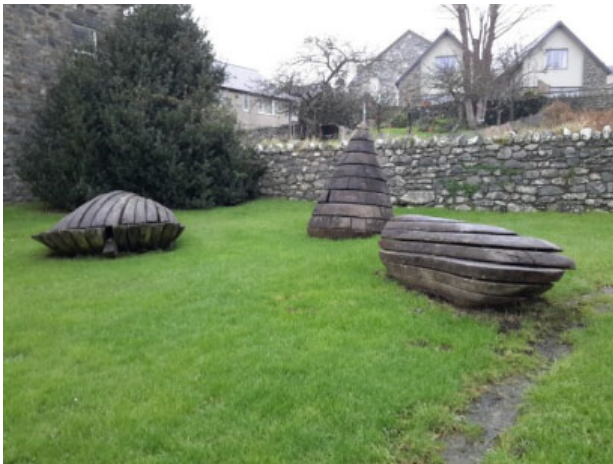
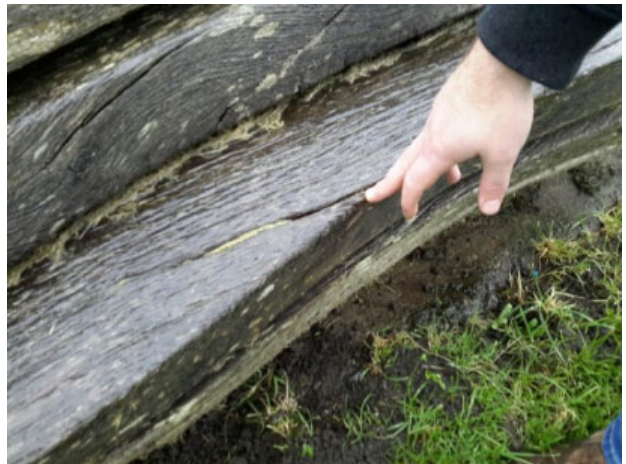
6 - Low Risk (Finding 6)

**Finding:** Parts of the timber are rough or splintered

**Action:** Remove all rough or sharp edges

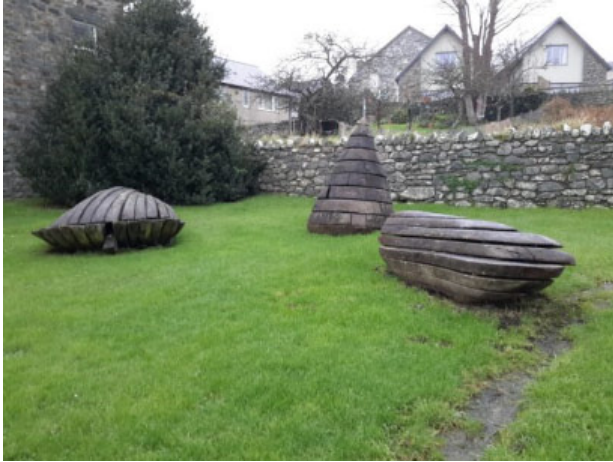
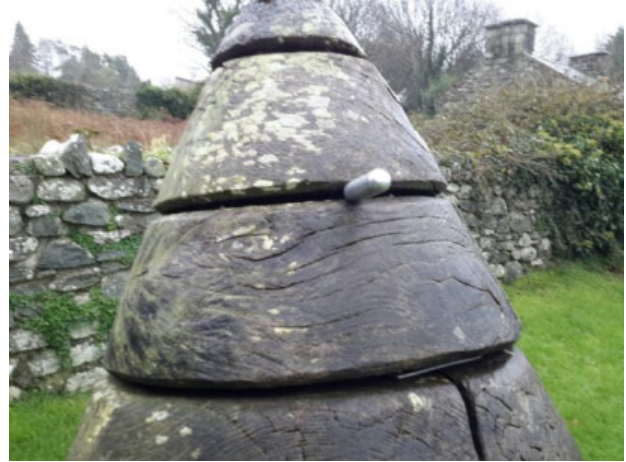
5 - Very Low Risk (Finding 7)

**Finding:** There is/are finger entrapment/s in the openings and the item fails to meet the requirements of BS EN 1176:2008 Part 1 4.2.7.6 Entrapment of fingers

**Action:** Monitor use

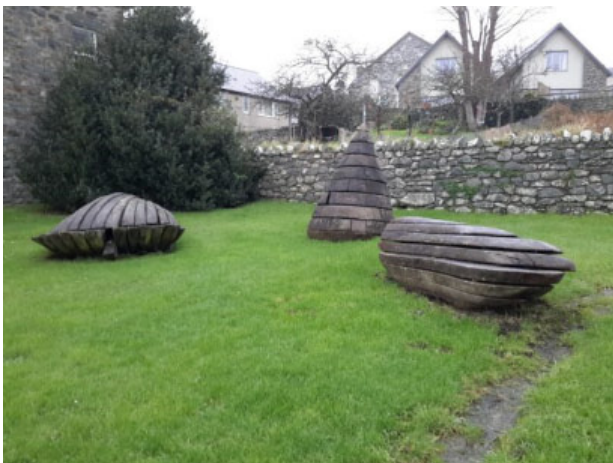
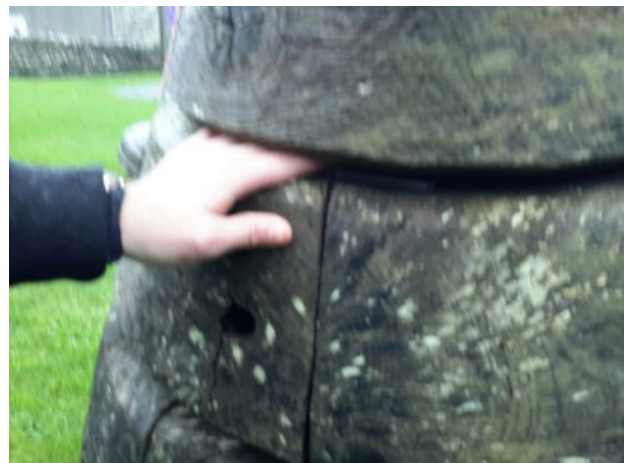
8 - Low Risk (Finding 8)

**Finding:** There is a potential crush point between the rotating sections

**Action:** Adjust item to remove crush point
