Annual Inspection

Dyffryn Ardudwy and Talybont Community Council

Old Swings

Talybont, LL44 2HT

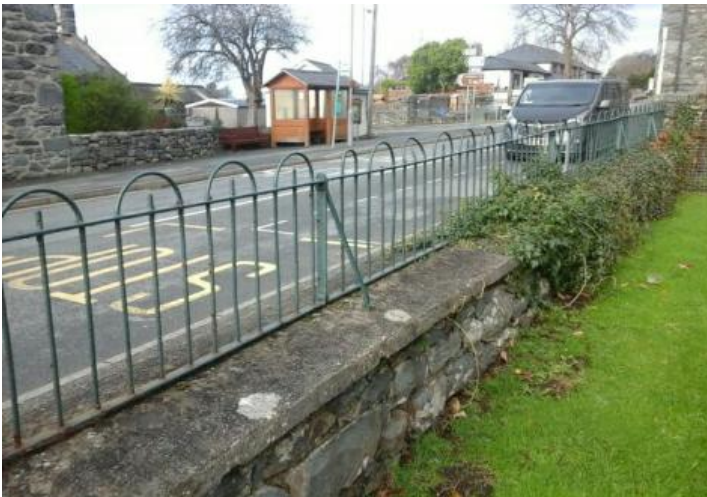
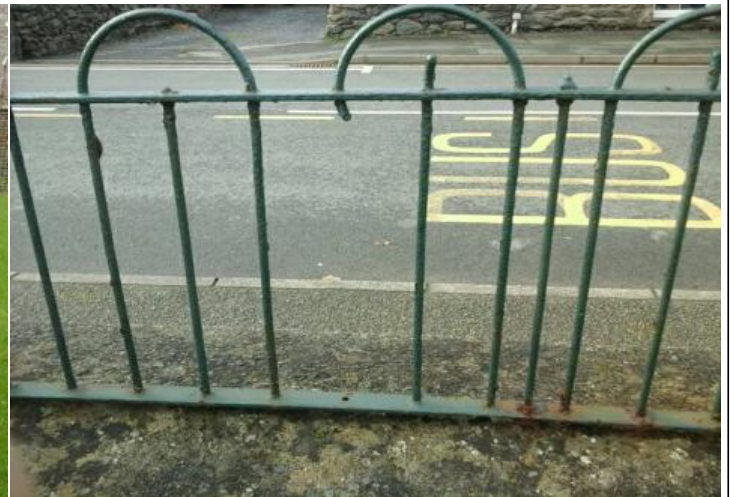
6 - Low Risk (Finding 1)

There are a number of poles missing from the fence -
 Replace missing poles

Finding: There are a number of poles missing from the fence
Action: Replace missing poles

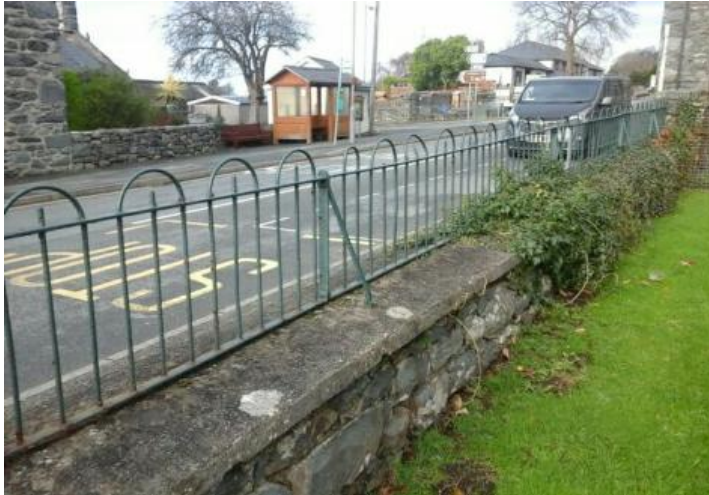
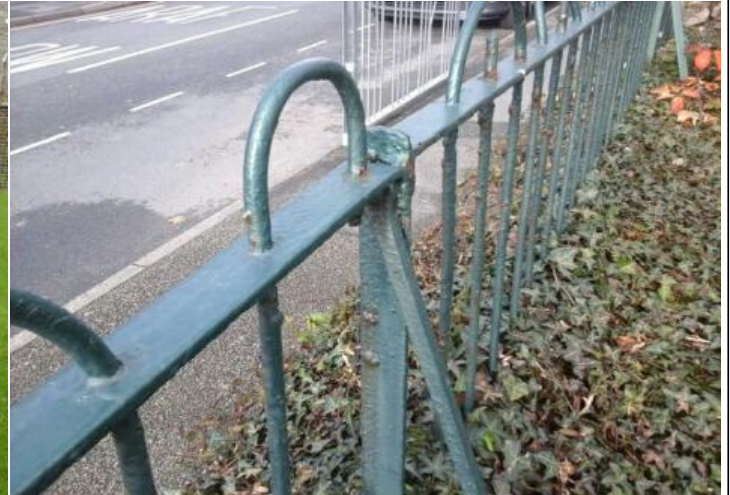
i 6 - Low Risk (Finding 2)

There is surface corrosion present on the item - Consider
 treating and repainting the item

Finding: There is surface corrosion present on the item

Action: Consider treating and repainting the item

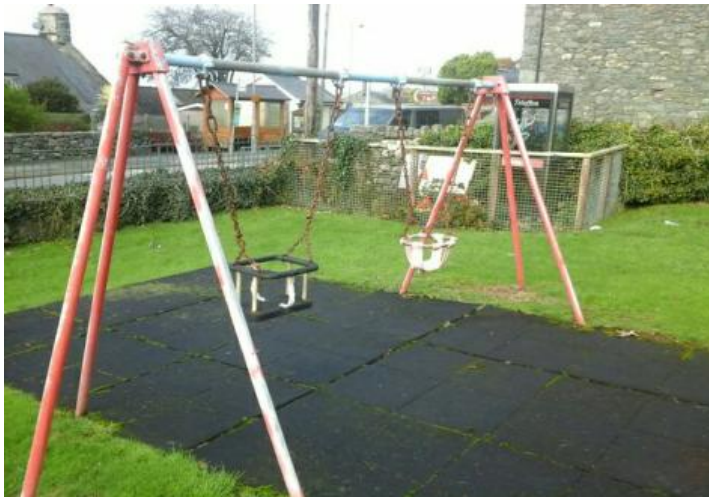
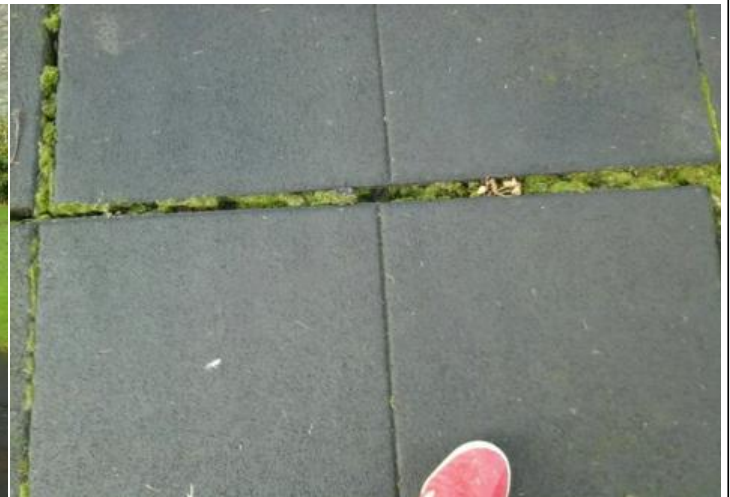
i 9 - Low Risk (Finding 1)

There are significant gaps (over 30mm) between the surface and the edging or between the joints in the surface; these are large enough for a small foot to enter - Repair surfacing

Finding: There are significant gaps (over 30mm) between the surface and the edging or between the joints in the surface; these are large enough for a small foot to enter

Action: Repair surfacing

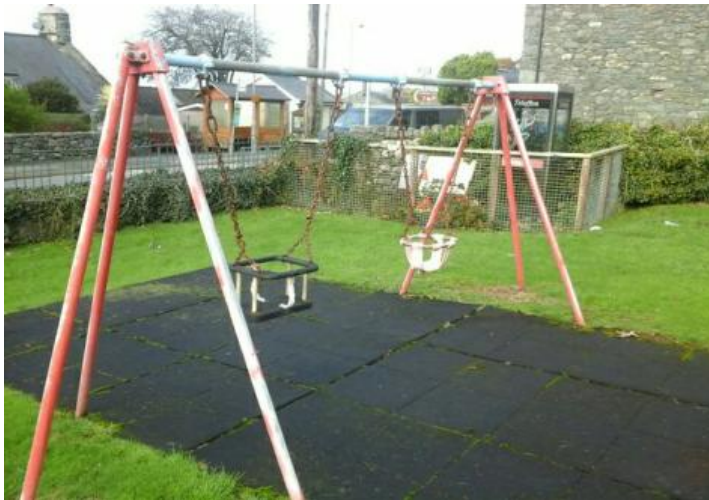
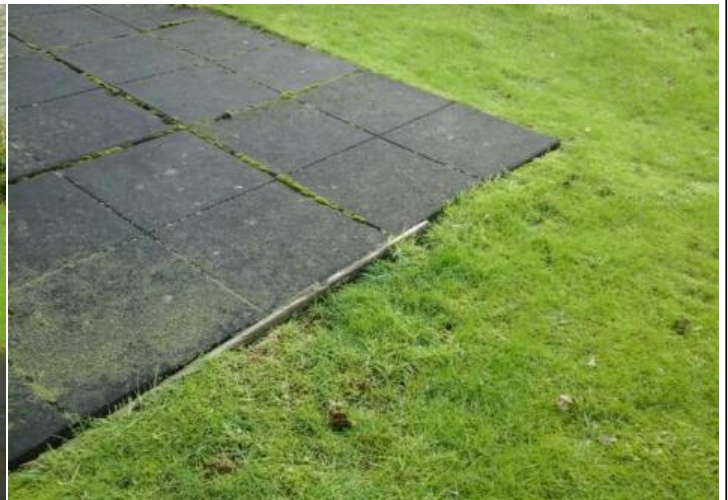
8 - Low Risk (Finding 3)

There are trip hazards at the edges of the surface - Reinstate surrounding surface levels to remove the trip points

Finding: There are trip hazards at the edges of the surface
Action: Reinststate surrounding surface levels to remove the trip points

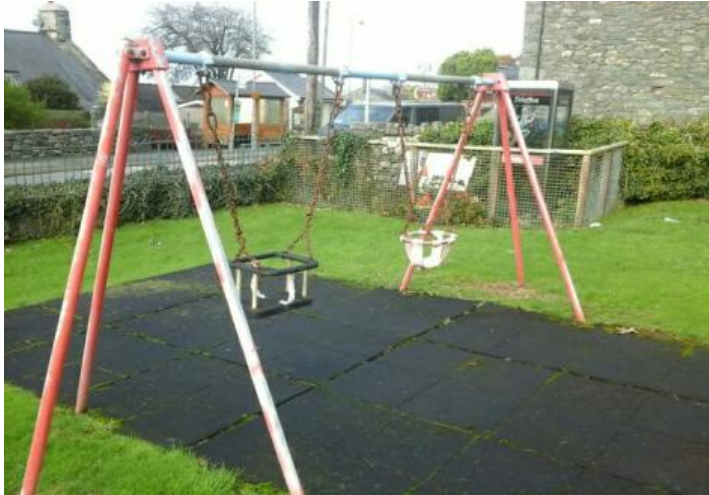
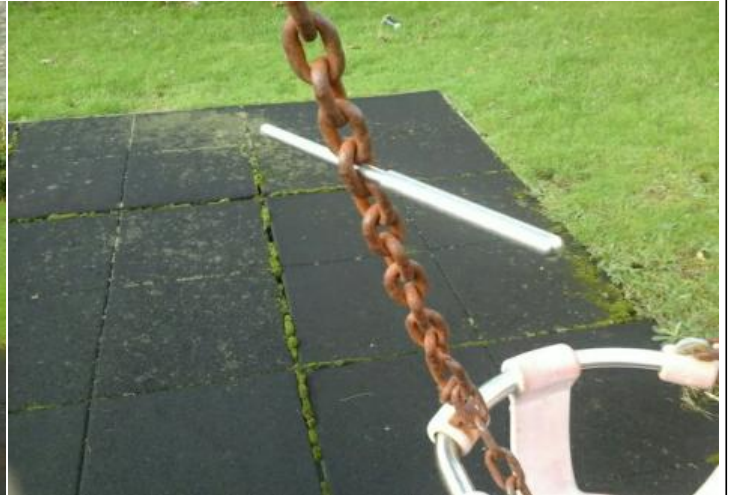
i 5 - Very Low Risk (Finding 4)

The chain openings are in excess of the 8.6mm as recommended by BS EN 1176 - Monitor use

Finding: The chain openings are in excess of the 8.6mm as recommended by BS EN 1176 **Action:** Monitor use

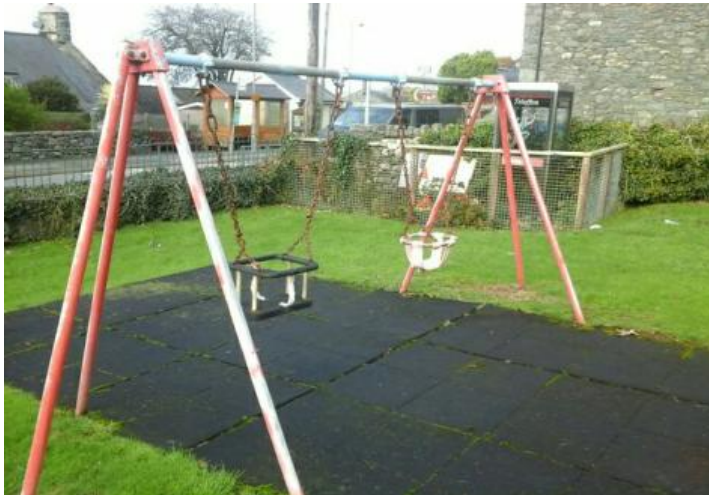
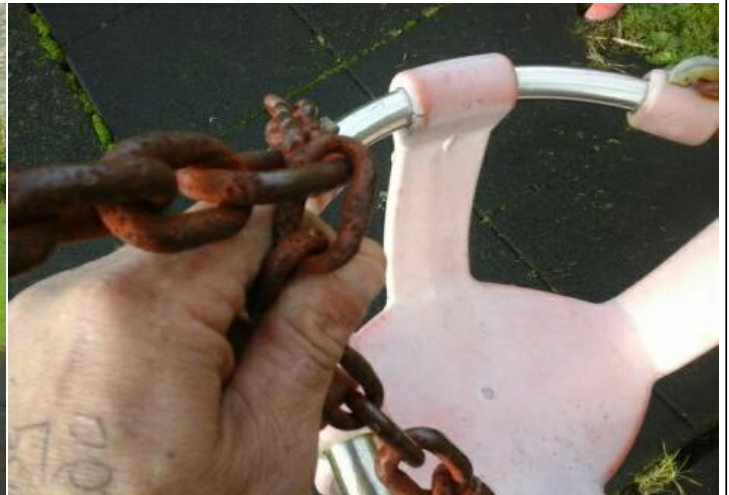
! 12 - Moderate Risk (Finding 5)

The chain links are worn in excess of 40% and require renewing - Replace worn chains

Finding: The chain links are worn in excess of 40% and require renewing **Action:** Replace worn chains

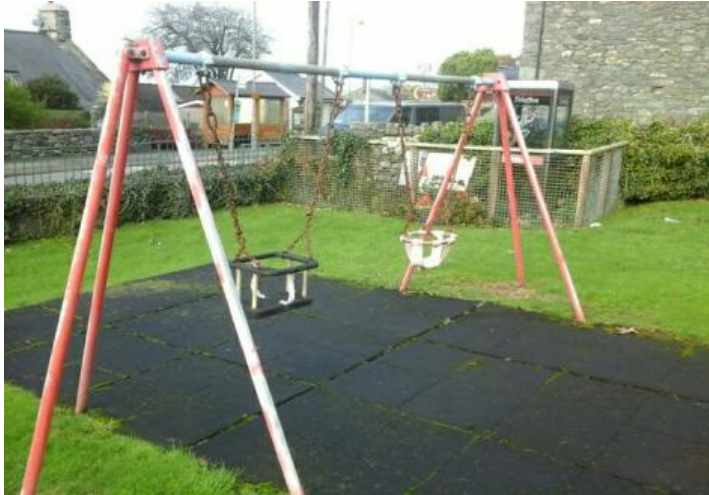
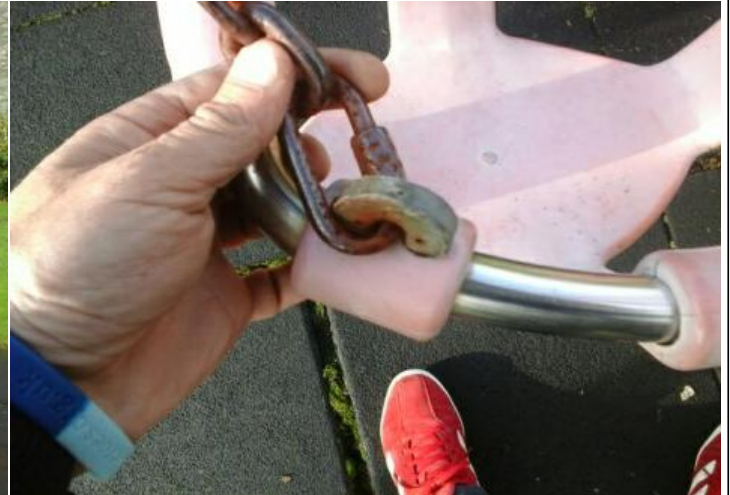
i 6 - Low Risk (Finding 6)

There is some wear to the shackles. - Monitor for any further deterioration and replace when 40% worn

Finding: There is some wear to the shackles.

Action: Monitor for any further deterioration and replace when 40% worn

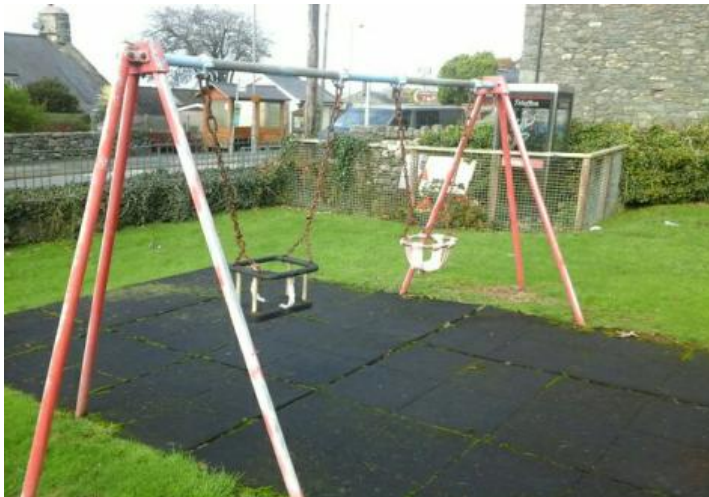
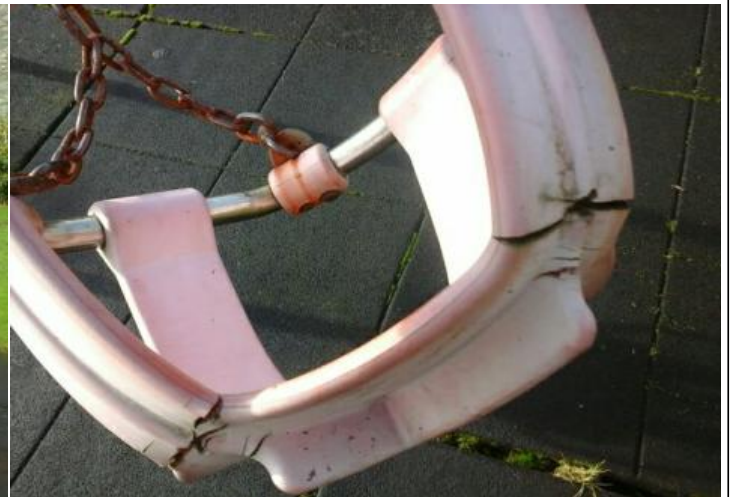
i 6 - Low Risk (Finding 7)

The seat has minor damage or wear - Monitor for any further deterioration and replace as required

Finding: The seat has minor damage or wear

Action: Monitor for any further deterioration and replace as required

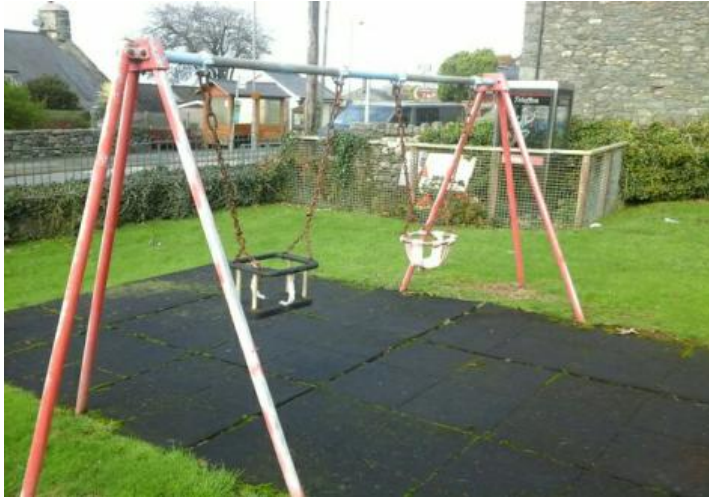
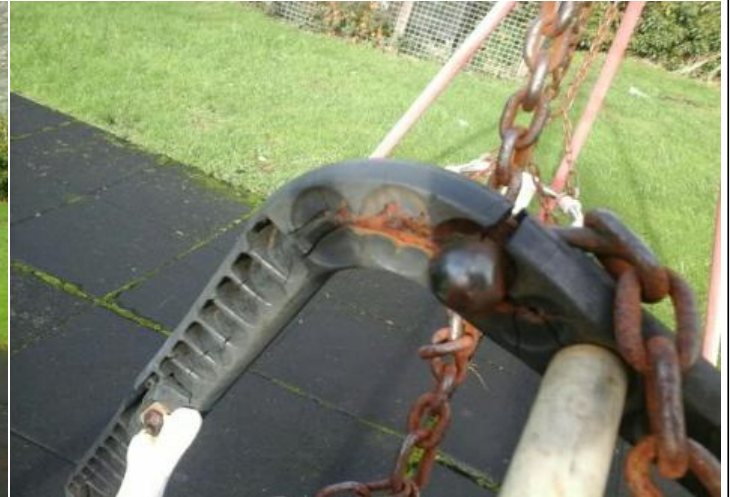
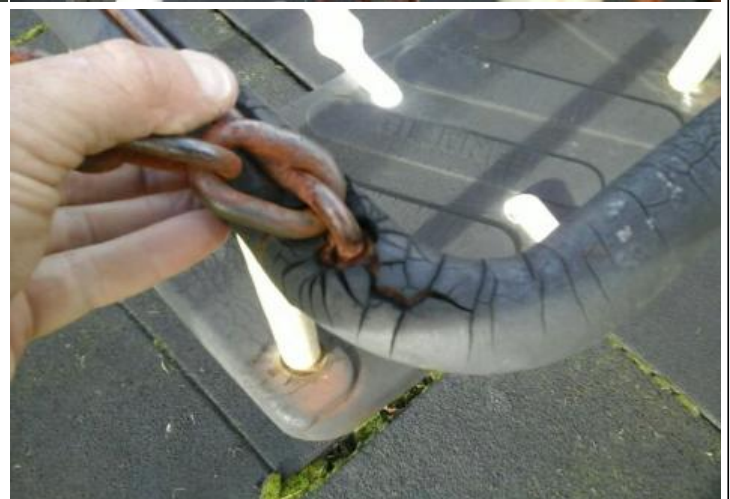
! 12 - Moderate Risk (Finding 8)

The swing seat frame is severely corroded and requires replacement - Replace seat

Finding: The swing seat frame is severely corroded and requires replacement

Action: Replace seat

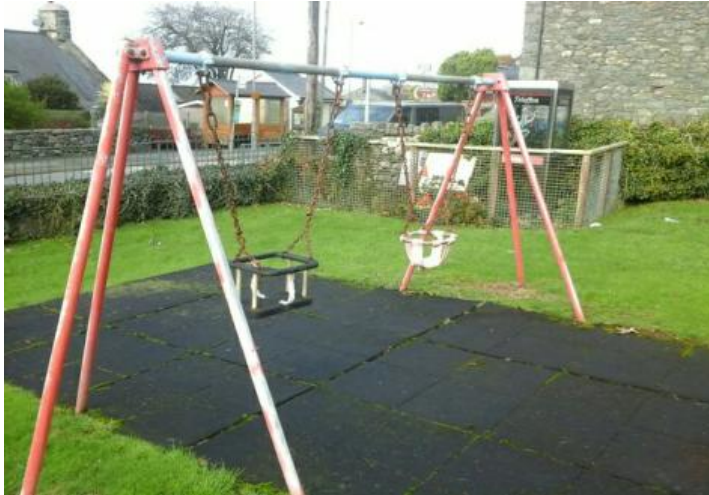
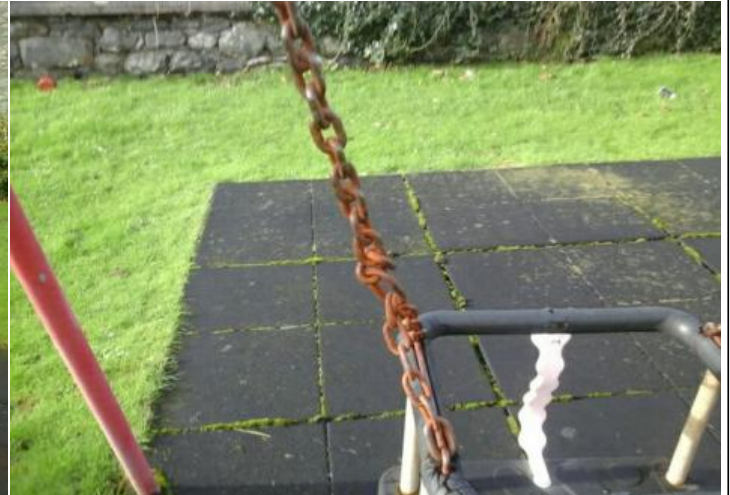
8 - Low Risk (Finding 9)

The chains are heavily corroded - Replace chains

Finding: The chains are heavily corroded

Action: Replace chains

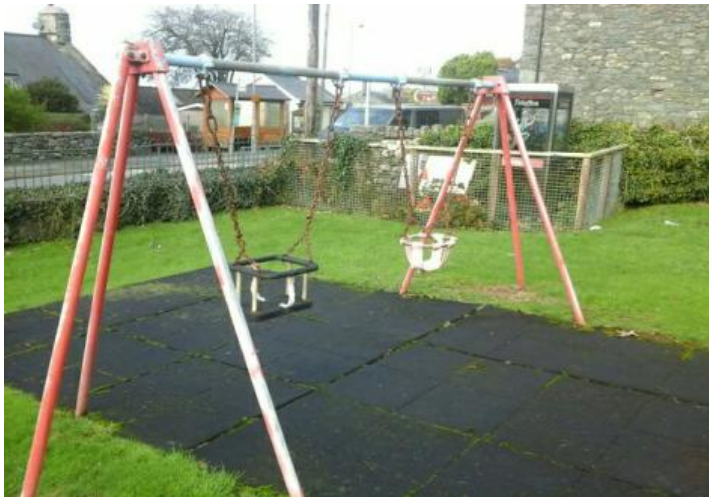
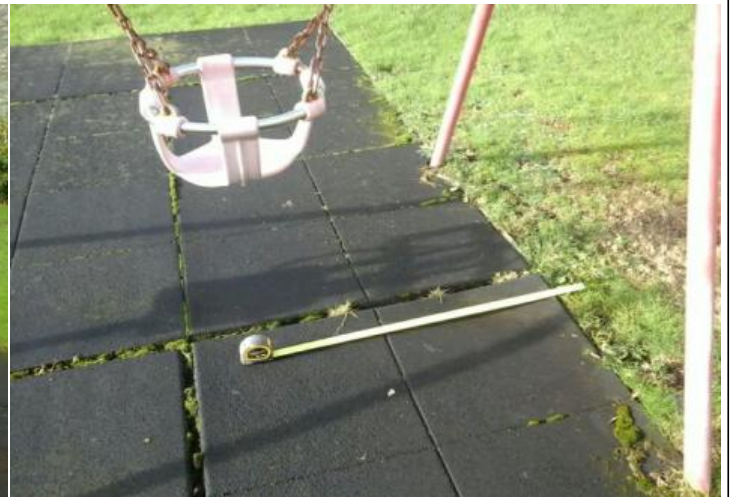
5 - Very Low Risk (Finding 10)

The surfacing width under each seat is less than 1.75 metres and fails the requirements of BS EN 1176 Part 2 - Monitor use

Finding: The surfacing width under each seat is less than 1.75 metres and fails the requirements of BS EN 1176 Part 2

Action: Monitor use

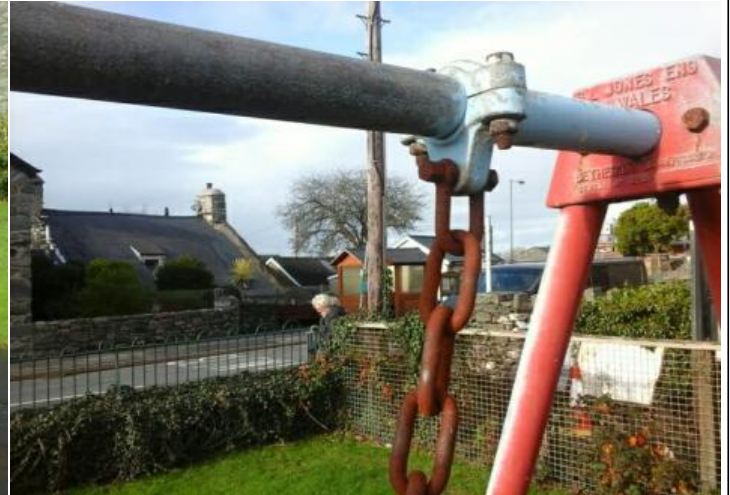
i 6 - Low Risk (Finding 11)

The shackles are corroding - Monitor for any further deterioration and repair as required

Finding: The shackles are corroding

Action: Monitor for any further deterioration and repair as required

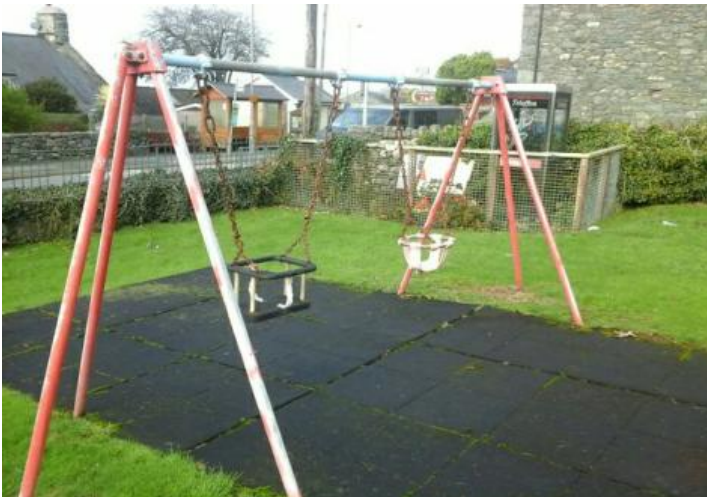
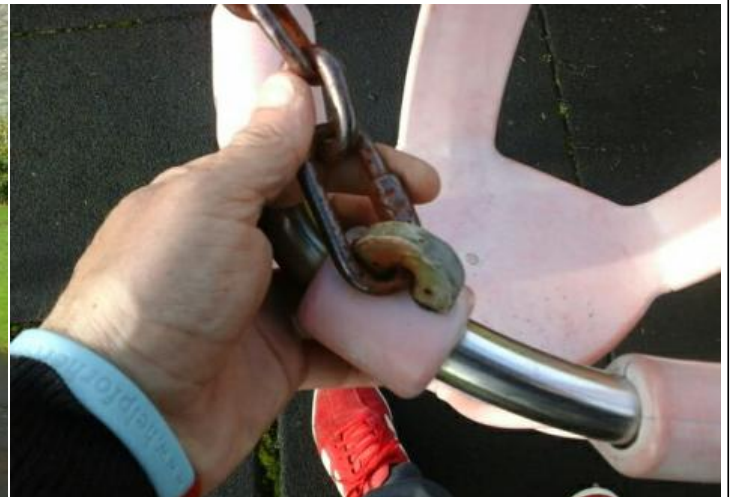
i 6 - Low Risk (Finding 12)

There is some wear to the shackles. - Monitor for any further deterioration and replace when 40% worn

Finding: There is some wear to the shackles.

Action: Monitor for any further deterioration and replace when 40% worn

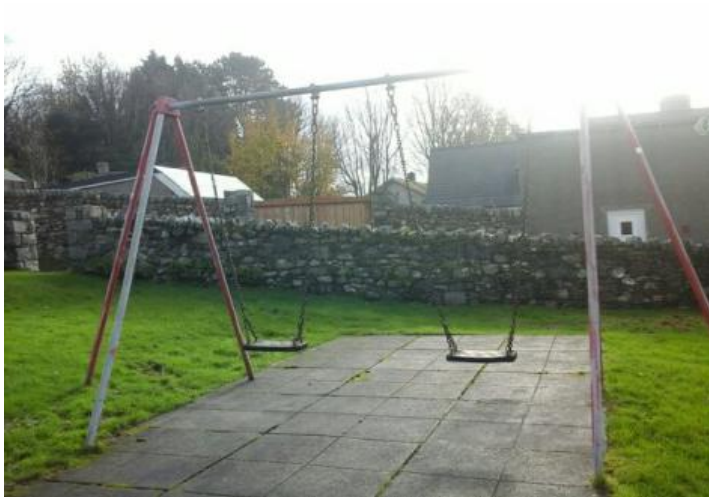
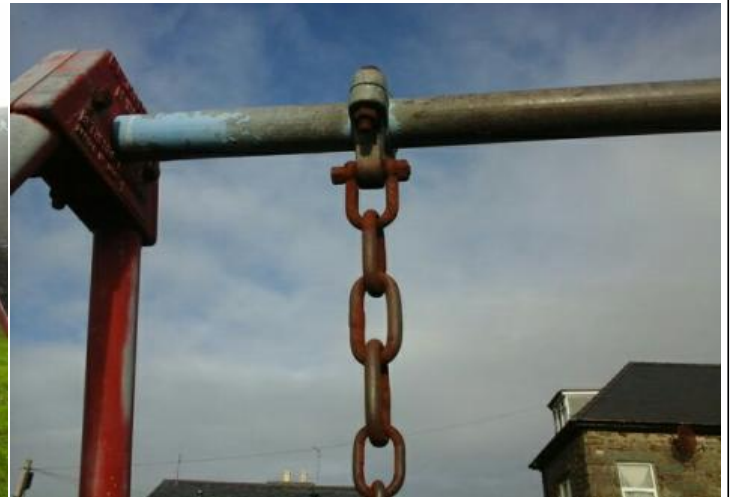
i 4 - Very Low Risk (Finding 1)

The bushes are showing signs of wear - Monitor for any further deterioration and replace as required

Finding: The bushes are showing signs of wear

Action: Monitor for any further deterioration and replace as required

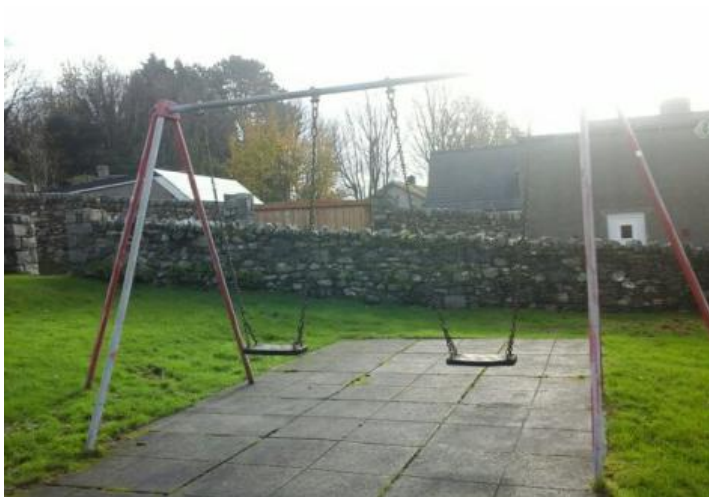
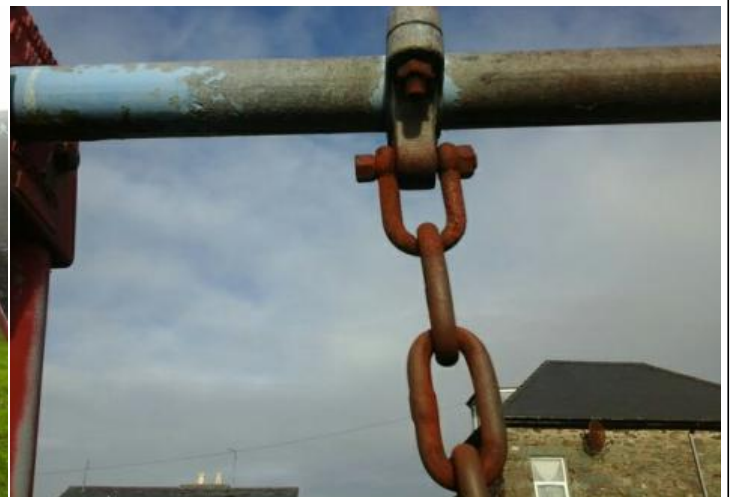
i 6 - Low Risk (Finding 2)

There is some wear to the shackles. - Monitor for any further deterioration and replace when 40% worn

Finding: There is some wear to the shackles.

Action: Monitor for any further deterioration and replace when 40% worn

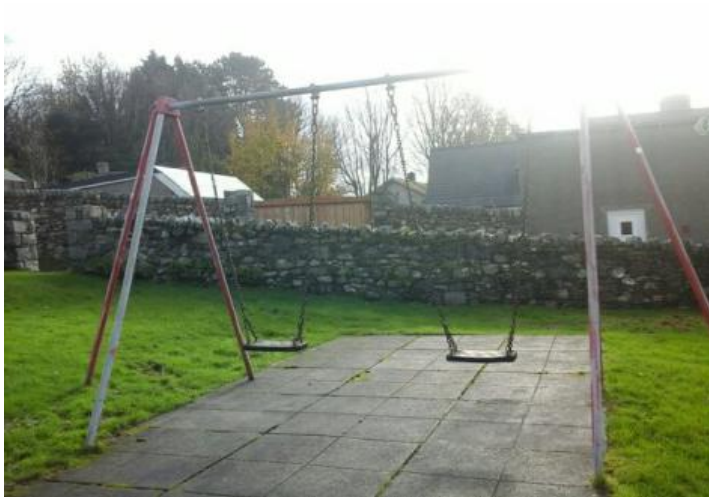
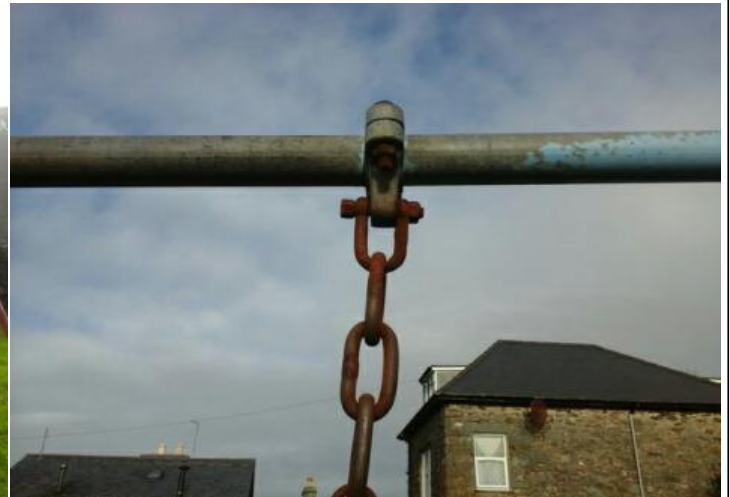
i 6 - Low Risk (Finding 3)

The shackles are corroding - Monitor for any further deterioration and repair as required

Finding: The shackles are corroding

Action: Monitor for any further deterioration and repair as required

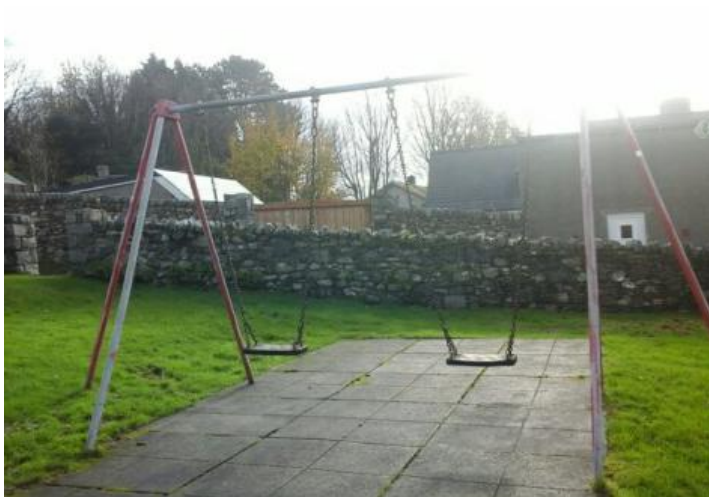
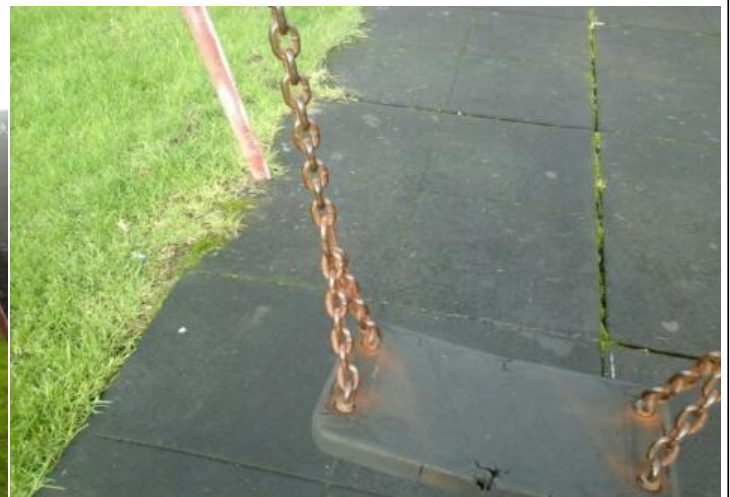
i 6 - Low Risk (Finding 4)

The chains are corroding - Monitor for any further deterioration and repair as required.

Finding: The chains are corroding

Action: Monitor for any further deterioration and repair as required.

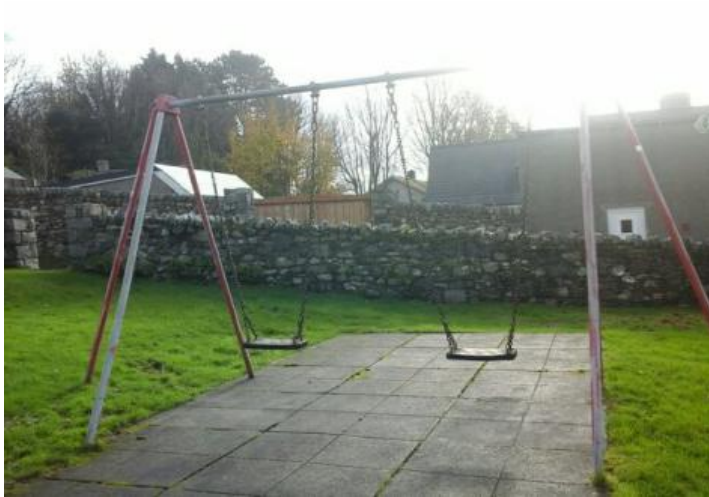
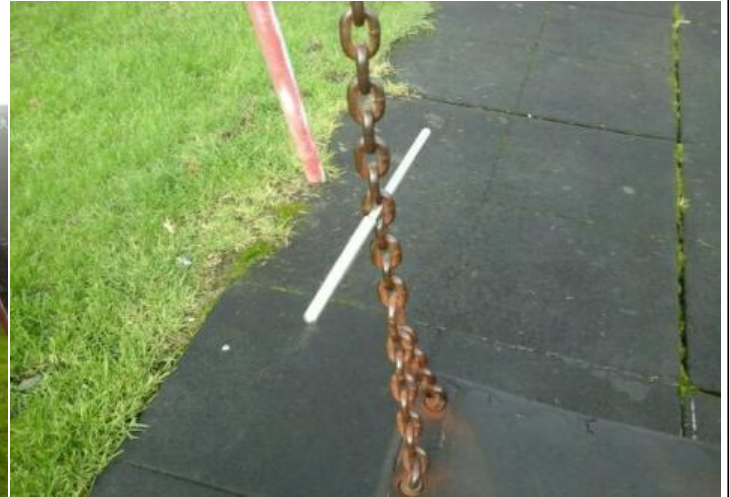
5 - Very Low Risk (Finding 5)

The chain openings are in excess of the 8.6mm as recommended by BS EN 1176 - Monitor use

Finding: The chain openings are in excess of the 8.6mm as recommended by BS EN 1176 **Action:** Monitor use

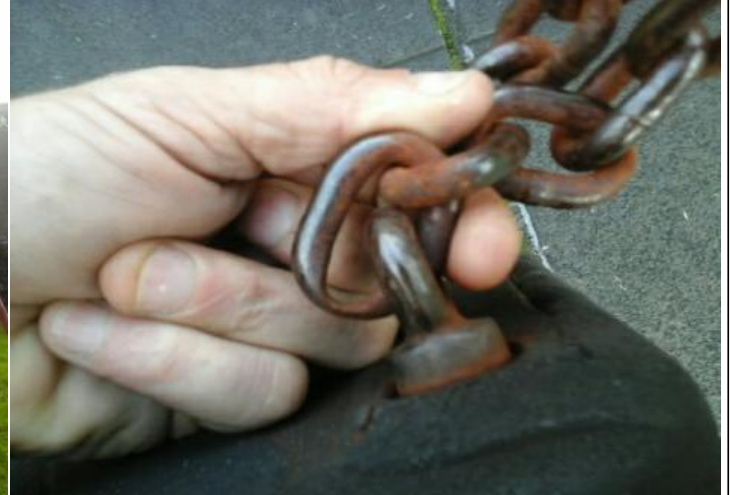
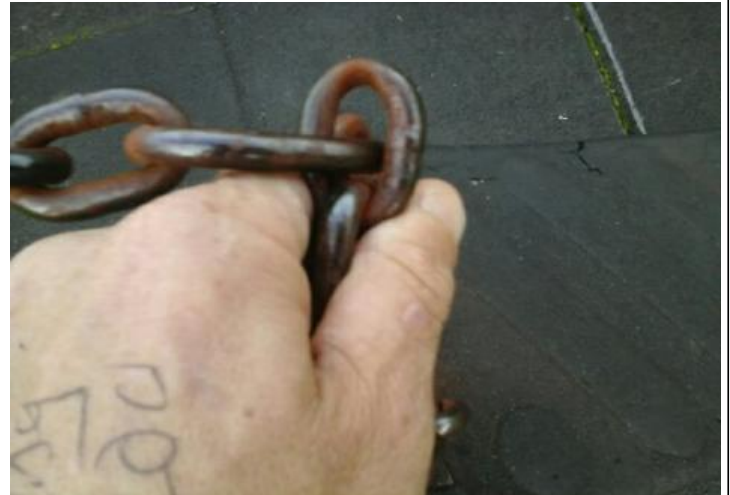
! 12 - Moderate Risk (Finding 6)

The chain links are worn in excess of 40% and require renewing - Replace worn chains

Finding: The chain links are worn in excess of 40% and require renewing

Action: Replace worn chains

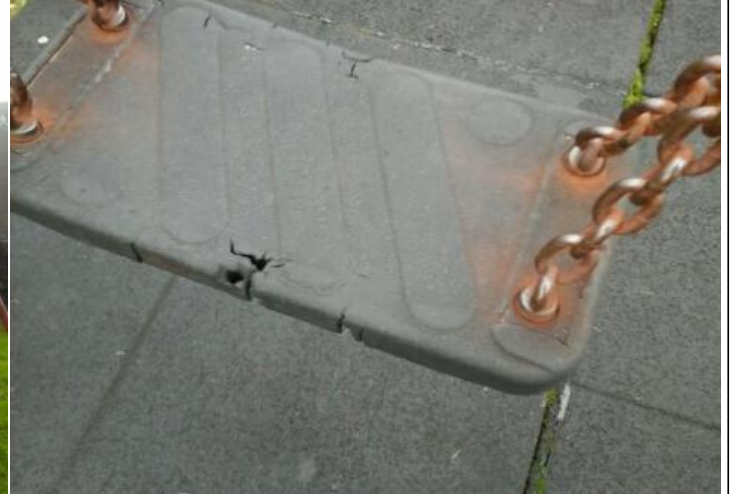
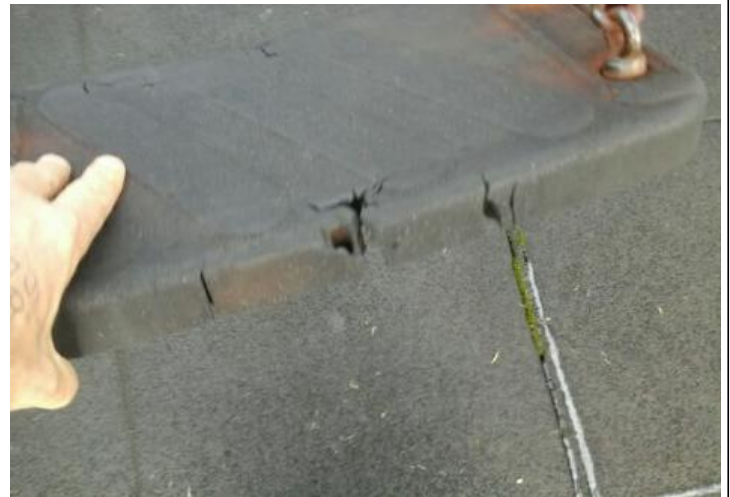
i 8 - Low Risk (Finding 7)

The seat is severely damaged and requires replacing - Replace damaged seat

Finding: The seat is severely damaged and requires replacing

Action: Replace damaged seat

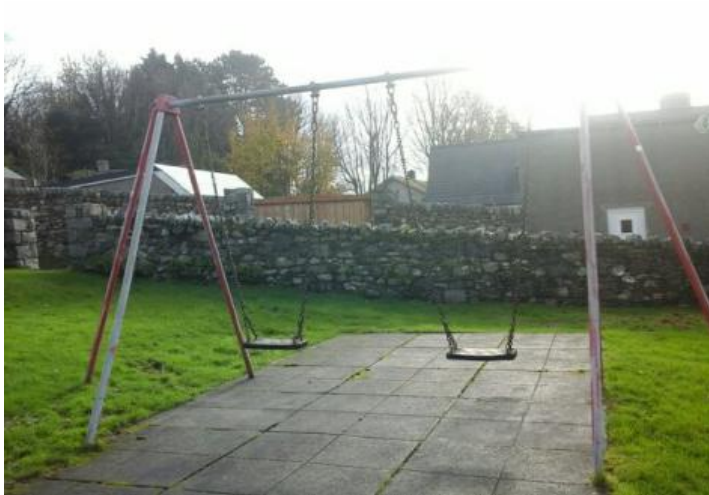
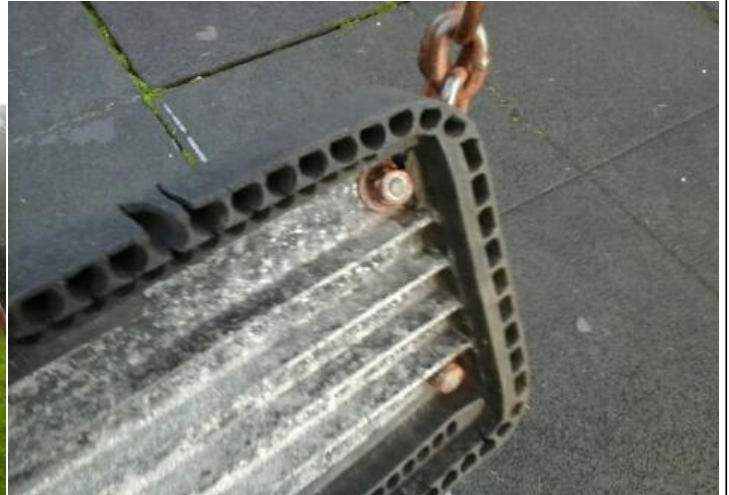
i 8 - Low Risk (Finding 8)

The seat fixings are corroded - Replace fixings

Finding: The seat fixings are corroded

Action: Replace fixings

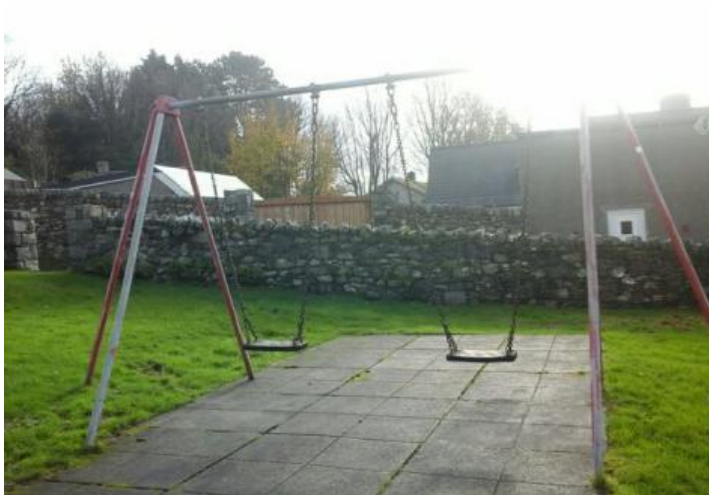
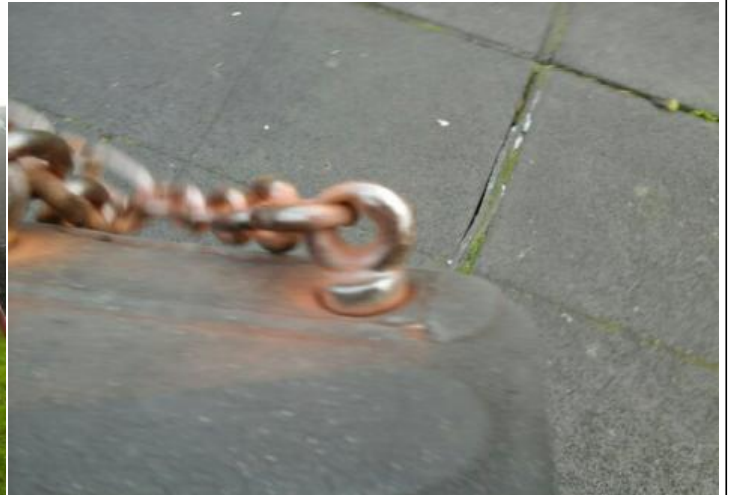
! 12 - Moderate Risk (Finding 9)

The seat eye bolts are worn - Replace bolts

Finding: The seat eye bolts are worn

Action: Replace bolts

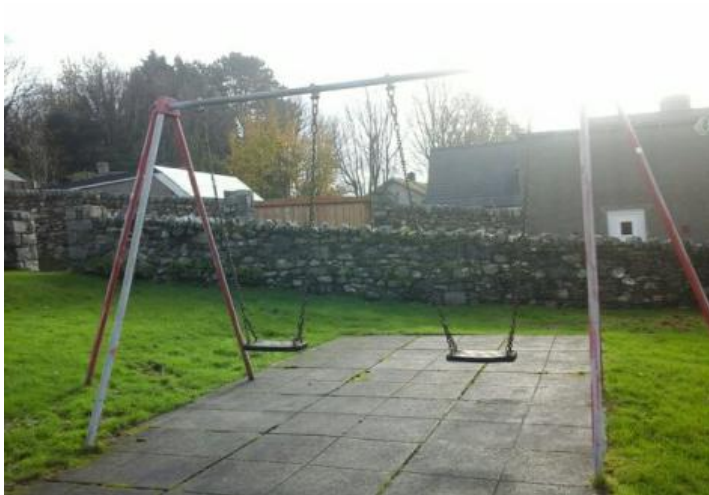
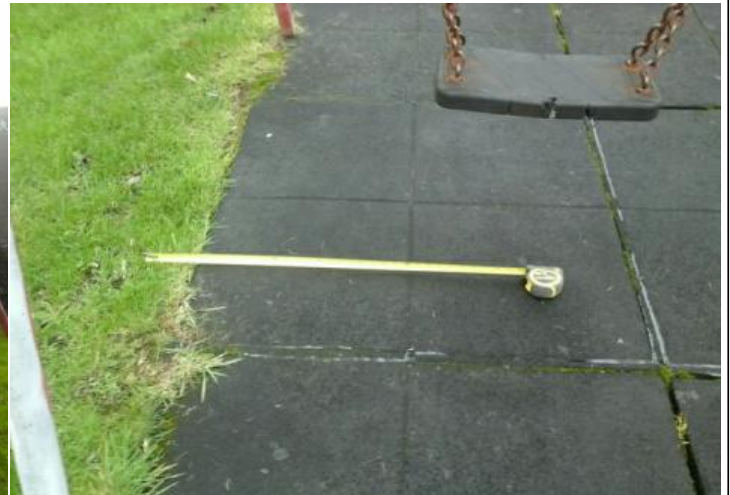
i 5 - Very Low Risk (Finding 10)

The surfacing width under each seat is less than 1.75 metres and fails the requirements of BS EN 1176 Part 2 - Monitor use

Finding: The surfacing width under each seat is less than 1.75 metres and fails the requirements of BS EN 1176 Part 2
Action: Monitor use

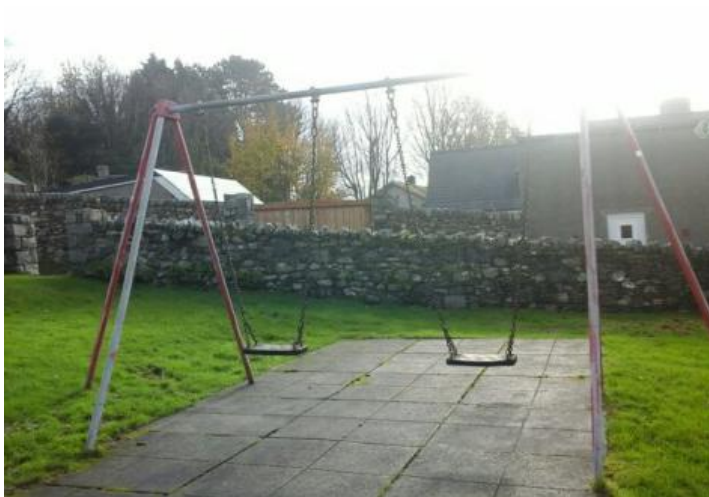
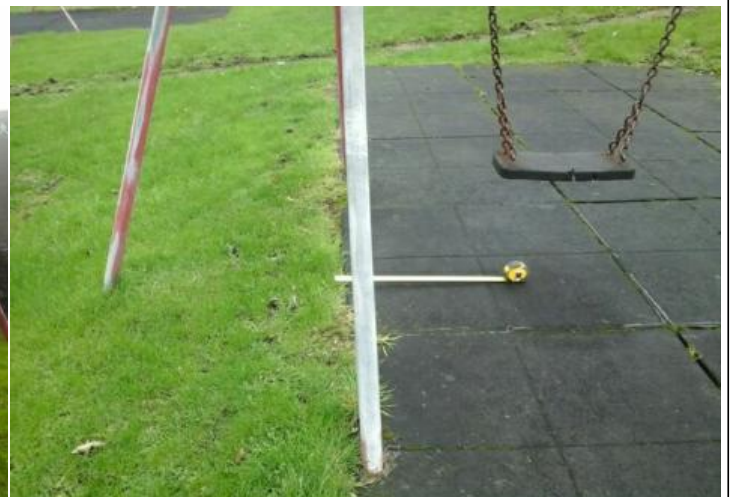
i 4 - Very Low Risk (Finding 11)

The seats are too close to the frame as defined in BS EN 1176 Part 2; this is a low risk failure and no remedial action is required - Monitor use

Finding: The seats are too close to the frame as defined in BS EN 1176 Part 2; this is a low risk failure and no remedial action is required
Action: Monitor use

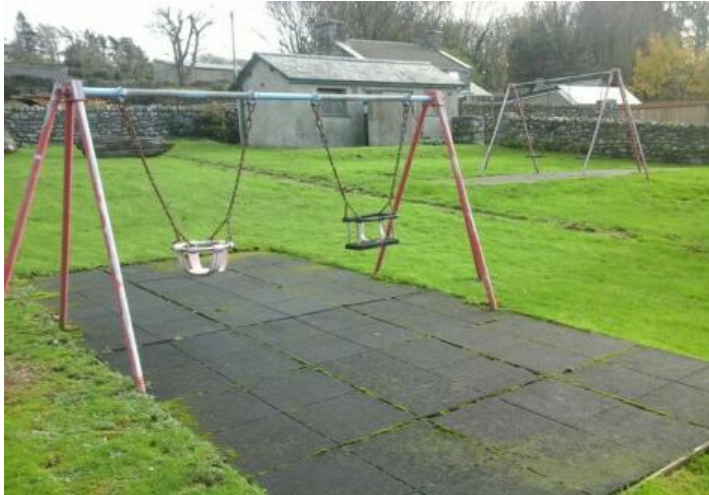
i 2 - Very Low Risk (Finding 1)

It is recommended that information signs with emergency contact details are installed at each entrance/exit point to the playground - Provide in accordance with the recommendations set out in BS EN 1176

Finding: It is recommended that information signs with emergency contact details are installed at each entrance/exit set out in BS EN 1176 point to the playground
Action: Provide in accordance with the recommendations

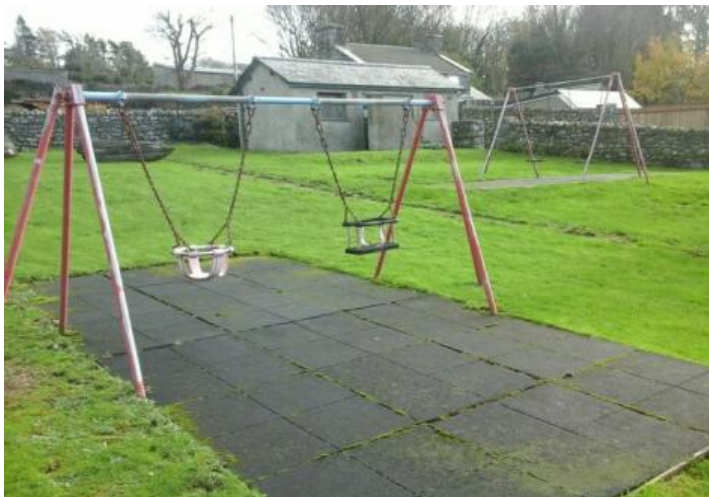
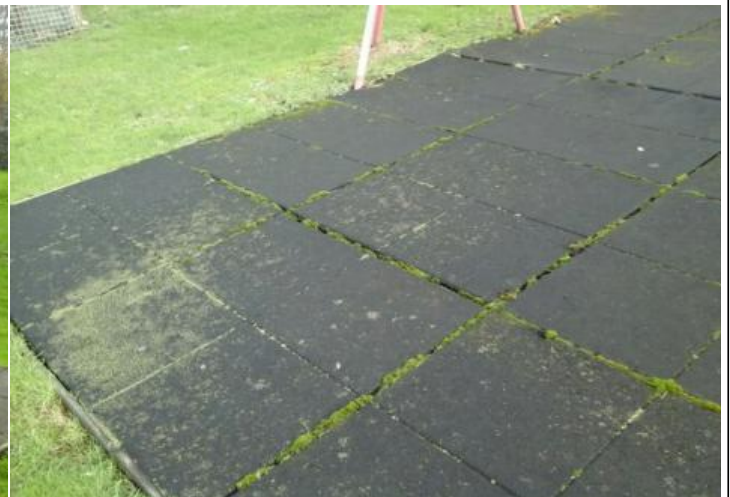
i 8 - Low Risk (Finding 2)

There is algae or moss growth on the surface resulting in slippery conditions - Clean and treat appropriately

Finding: There is algae or moss growth on the surface resulting in slippery conditions
Action: Clean and treat appropriately

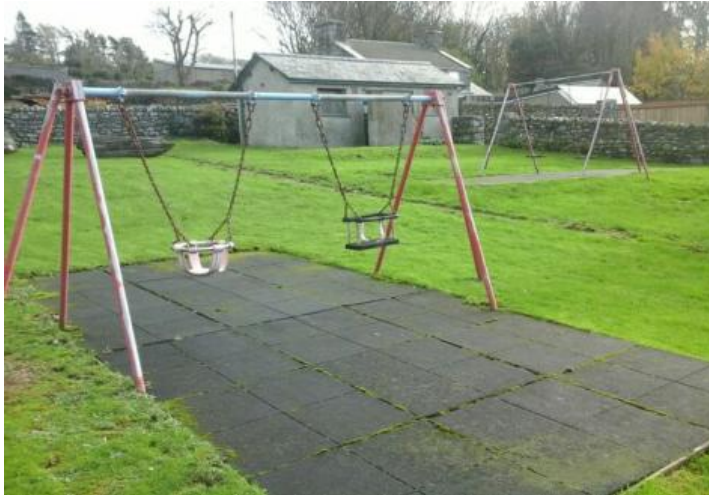
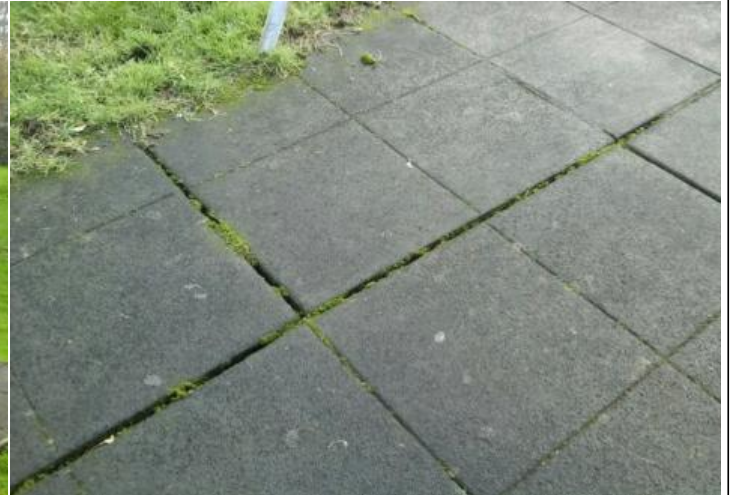
i 6 - Low Risk (Finding 3)

There are gaps opening in between the tiles - Monitor for any further deterioration and repair as required

Finding: There are gaps opening in between the tiles

Action: Monitor for any further deterioration and repair as required

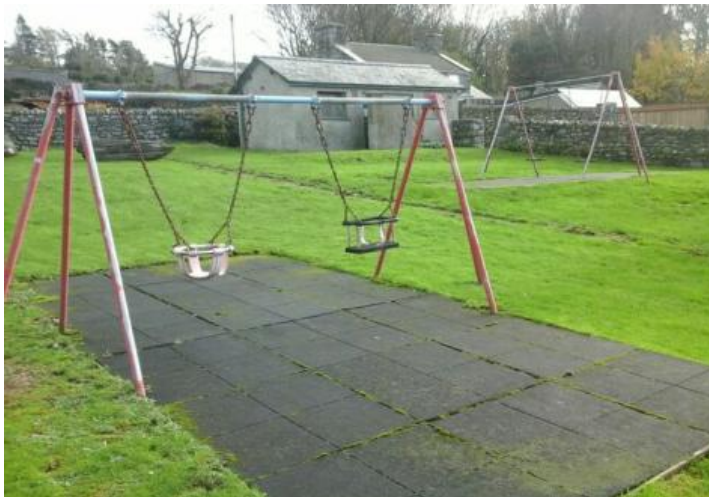
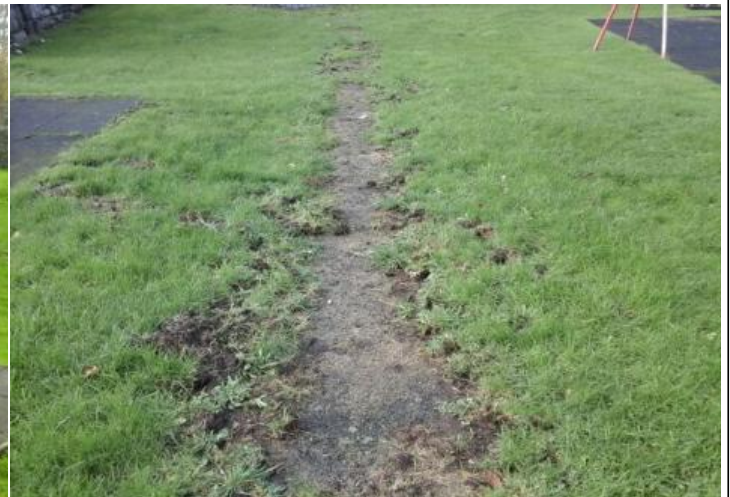
i 8 - Low Risk (Finding 4)

There is algae or moss growth on the surface resulting in slippery conditions - Clean and treat appropriately

Finding: There is algae or moss growth on the surface resulting in slippery conditions

Action: Clean and treat appropriately

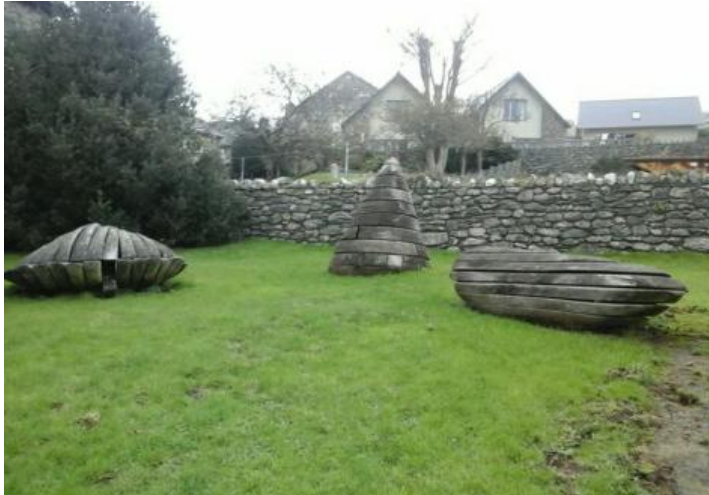
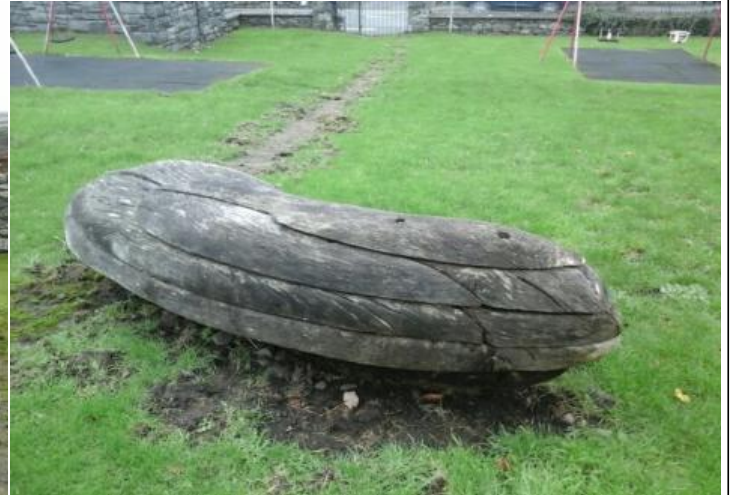
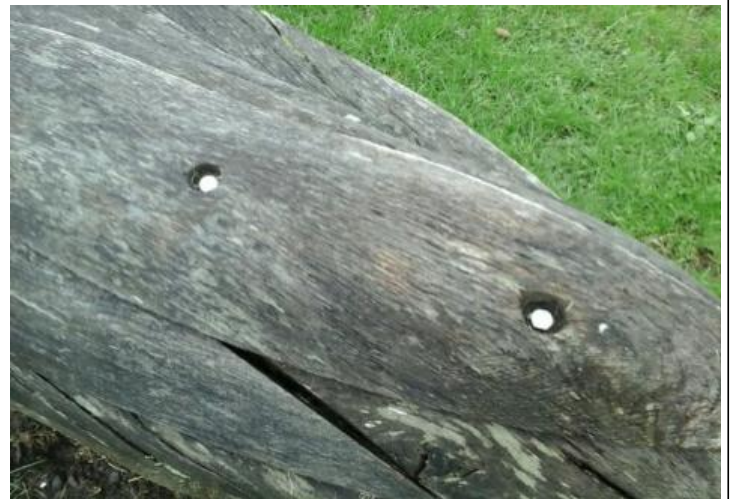
6 - Low Risk (Finding 1)

A number of fixing(s) have worked loose - Secure all loose fixings

Finding: A number of fixing(s) have worked loose

Action: Secure all loose fixings
