Annual Inspection

Dyffryn Ardudwy and Talybont Community Council

Old Swings

Talybont, LL44 2HT

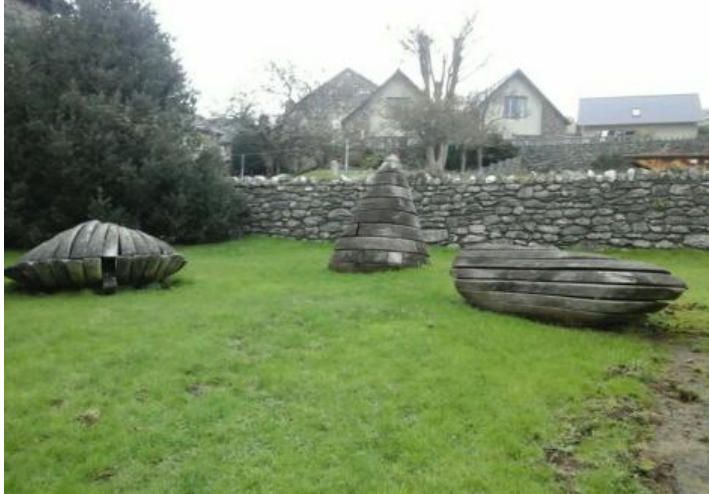
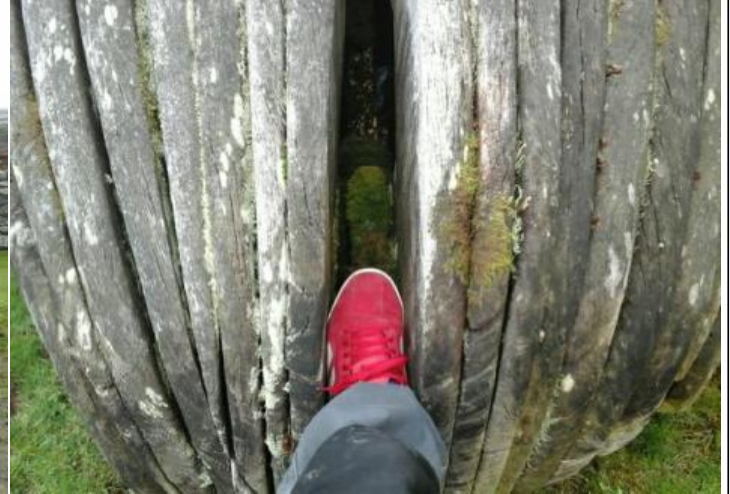
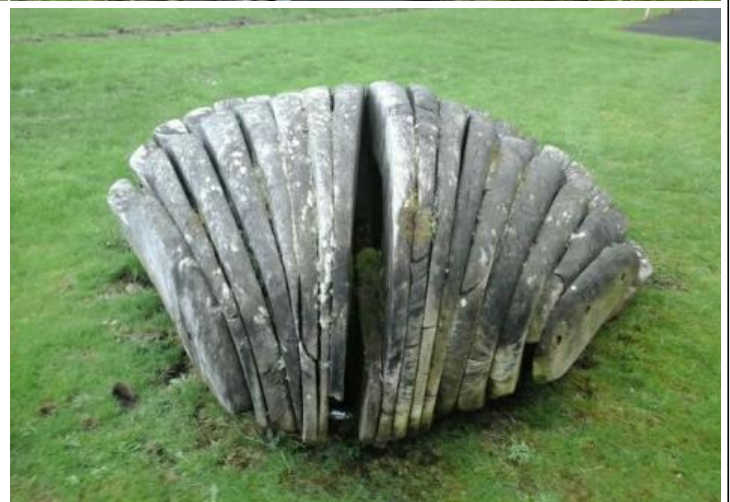
i 8 - Low Risk (Finding 2)

The item has separated resulting in a foot entrapment/s in the item - Repair removing entrapment

Finding: The item has separated resulting in a foot entrapment/s in the item

Action: Repair removing entrapment

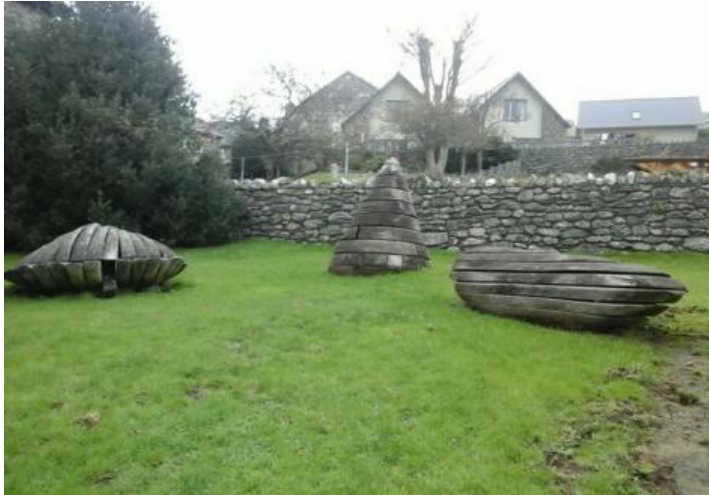
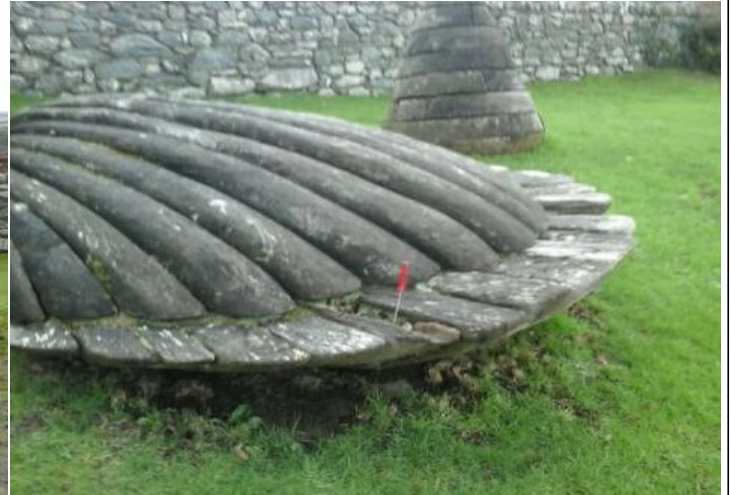
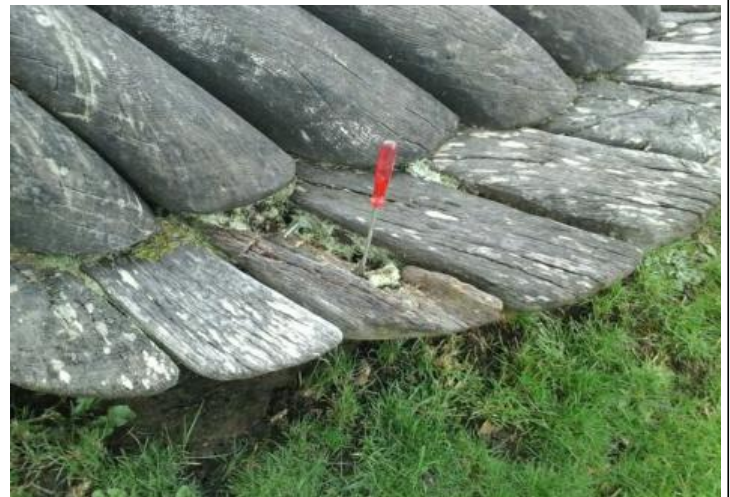
8 - Low Risk (Finding 3)

There are areas or parts of the timber on the structure that have rotted - Replace all affected timbers

Finding: There are areas or parts of the timber on the structure that have rotted

Action: Replace all affected timbers

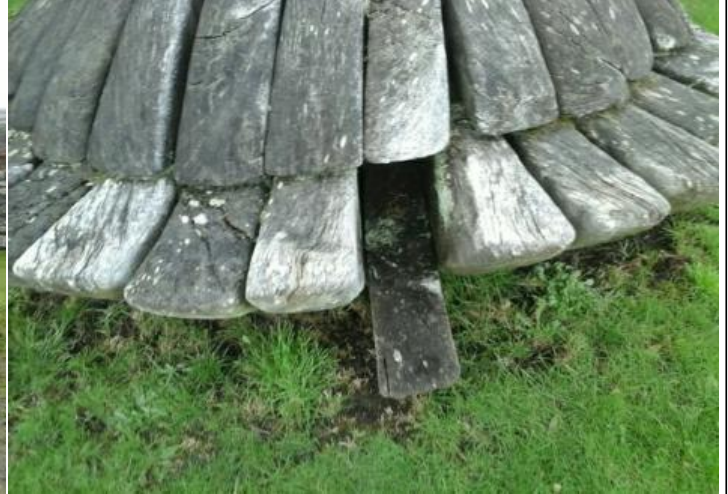
8 - Low Risk (Finding 4)

A timber section has collapsed - Repair

Finding: A timber section has collapsed

Action: Repair

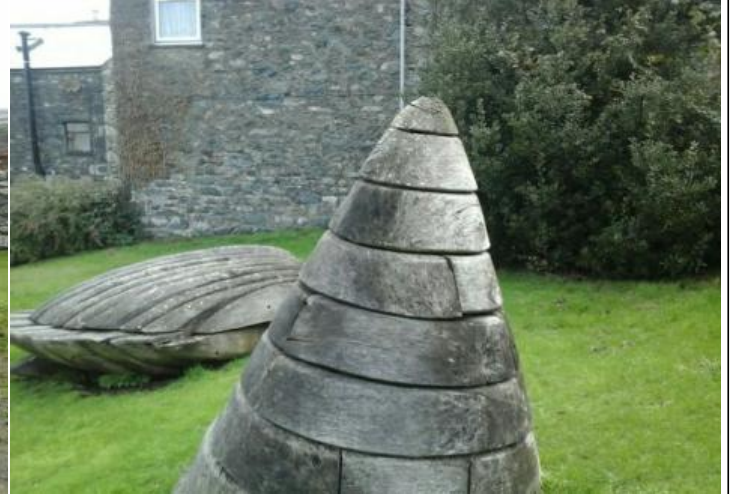
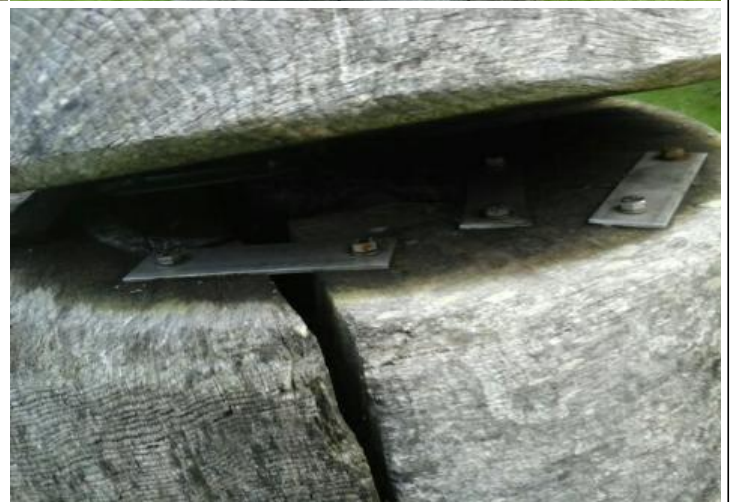
8 - Low Risk (Finding 6)

The top section is loose - Re secure fixings

Finding: The top section is loose

Action: Re secure fixings

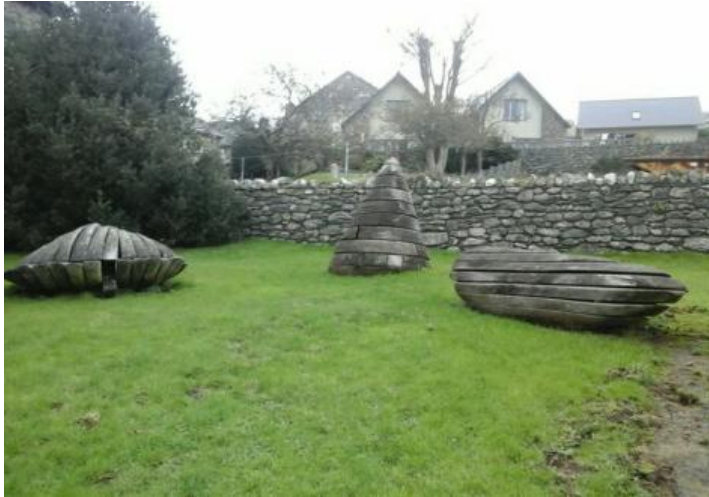
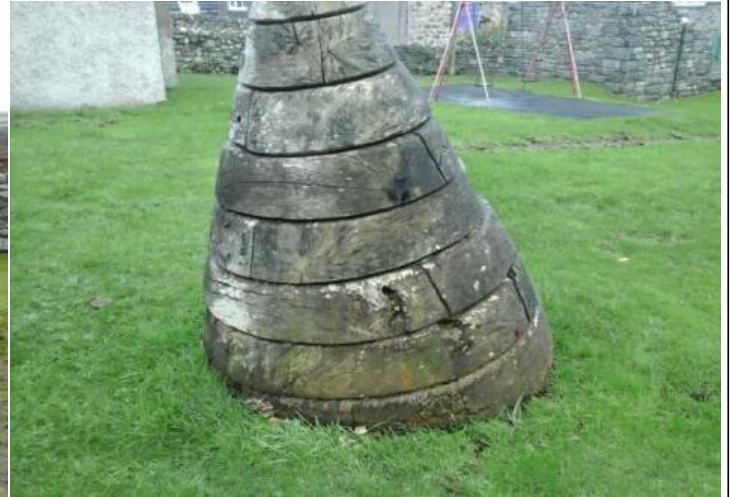
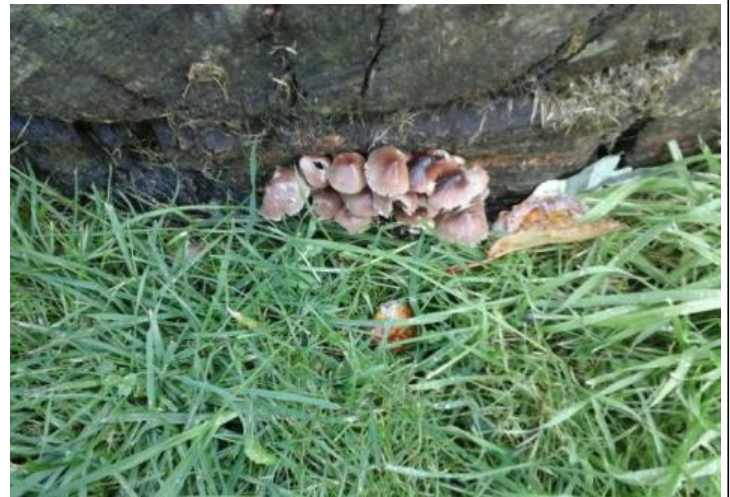
5 - Very Low Risk (Finding 7)

Fungus or algae was found on the equipment - Remove fungi or algae from the equipment

Finding: Fungus or algae was found on the equipment

Action: Remove fungi or algae from the equipment
