Annual Inspection

Dyffryn Ardudwy and Talybont Community Council

Pentre Uchaf Play Park

Dyffrn Ardudwy, LL44 2HT

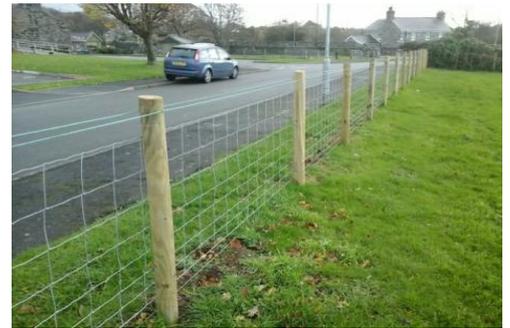
Item: Fence - Steel Mesh
Manufacturer: Owner/Operator
Surface Type: Grass
Equipment Compliance: N/A
Surface Area Compliance: N/A

There are a number of loose posts around the fence - Monitor for any further deterioration and reset as required

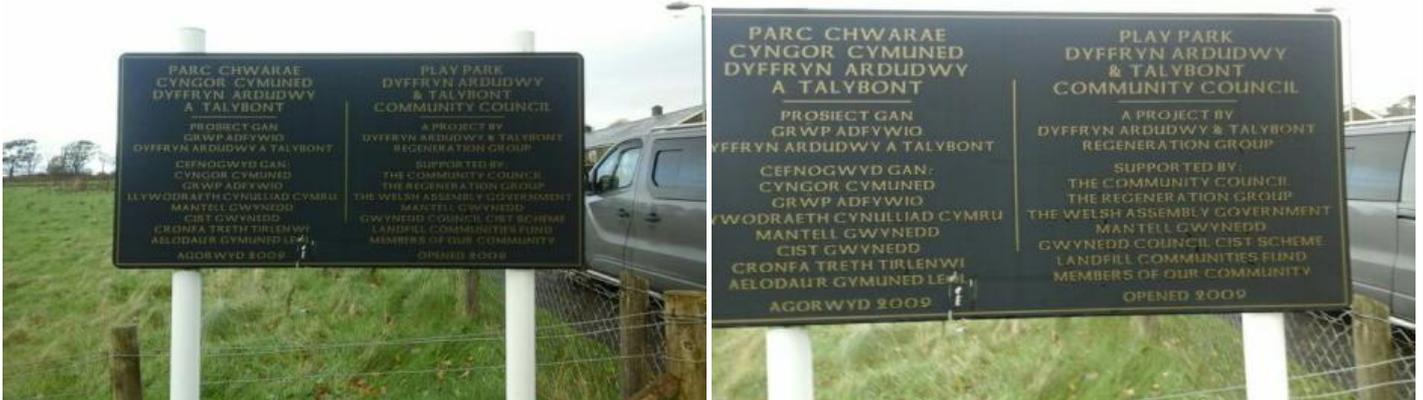
Item: Ancillary Items - Sign
Manufacturer: Owner/Operator

Finding: It is recommended that information signs with emergency contact details are installed at each entrance/exit point to the playground

Action: Provide in accordance with the recommendations set out in BS EN 1176

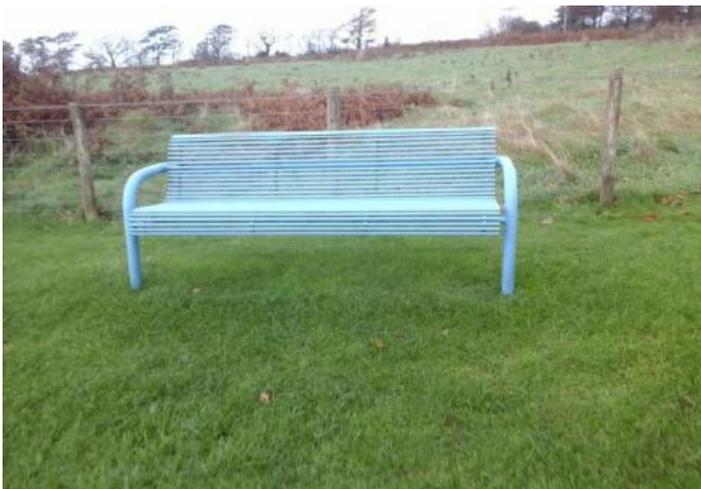
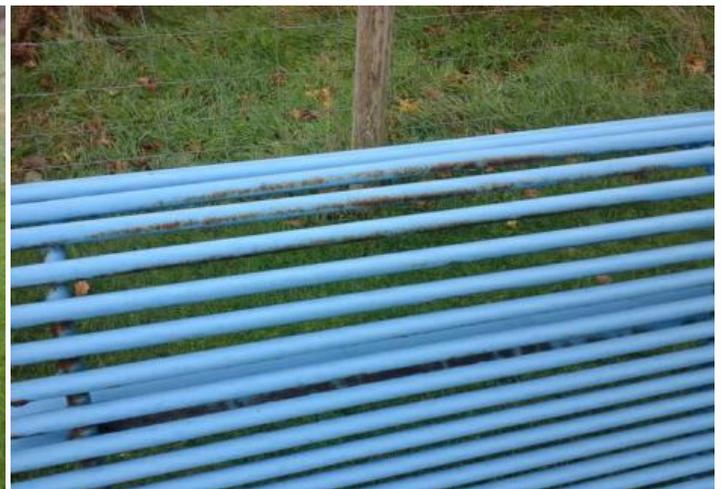
Item: Ancillary Items - Bench
Manufacturer: Lightmain Engineering

Finding: There is surface corrosion present on the item

Action: Consider treating and repainting the item

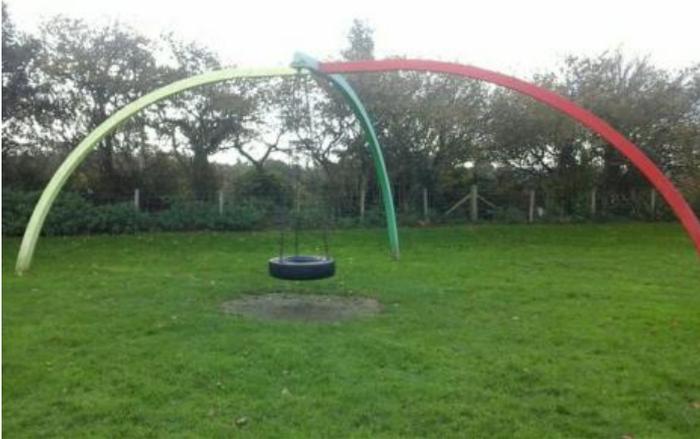
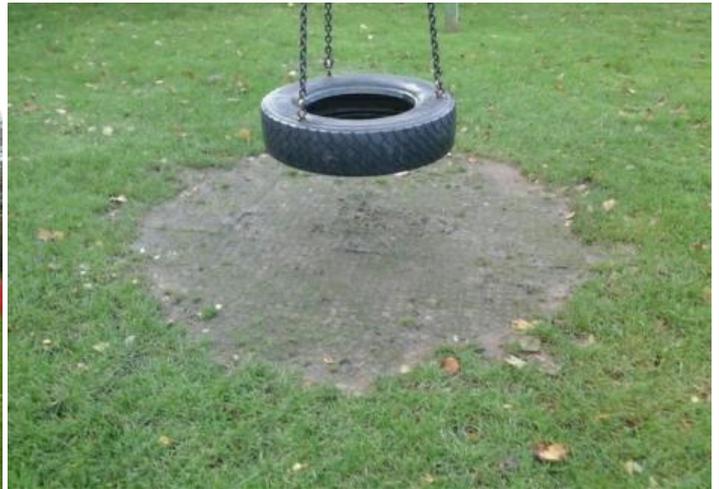
Item: Swings - Single Point Swing - Type 3
Manufacturer: Park Leisure Ltd

Finding: The grass mats are silted up and the soil is compacted; this may have an effect on the impact absorbing properties of the surface

Action: Consider HIC testing impact absorbing properties to ensure the correct surface qualities are maintained for the equipment and replace as required

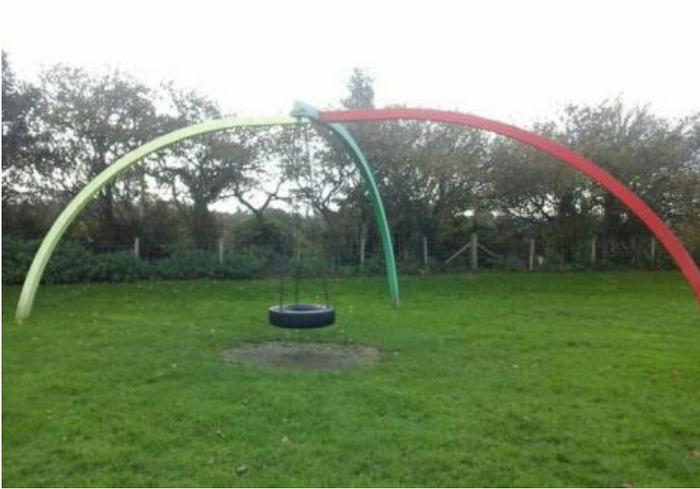
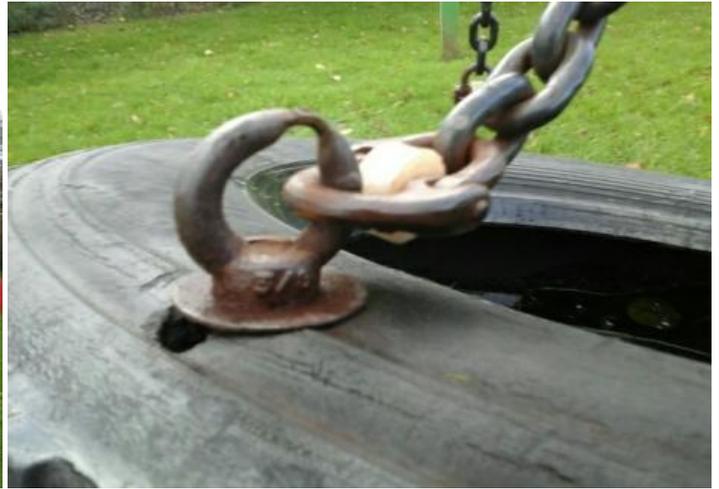
Item: Swings - Single Point Swing - Type 3
Manufacturer: Park Leisure Ltd

Finding: The eye bolts are heavily worn, H.O. informed

Action: Replace

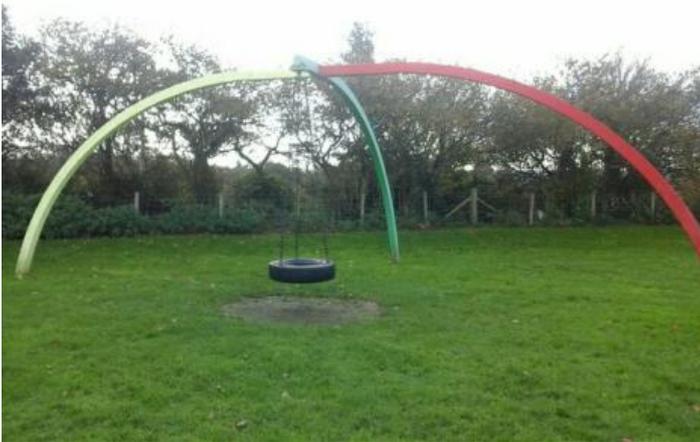
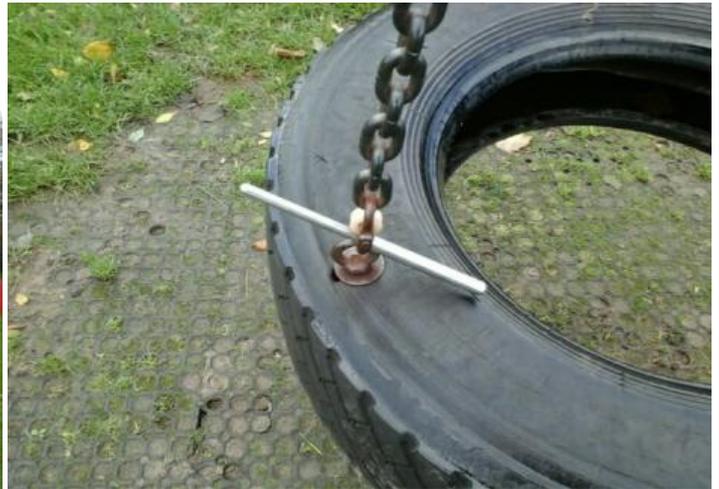
Item: Swings - Single Point Swing - Type 3
Manufacturer: Park Leisure Ltd

Finding: The connecting links are in excess of 8.6mm and less than 12mm and fail the requirements of BS EN 1176 Part 1; clause 4.2.13, Chains

Action: Monitor use

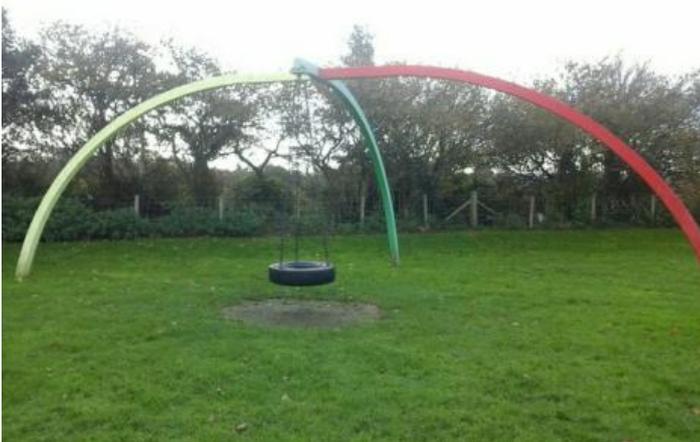
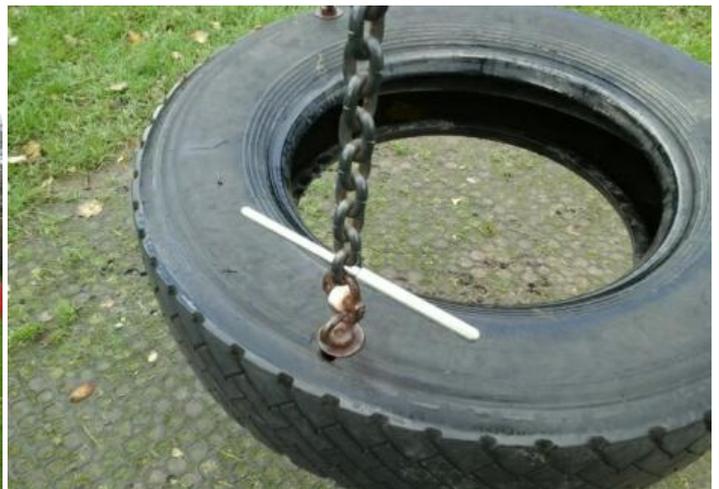
Item: Swings - Single Point Swing - Type 3
Manufacturer: Park Leisure Ltd

Finding: The chain openings are in excess of the 8.6mm as recommended by BS EN 1176

Action: Monitor use

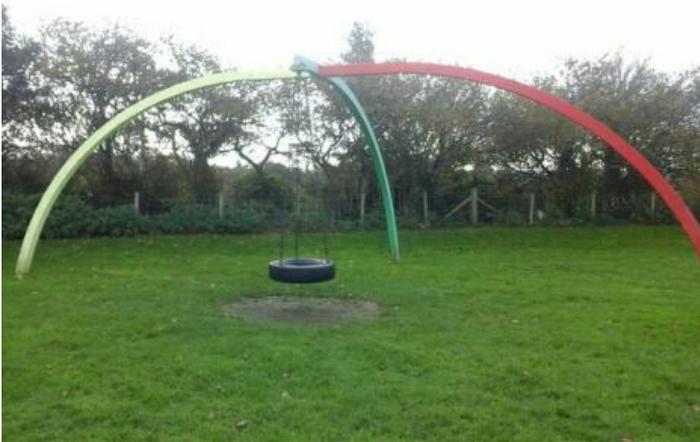
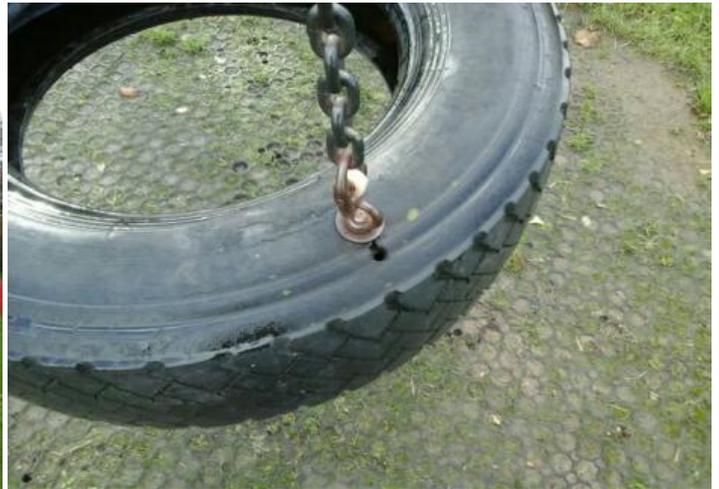
Item: Swings - Single Point Swing - Type 3
Manufacturer: Park Leisure Ltd

Finding: The seat has minor damage or wear

Action: Monitor for any further deterioration and replace as required

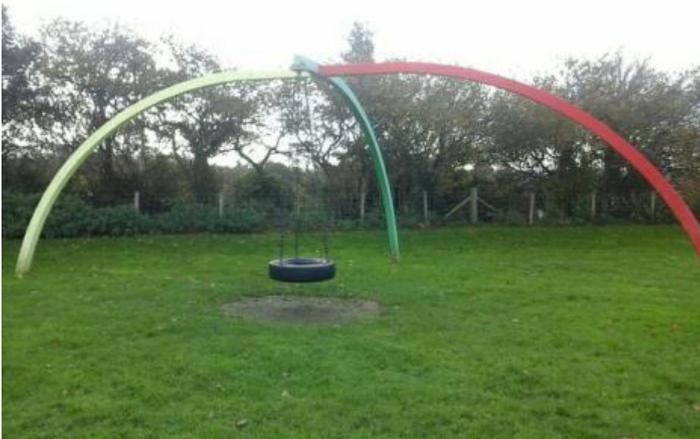
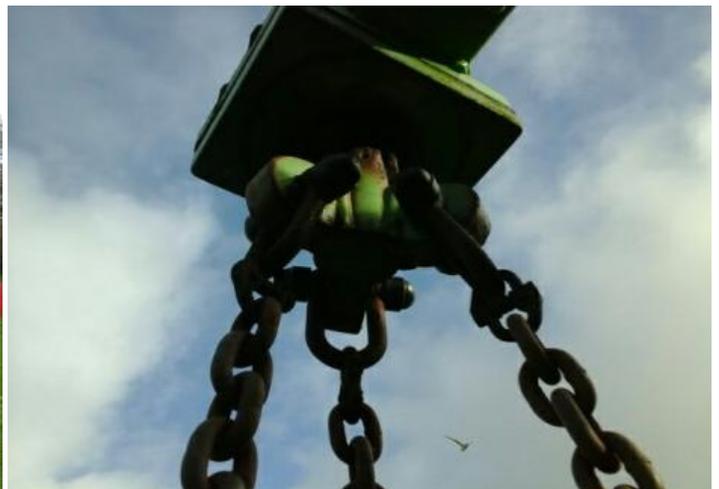
Item: Swings - Single Point Swing - Type 3
Manufacturer: Park Leisure Ltd

Finding: The shackles have been overtightened or seized transferring wear to the chain links below

Action: Loosen shackles to ensure free movement at the pivot

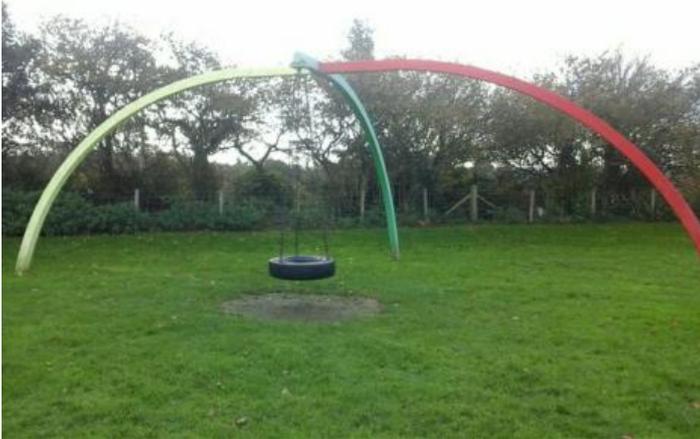
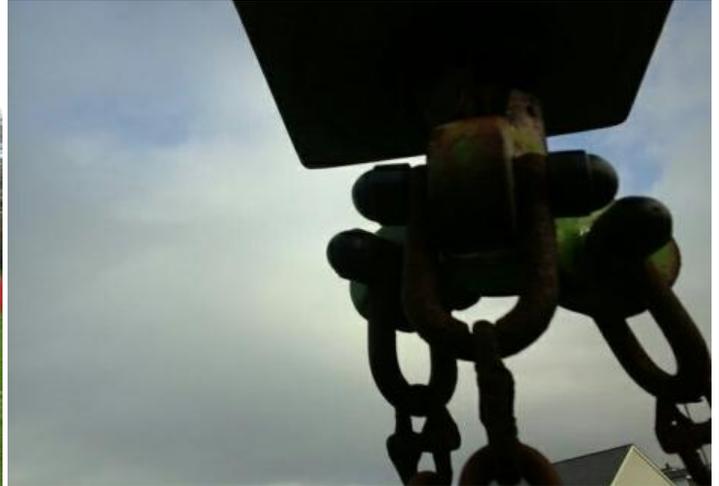
Item: Swings - Single Point Swing - Type 3
Manufacturer: Park Leisure Ltd

Finding: There is some wear to the shackles.

Action: Monitor for any further deterioration and replace when 40% worn

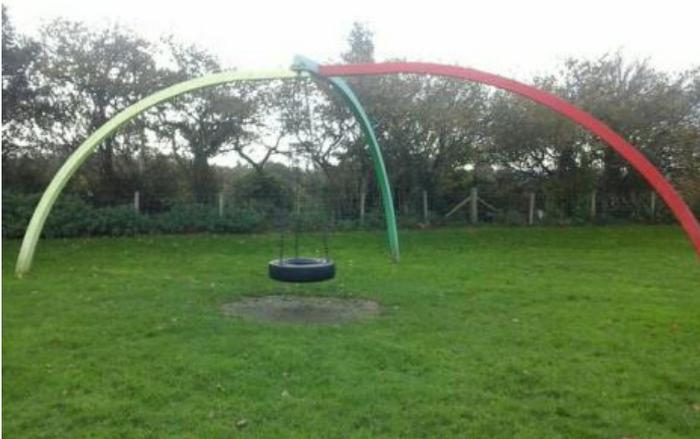
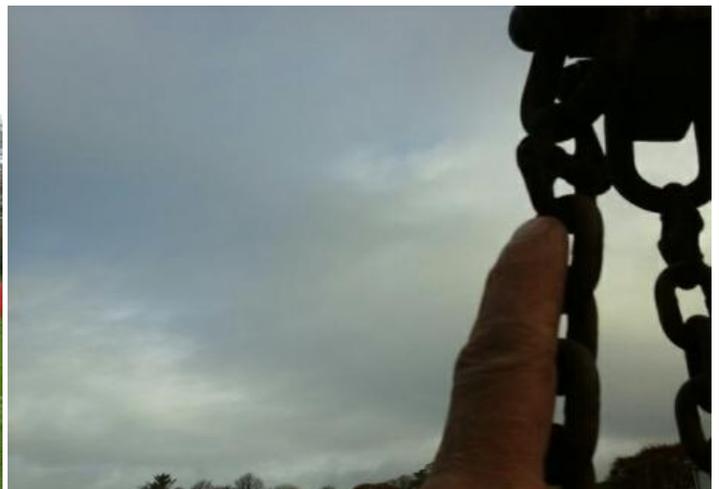
Item: Swings - Single Point Swing - Type 3
Manufacturer: Park Leisure Ltd

Finding: The shackles are worn in excess of 40% and require renewing

Action: Replace worn shackles

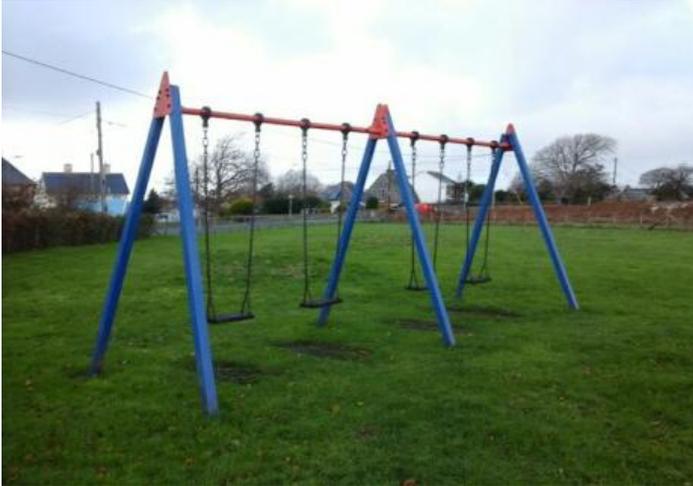
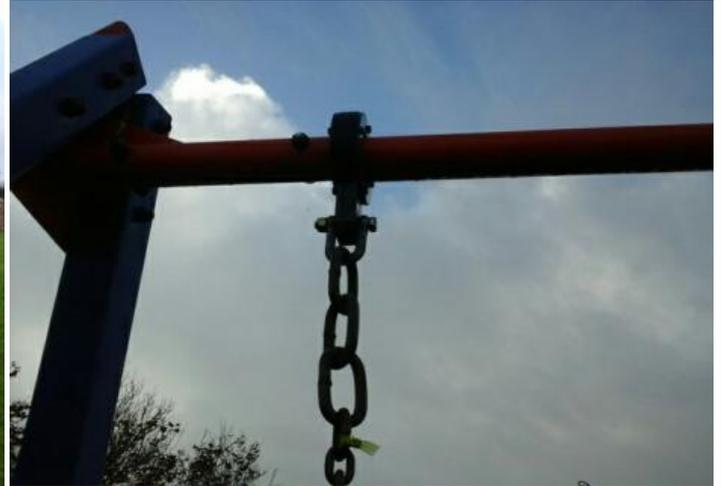
Item: Swings - 2 Bay 4 Seat (Flat)
Manufacturer: Park Leisure Ltd

Finding: The shackles have been overtightened or seized transferring wear to the chain links below

Action: Loosen shackles to ensure free movement at the pivot

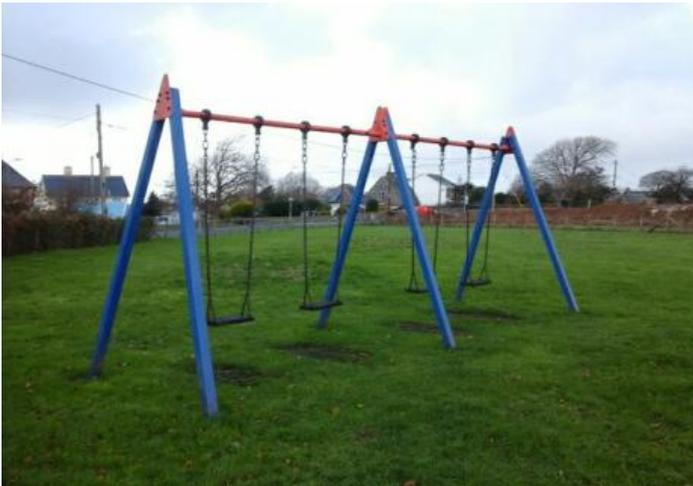
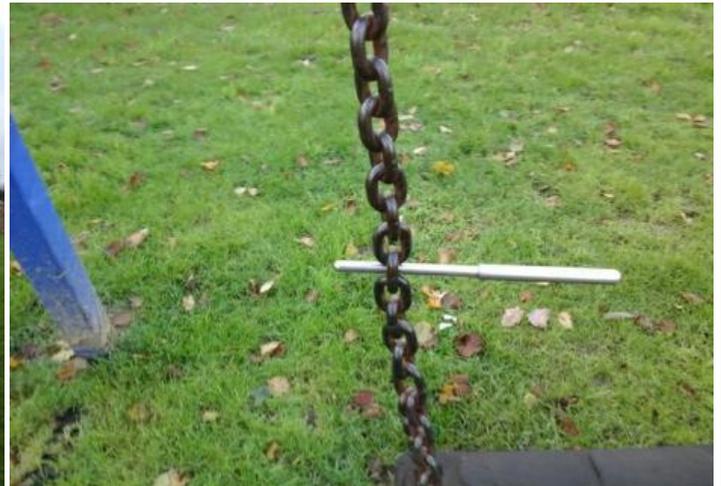
Item: Swings - 2 Bay 4 Seat (Flat)
Manufacturer: Park Leisure Ltd

Finding: The chain openings are in excess of the 8.6mm as recommended by BS EN 1176

Action: Monitor use

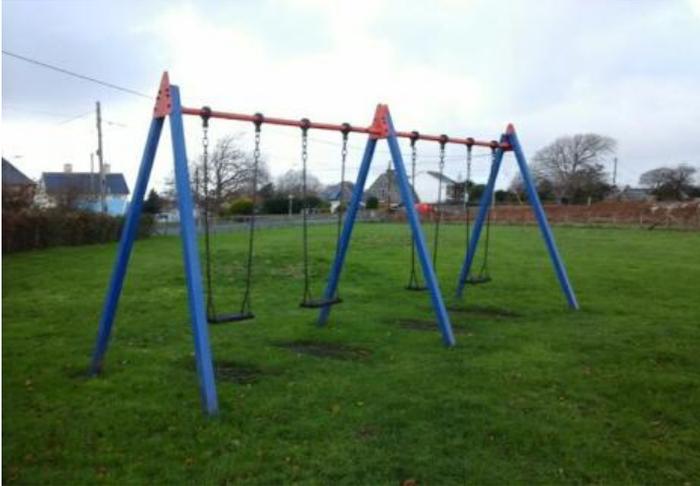
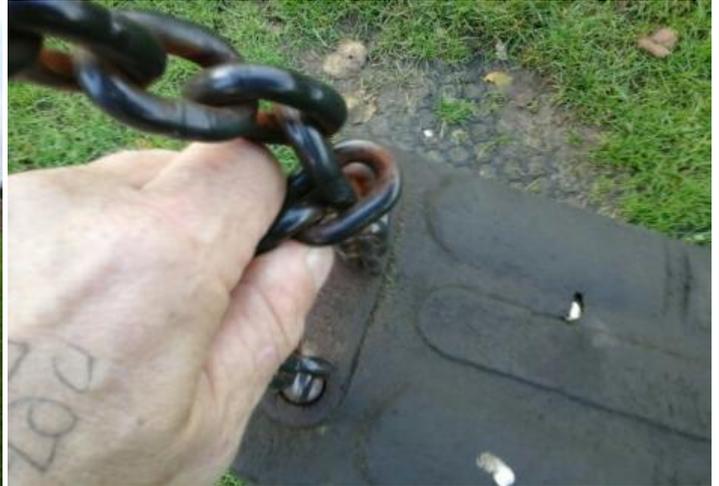
Item: Swings - 2 Bay 4 Seat (Flat)
Manufacturer: Park Leisure Ltd

Finding: There is some notable evidence of chain wear

Action: Monitor for any further deterioration and replace when 40% worn

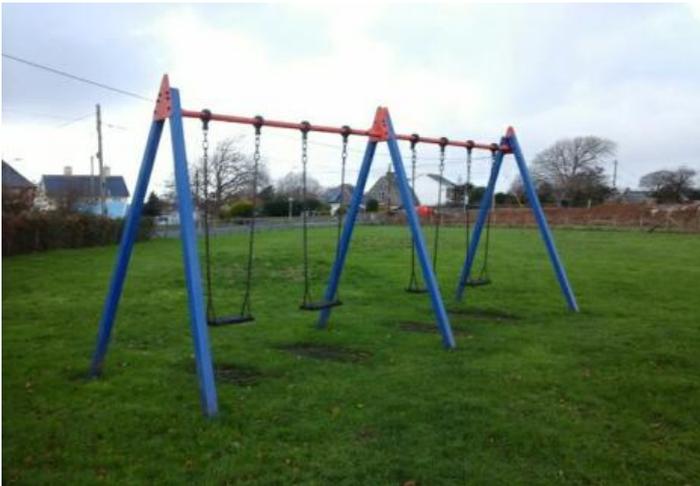
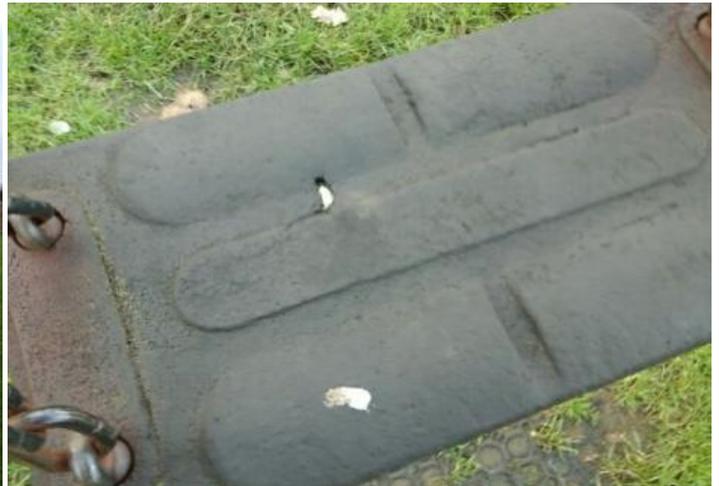
Item: Swings - 2 Bay 4 Seat (Flat)
Manufacturer: Park Leisure Ltd

Finding: The seat has minor damage or wear

Action: Monitor for any further deterioration and replace as required

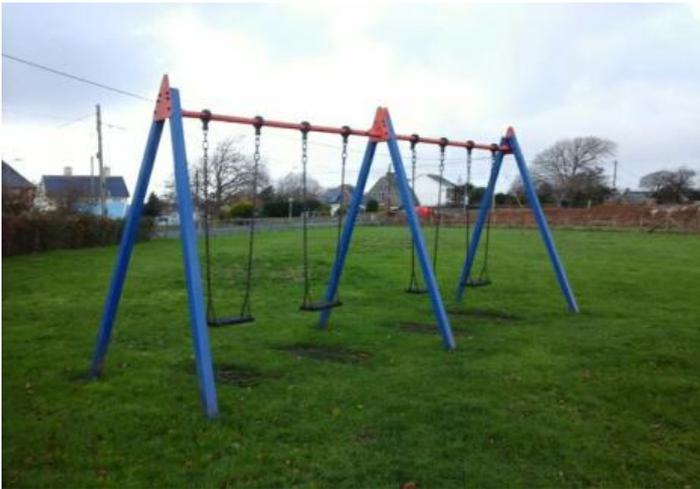
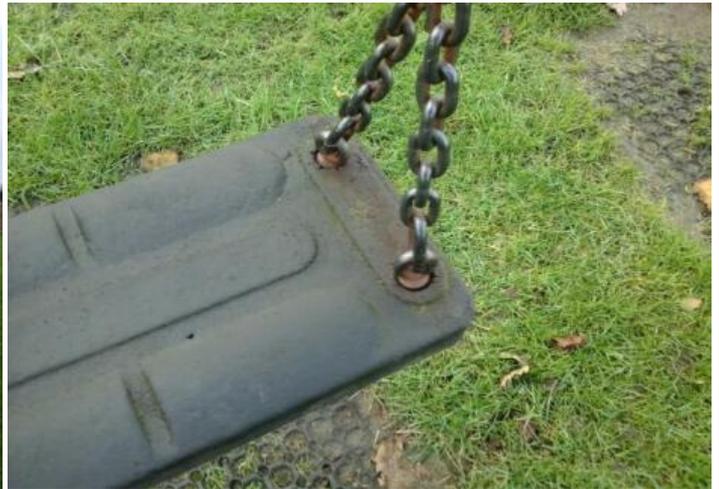
Item: Swings - 2 Bay 4 Seat (Flat)
Manufacturer: Park Leisure Ltd

Finding: The swing seat connectors are loose

Action: Tighten to secure

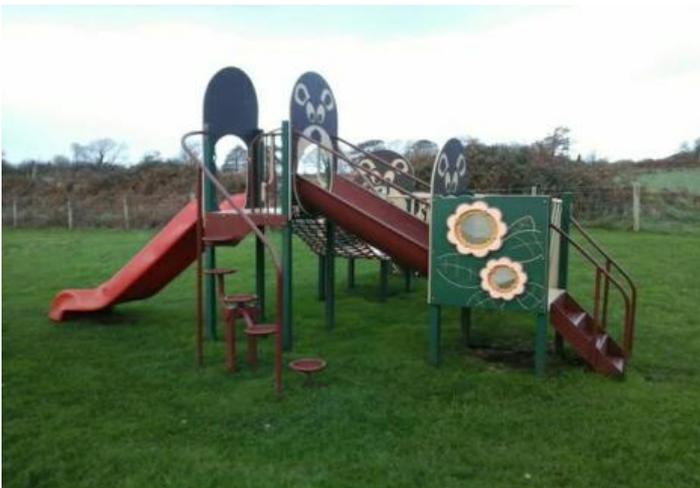
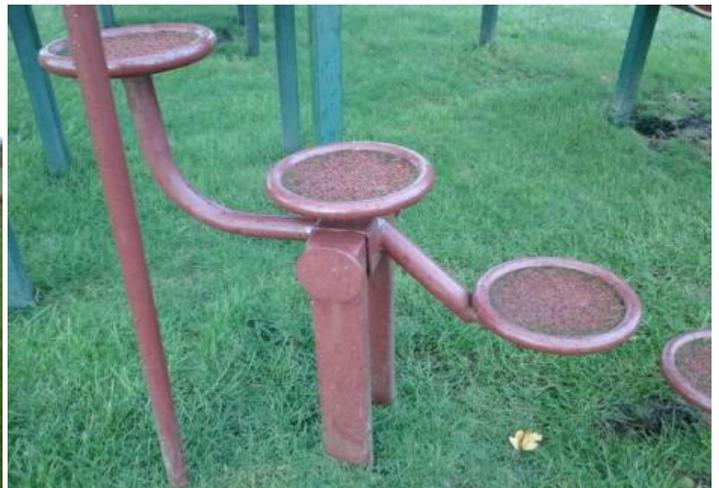
Item: Activity Equipment - Multi Play (Junior)
Manufacturer: Not Identified

Finding: There is wear to the torsion system

Action: Monitor for any further deterioration and repair as required.

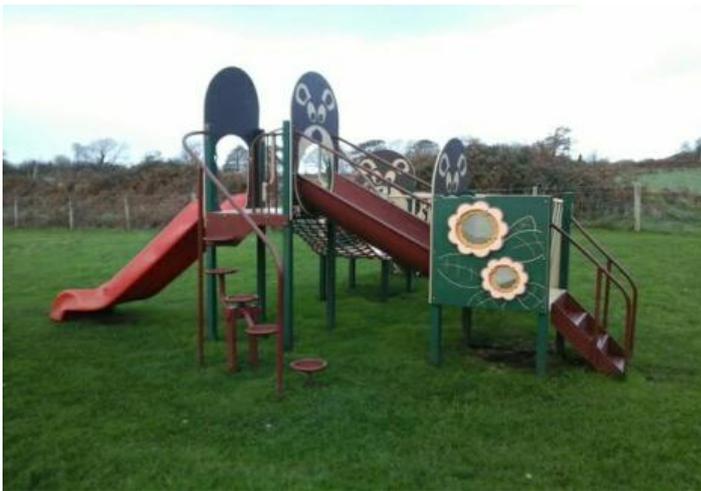
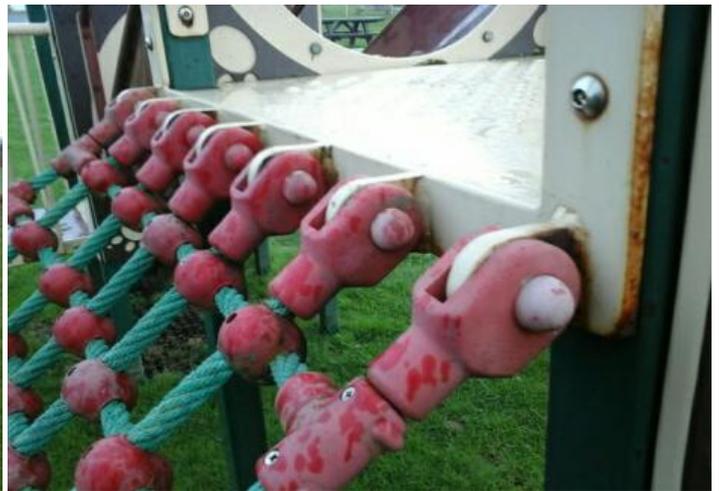
Item: Activity Equipment - Multi Play (Junior)
Manufacturer: Not Identified

Finding: There is surface corrosion present on the item

Action: Consider treating and repainting the item

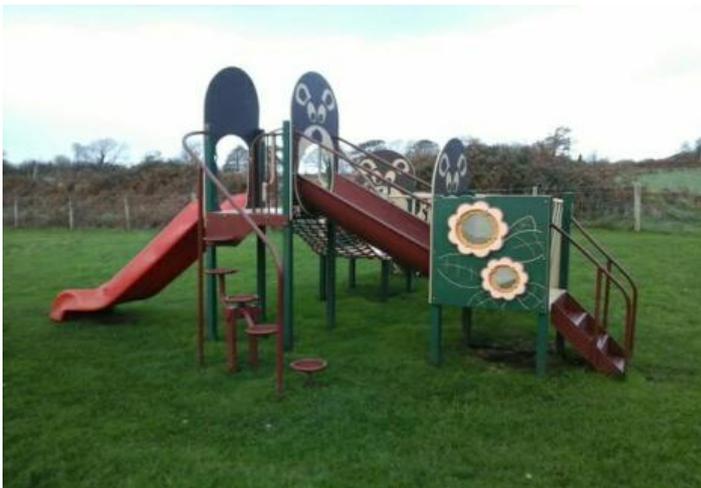
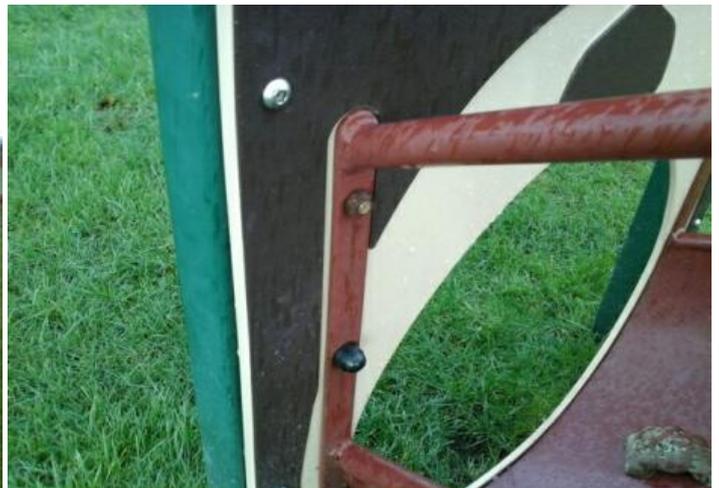
Item: Activity Equipment - Multi Play (Junior)
Manufacturer: Not Identified

Finding: There is/are bolt cap covers missing or damaged on the item

Action: Replace missing or damaged bolt cap covers

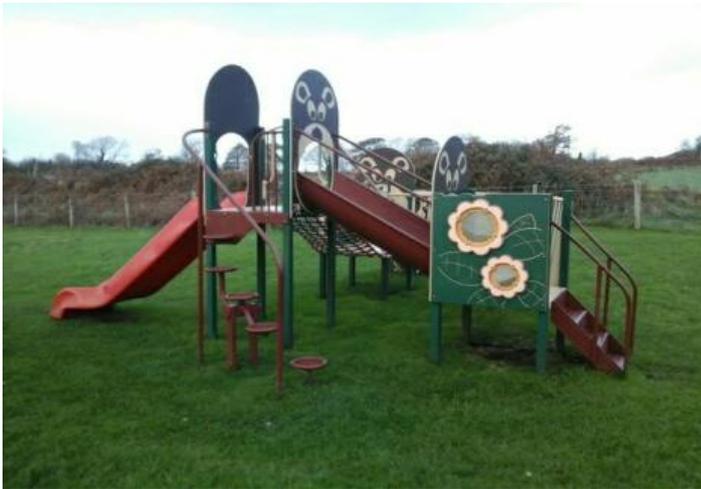
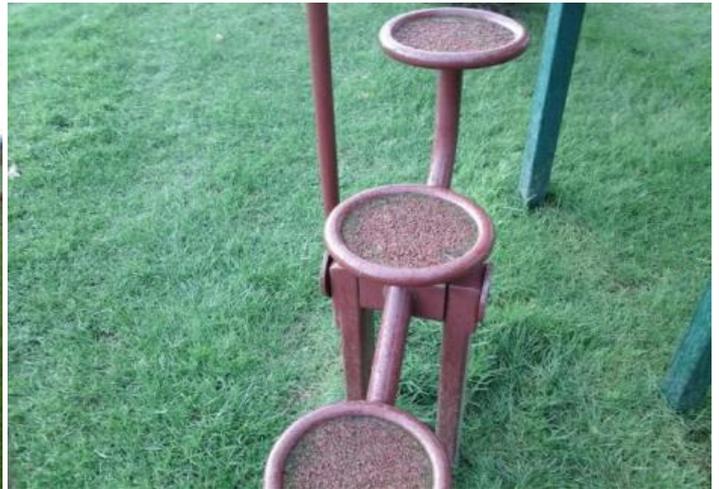
Item: Activity Equipment - Multi Play (Junior)
Manufacturer: Not Identified

Finding: Wetpour inlays are worn

Action: Repair

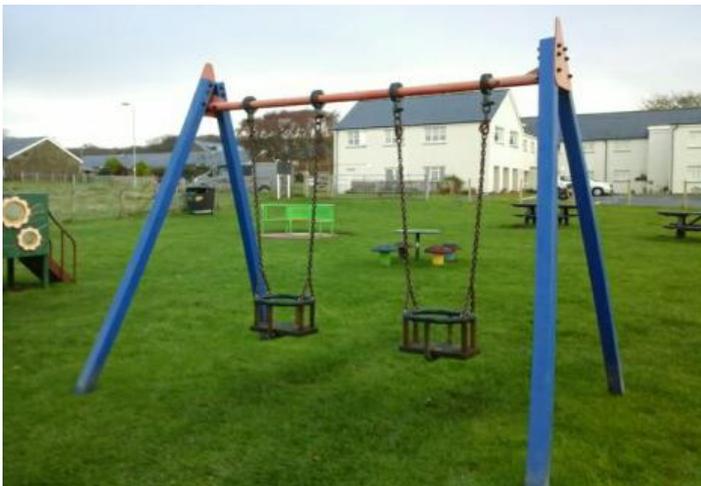
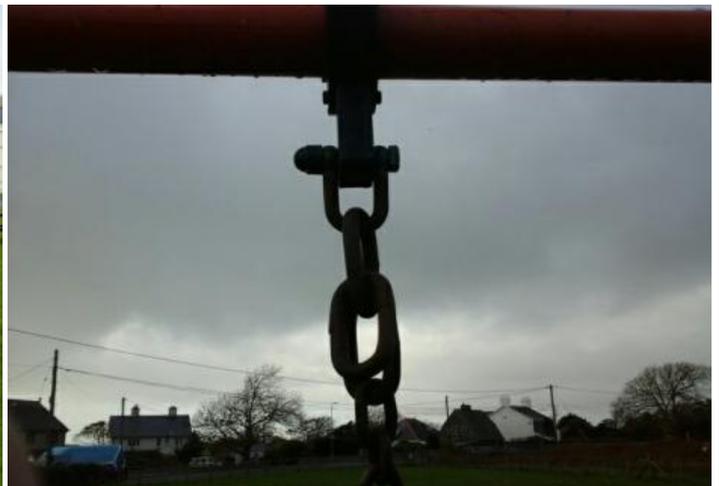
Item: Swings - 1 Bay 2 Seat (Cradle)
Manufacturer: Park Leisure Ltd

Finding: The shackles have been overtightened or seized transferring wear to the chain links below

Action: Loosen shackles to ensure free movement at the pivot

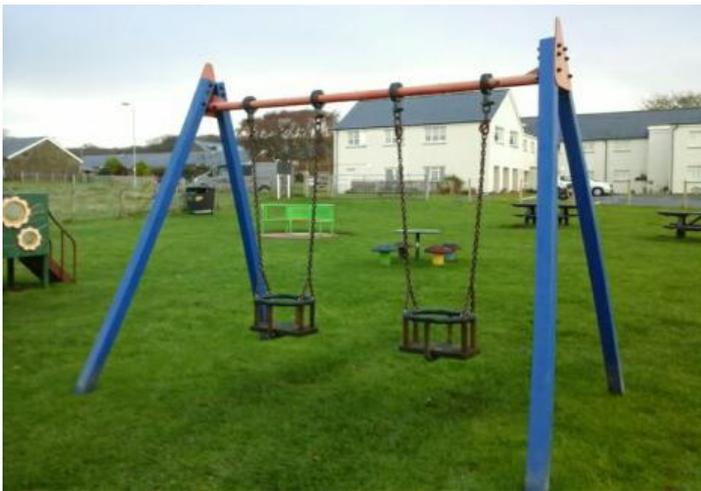
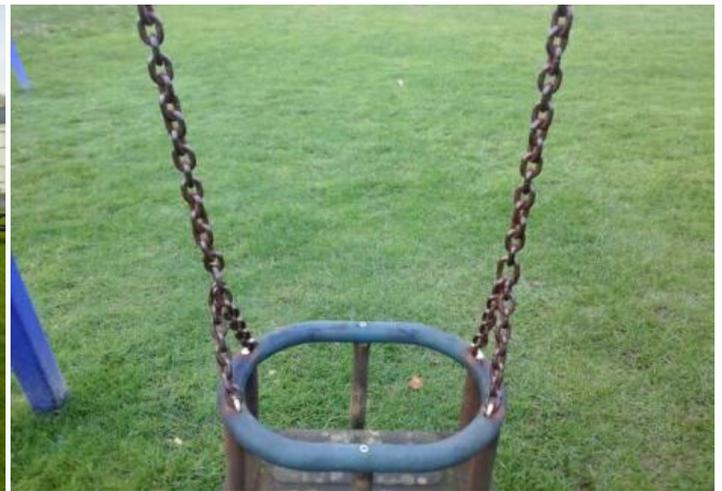
Item: Swings - 1 Bay 2 Seat (Cradle)
Manufacturer: Park Leisure Ltd

Finding: Chains have corroded

Action: Monitor and replace as required

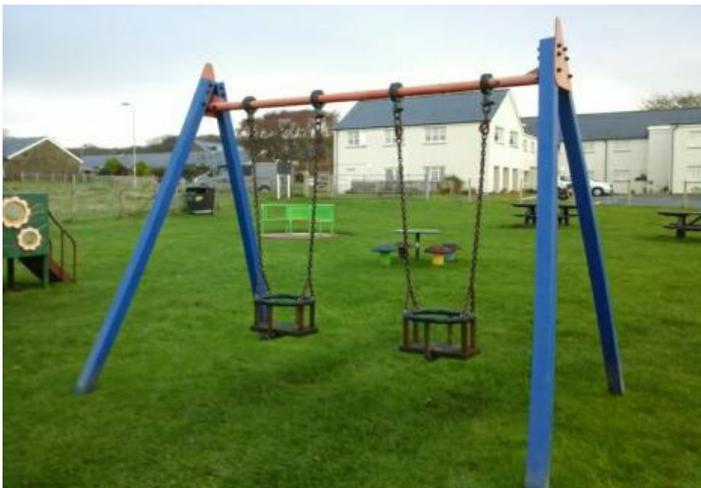
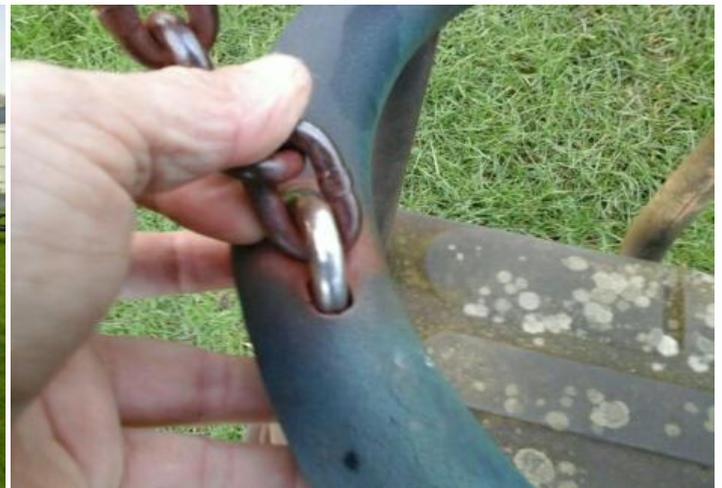
Item: Swings - 1 Bay 2 Seat (Cradle)
Manufacturer: Park Leisure Ltd

Finding: There is some notable evidence of chain wear

Action: Monitor for any further deterioration and replace when 40% worn

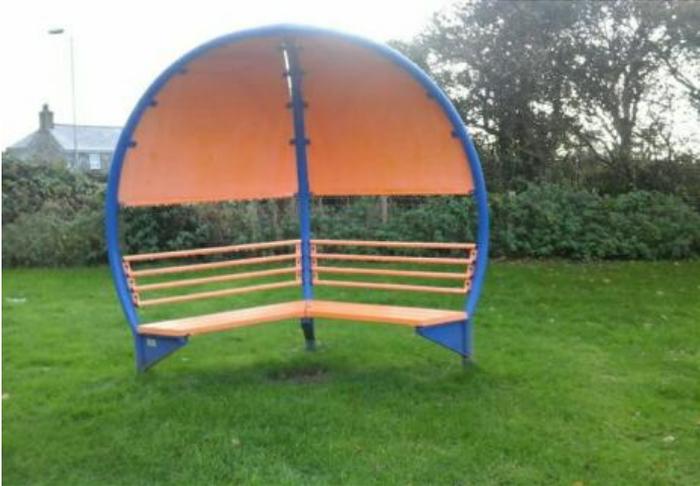
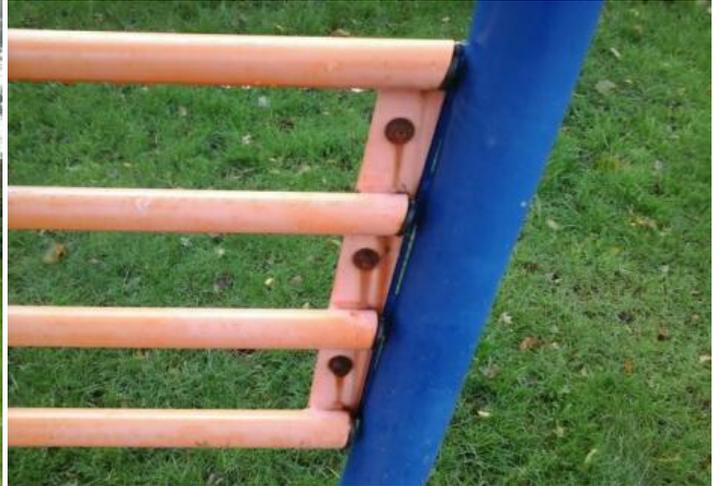
Item: Ancillary Items - Shelter
Manufacturer: Park Leisure Ltd

Finding: Fixings have corroded

Action: Replace

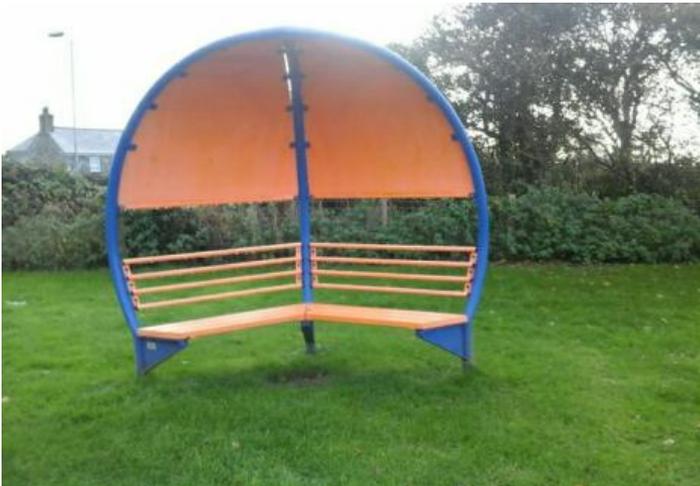
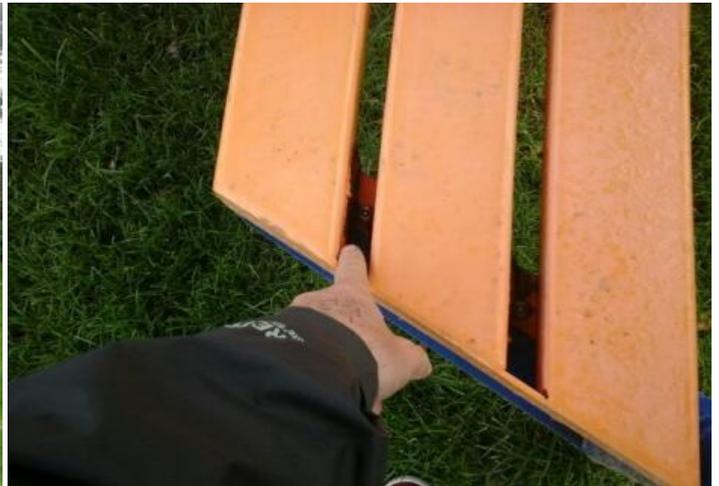
Item: Ancillary Items - Shelter
Manufacturer: Park Leisure Ltd

Finding: There is surface corrosion present on the item

Action: Consider treating and repainting the item

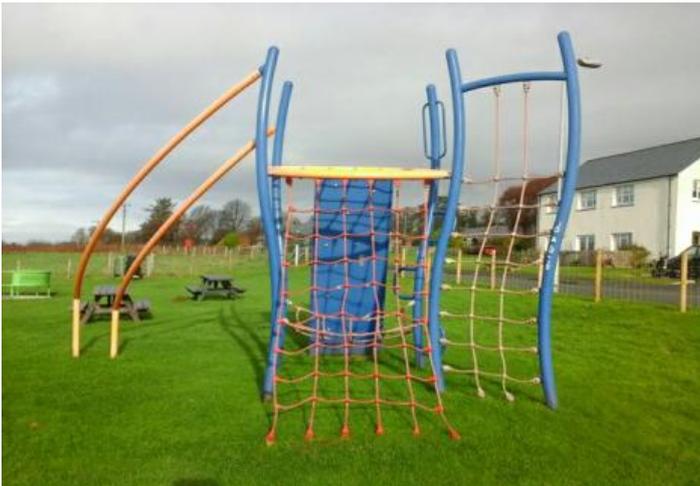
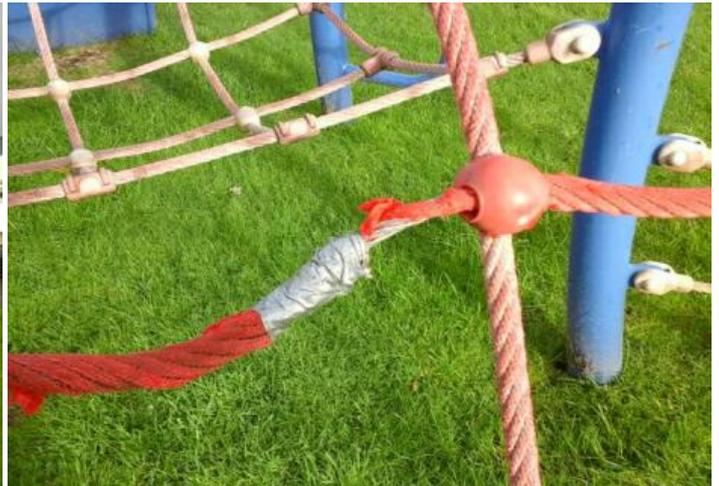
Item: Activity Equipment - Climbing Frame
Manufacturer: Park Leisure Ltd

Finding: The ropes/nets are worn/damaged in places

Action: Monitor for any further deterioration and repair or replace as required

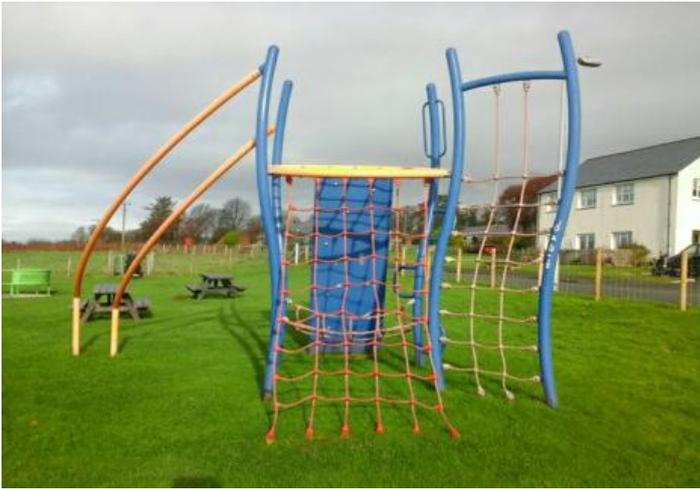
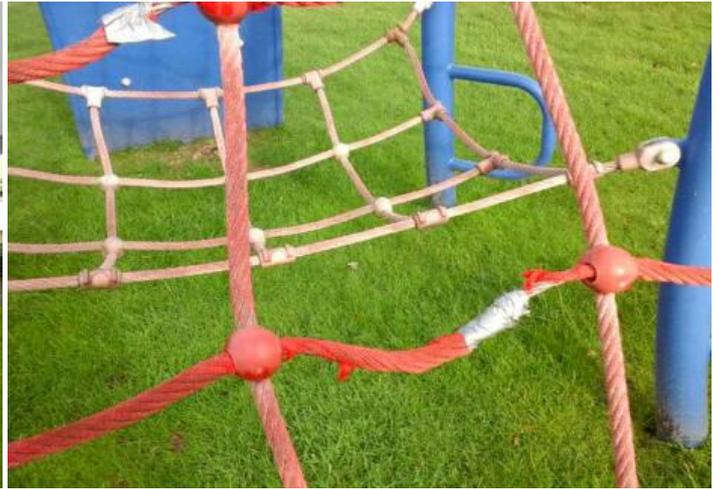
Item: Activity Equipment - Climbing Frame
Manufacturer: Park Leisure Ltd

Finding: The rope has worn and there are sharp wire strands protruding

Action: Replace rope or net

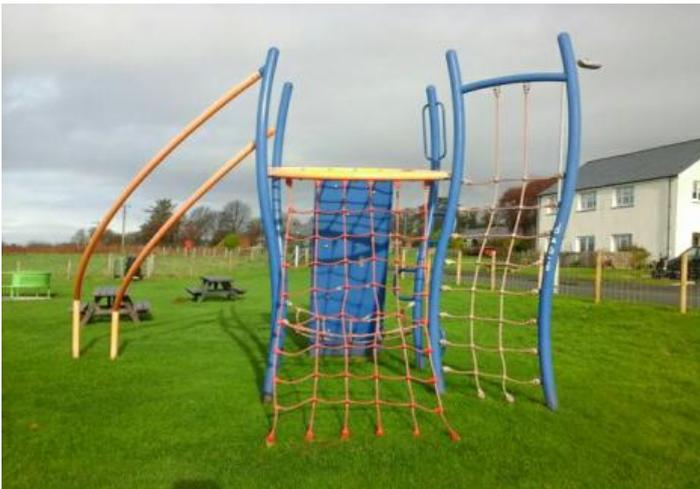
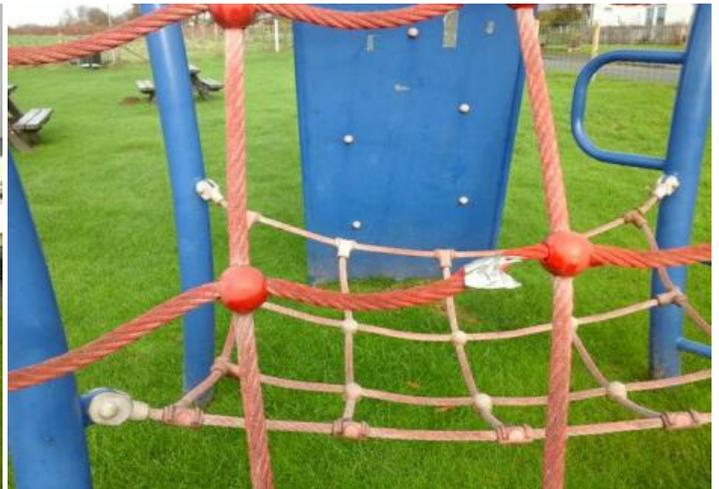
Item: Activity Equipment - Climbing Frame
Manufacturer: Park Leisure Ltd

Finding: The ropes on this item have been taped and we are unable to fully assess the condition of the rope, ensure no wire strands are broken beneath the tape

Action: Repair or replace as required

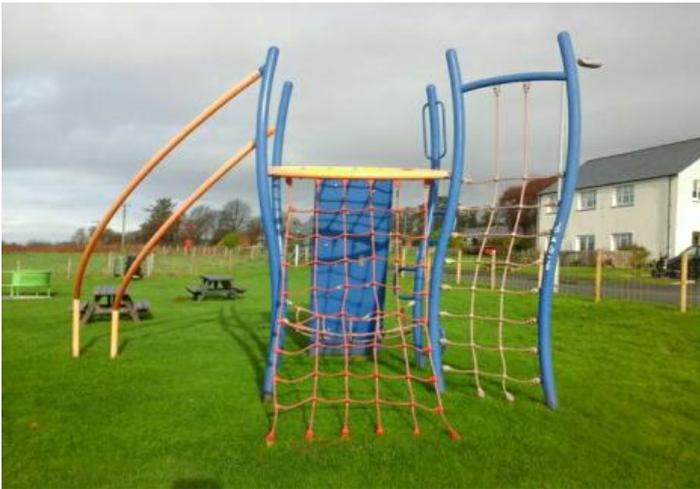
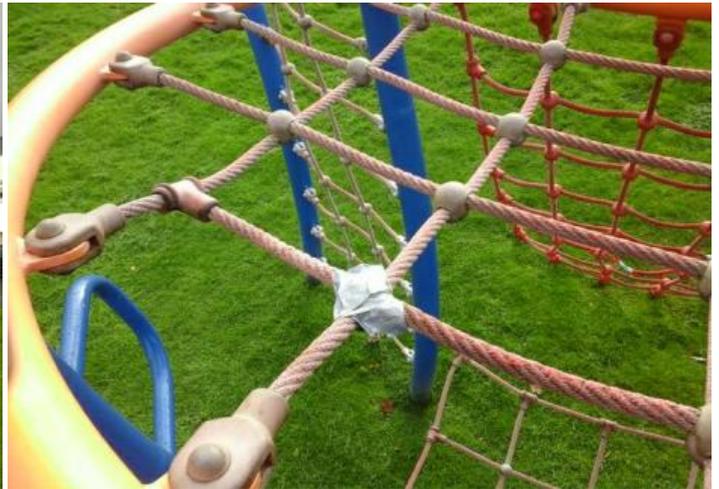
Item: Activity Equipment - Climbing Frame
Manufacturer: Park Leisure Ltd

Finding: The ropes on this item have been taped and we are unable to fully assess the condition of the rope, ensure no wire strands are broken beneath the tape

Action: Repair or replace as required

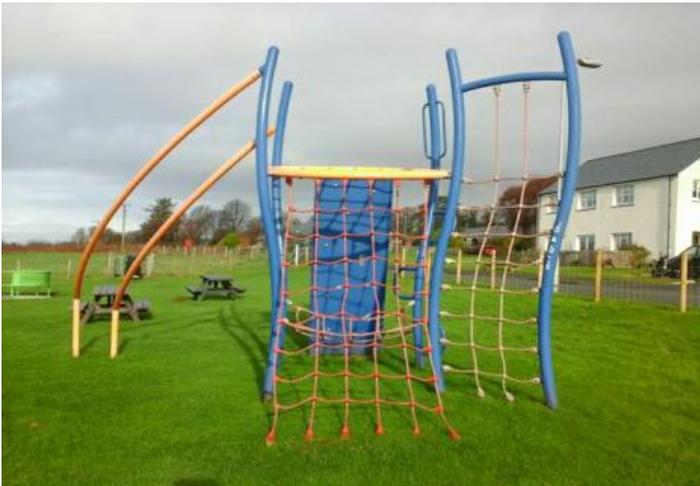
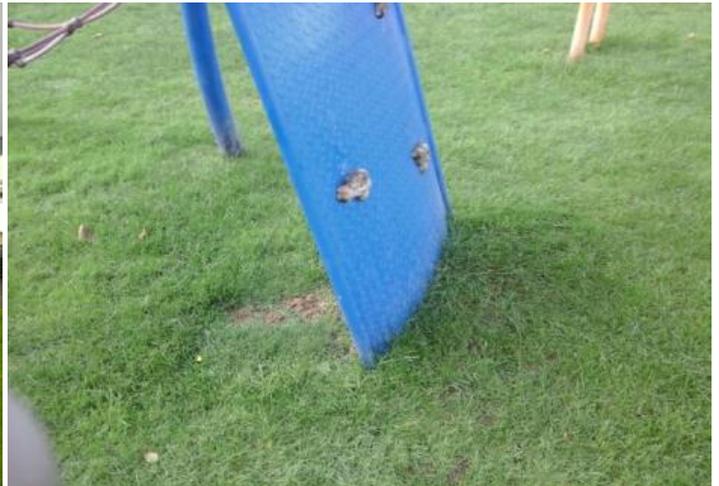
Item: Activity Equipment - Climbing Frame
Manufacturer: Park Leisure Ltd

Finding: Climbing wall loose in ground at base

Action: Re concrete

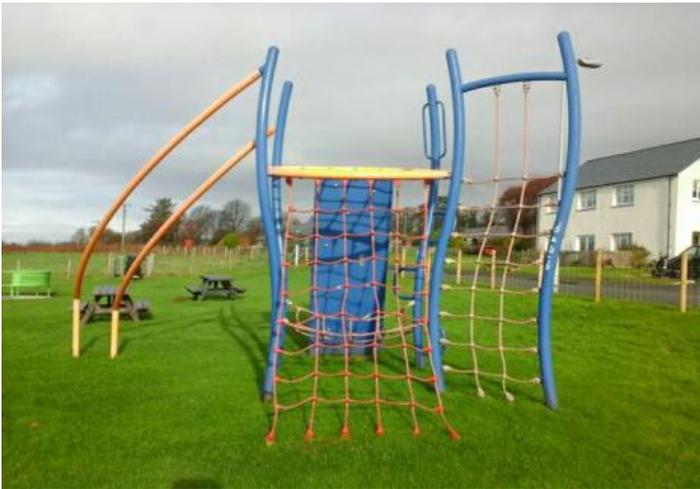
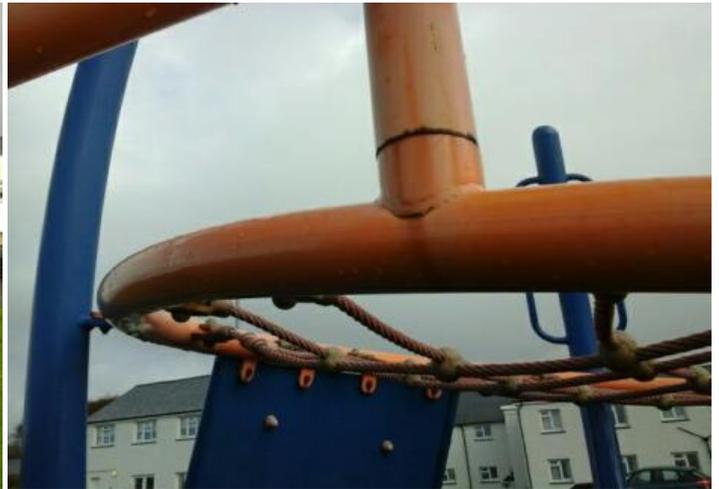
Item: Activity Equipment - Climbing Frame
Manufacturer: Park Leisure Ltd

Finding: There is surface corrosion present on the item

Action: Consider treating and repainting the item

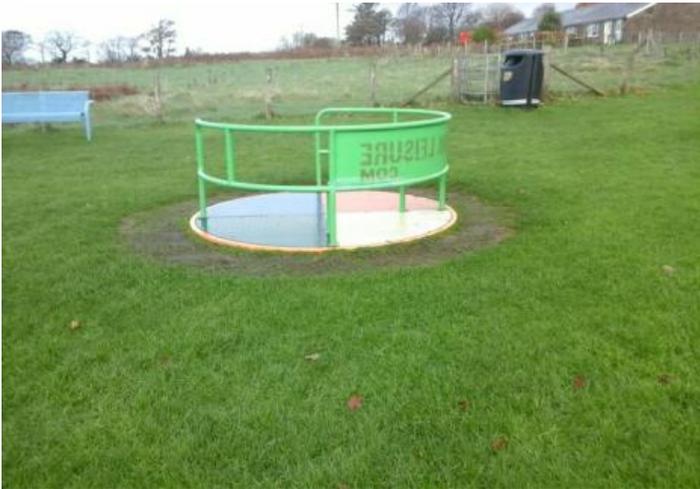
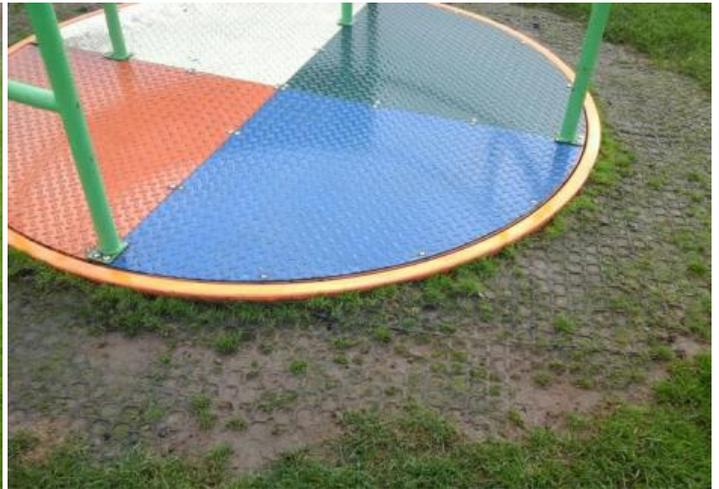
Item: Rotor Play - Roundabout
Manufacturer: Park Leisure Ltd

Finding: There are trip hazards at the edges of the surface

Action: Reinstate surrounding surface levels to remove the trip points
