Annual Inspection

Dyffryn Ardudwy and Talybont Community Council

Pentre Uchaf Play Park

Dyffrn Ardudwy, LL44 2HT

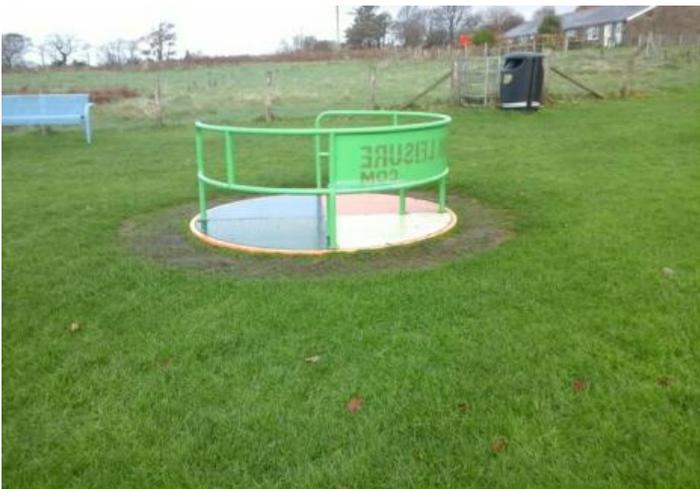
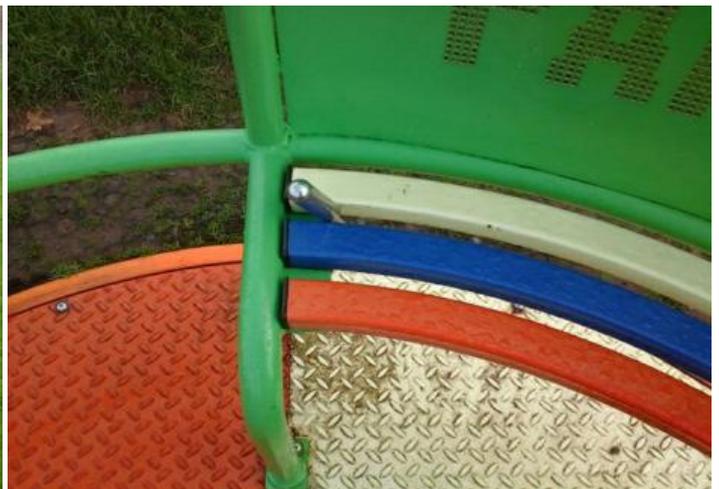
Item: Rotor Play - Roundabout
Manufacturer: Park Leisure Ltd

Finding: There is/are finger entrapment/s in the framework and the item fails to meet the requirements of BS EN 1176 Part 1 4.2.7.6 Entrapment of fingers

Action: Monitor use

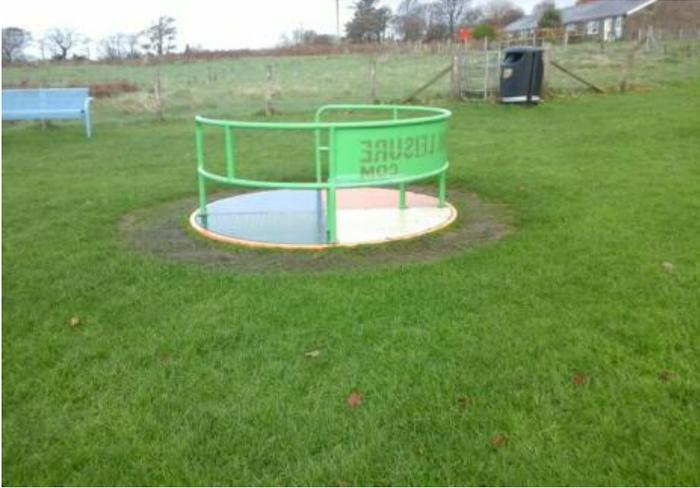
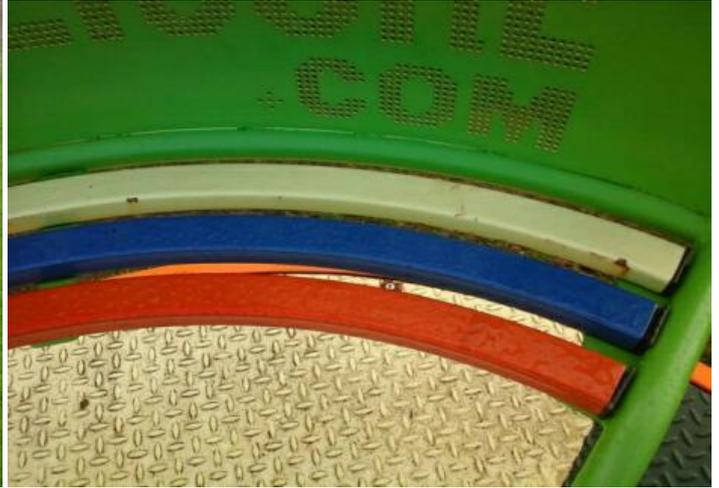
Item: Rotor Play - Roundabout
Manufacturer: Park Leisure Ltd

Finding: There is surface corrosion present on the item

Action: Consider treating and repainting the item

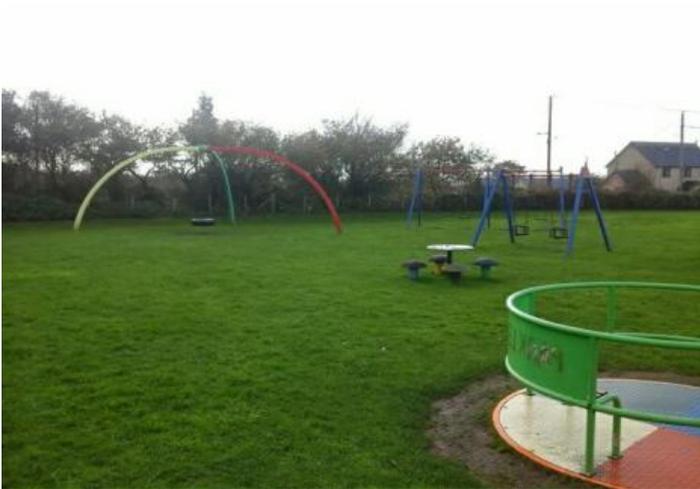
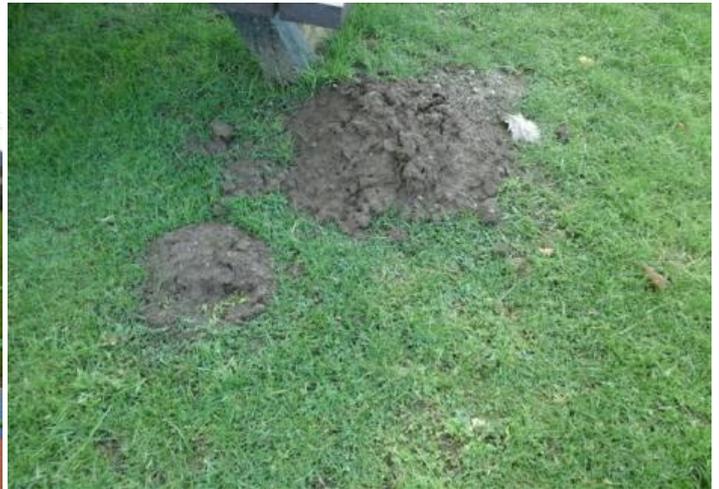
Item: Ancillary Items - Site General
Manufacturer: Owner/Operator

Finding: There are a number of molehills within the area and these may present unforeseen hazards for users

Action: Remove moles by appropriate means, reinstate surfaces to level and maintain the area

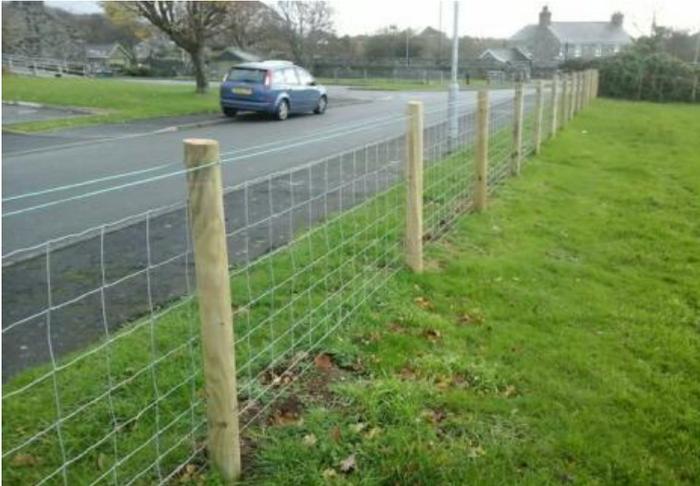
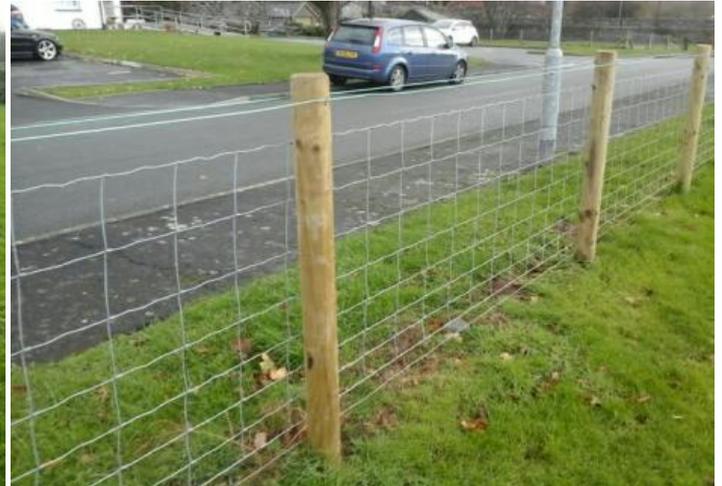
Item: Ancillary Items - Fence - Steel Mesh
Manufacturer: Owner/Operator

Finding: There are a number of loose posts around the fence

Action: Monitor for any further deterioration and reset as required
