Annual Inspection

Dyffryn Ardudwy and Talybont Community Council

Pentre Uchaf Play Park

Inspection Ref: 956006

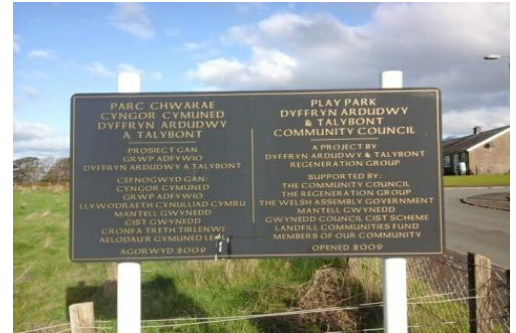
It is recommended that information signs with emergency contact details are installed at each entrance/exit point to the playground - Provide in accordance with the recommendations set out in BS EN 1176

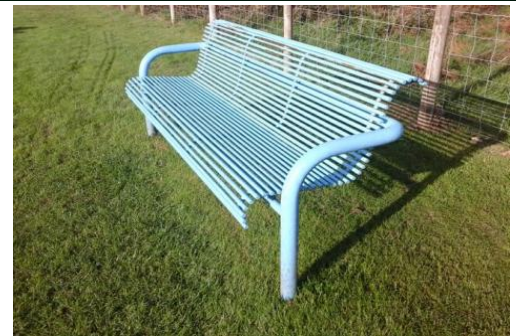
There is surface corrosion present on the item - Consider treating and repainting the item

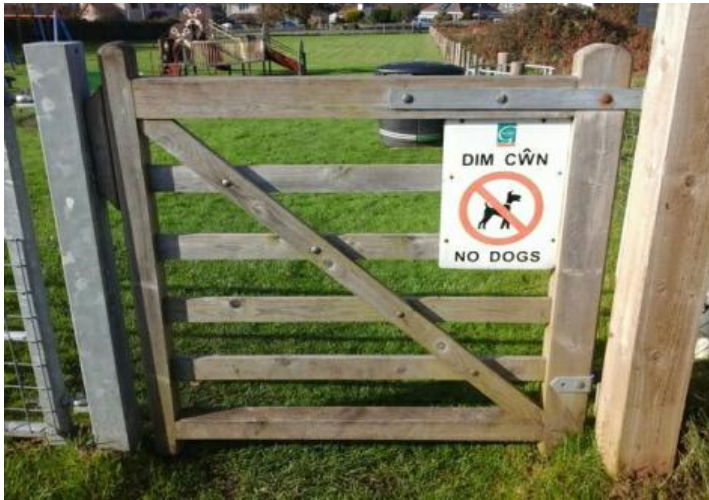
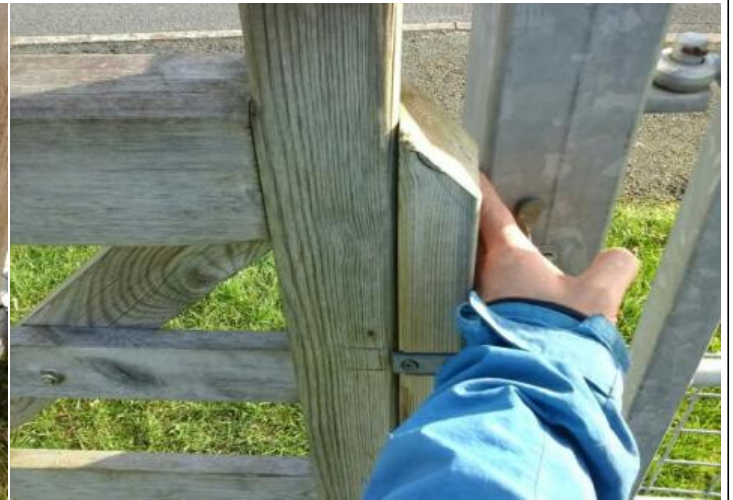
Item: Ancillary Items - Gate
Manufacturer: Owner/Operator

Finding: The opening between the gate and the post or the double gate leaves is less than 12mm and could trap users fingers

Action: Where possible a 12mm gap should be maintained on both sides or between the gate leaves of the gate

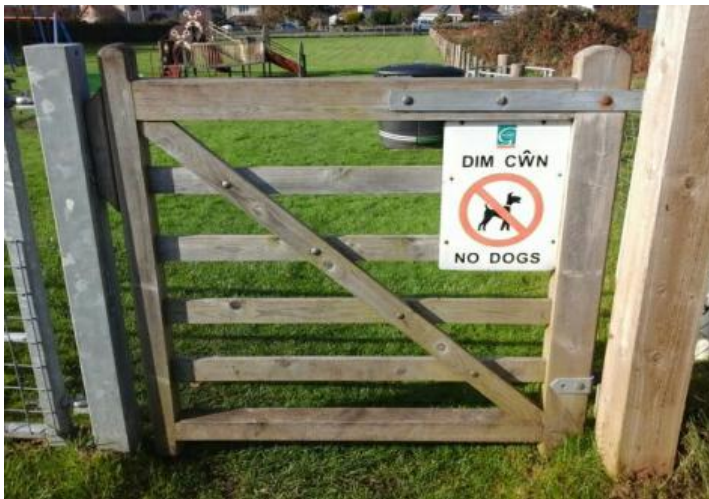
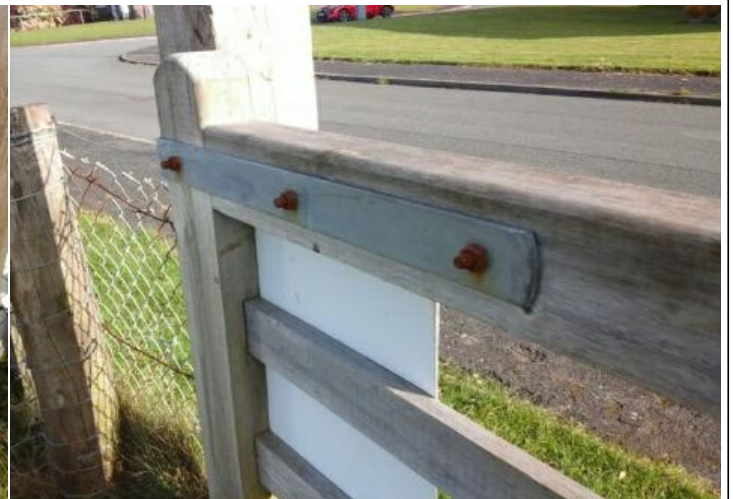
Item: Ancillary Items - Gate
Manufacturer: Owner/Operator

Finding: There are projecting bolt thread(s) present

Action: Remove excess thread length and deburr or provide cap

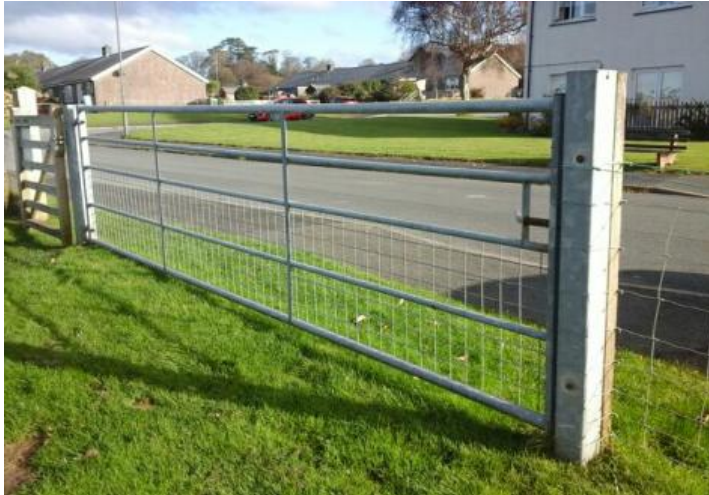
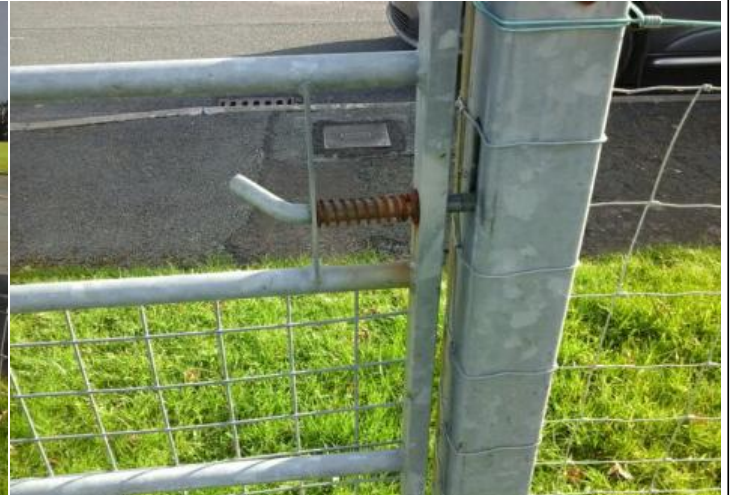
Item: Ancillary Items - Gate - Maintenance
Manufacturer: Owner/Operator

Finding: There is no padlock on the maintenance gate

Action: Provide a padlock to secure the gate

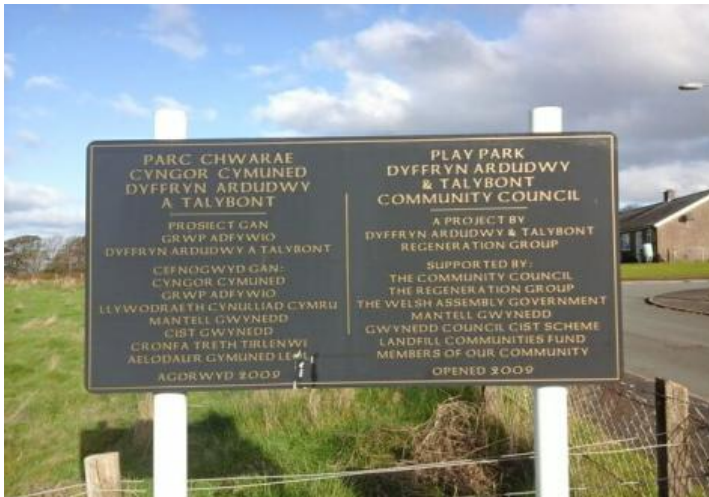
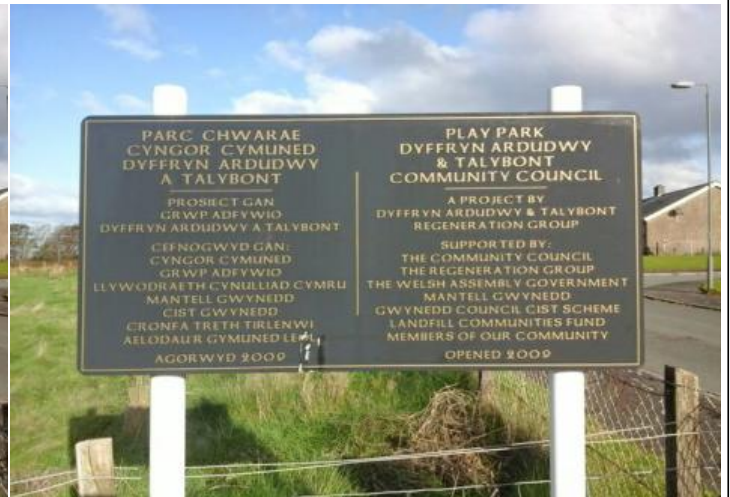
Item: Ancillary Items - Sign
Manufacturer: Owner/Operator

Finding: It is recommended that information signs with emergency contact details are installed at each entrance/exit point to the playground

Action: Provide in accordance with the recommendations set out in BS EN 1176

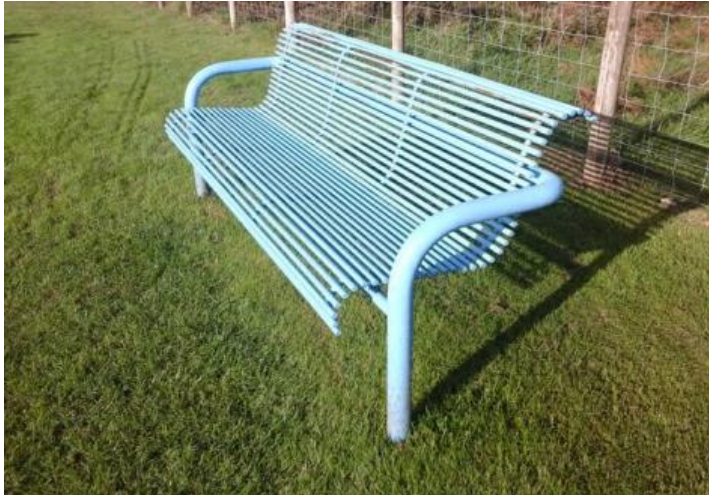
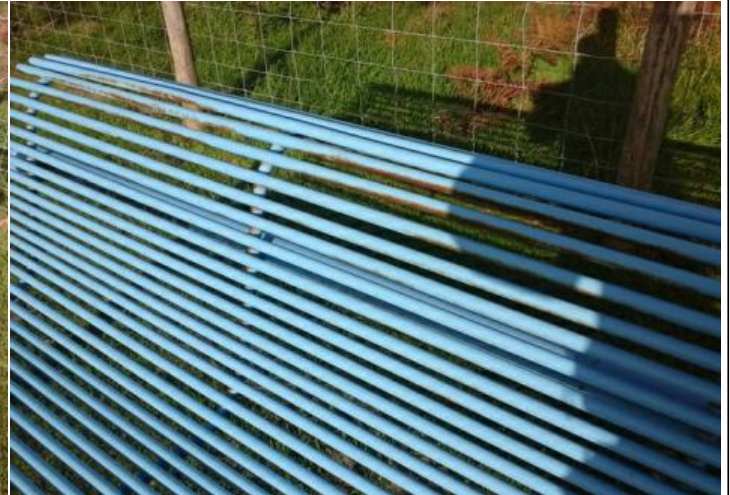
Item: Ancillary Items - Bench
Manufacturer: Lightmain Engineering

Finding: There is surface corrosion present on the item

Action: Consider treating and repainting the item

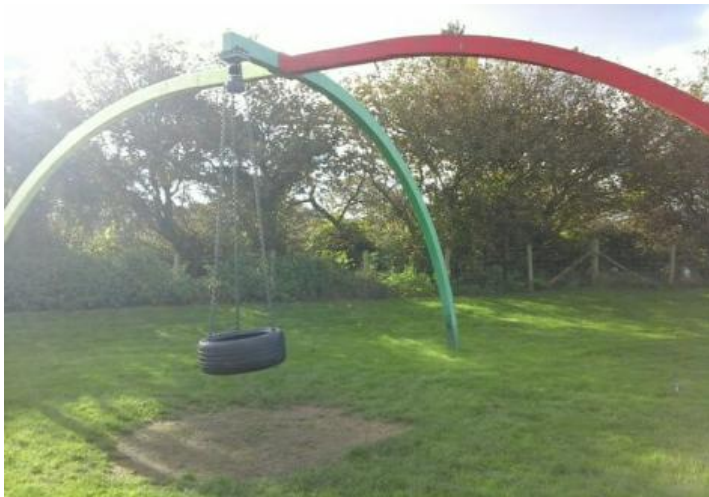
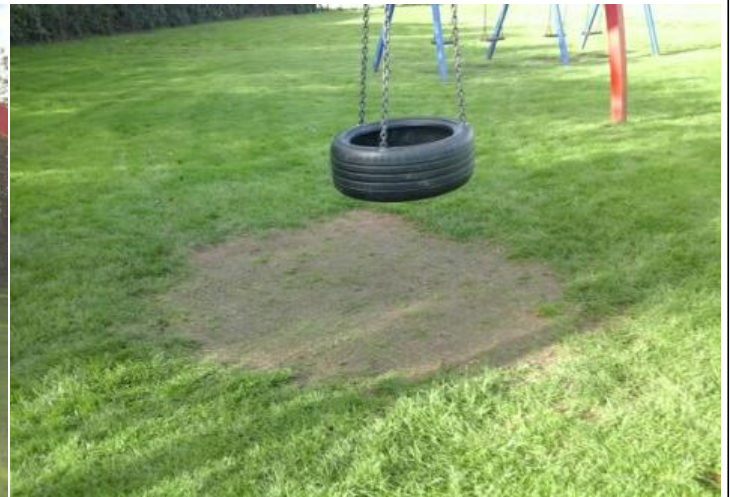
Item: Swings - Single Point Swing - Type 3
Manufacturer: Park Leisure Ltd

Finding: The grass mats are silted up and the soil is compacted; this may have an effect on the impact absorbing properties of the surface

Action: Consider HIC testing impact absorbing properties to ensure the correct surface qualities are maintained for the equipment and replace as required

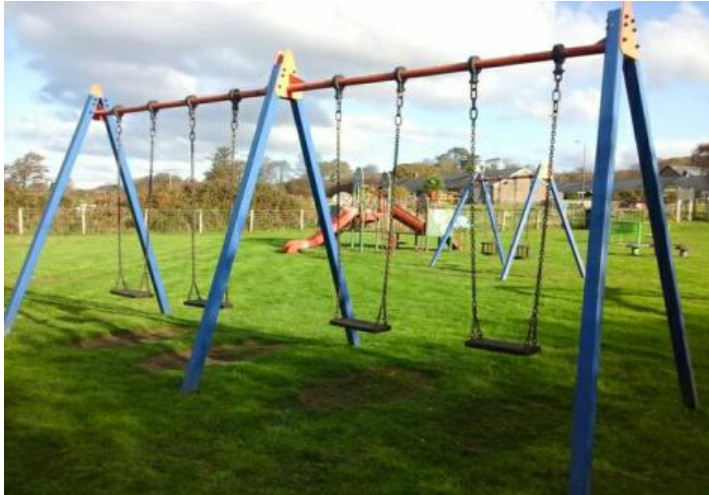
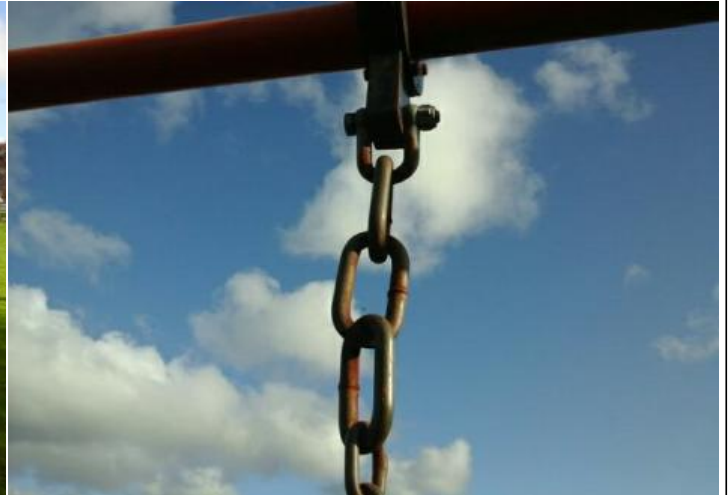
Item: Swings - 2 Bay 4 Seat (Flat)
Manufacturer: Park Leisure Ltd

Finding: There is some wear to the shackles.

Action: Monitor for any further deterioration and replace when 40% worn

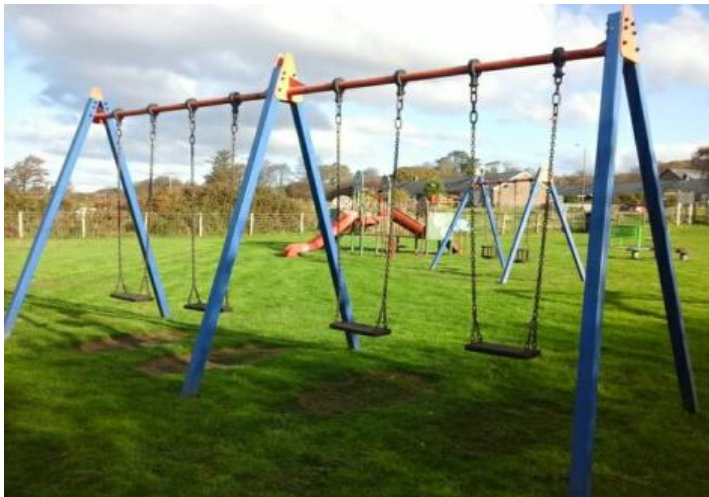
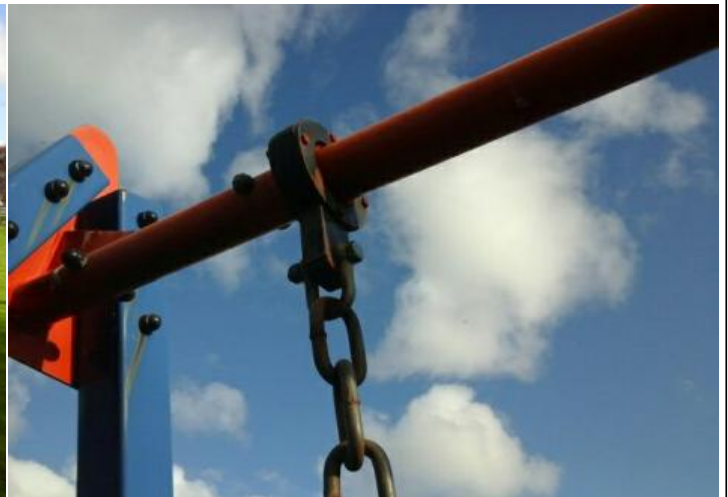
Item: Swings - 2 Bay 4 Seat (Flat)
Manufacturer: Park Leisure Ltd

Finding: The shackles have been overtightened or seized transferring wear to the chain links below

Action: Loosen shackles to ensure free movement at the pivot

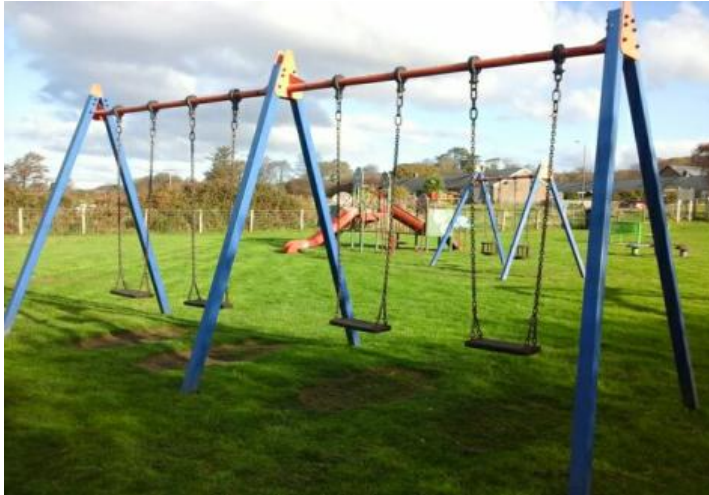
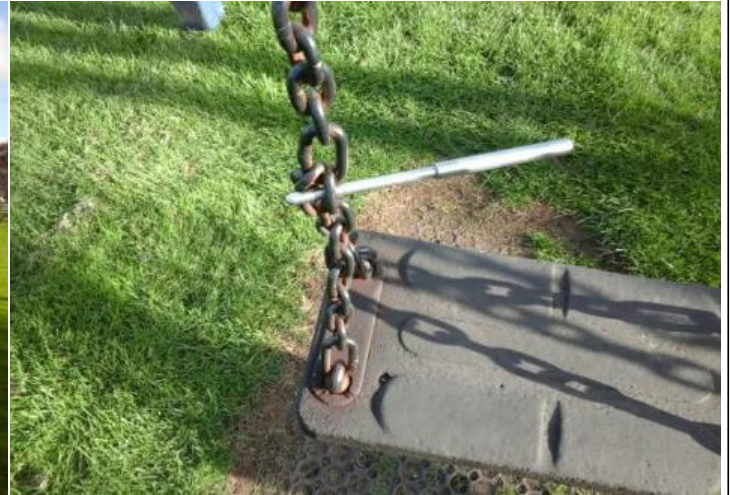
Item: Swings - 2 Bay 4 Seat (Flat)
Manufacturer: Park Leisure Ltd

Finding: The chain openings are in excess of the 8.6mm as recommended by BS EN 1176
Action: Monitor - No remedial work recommended

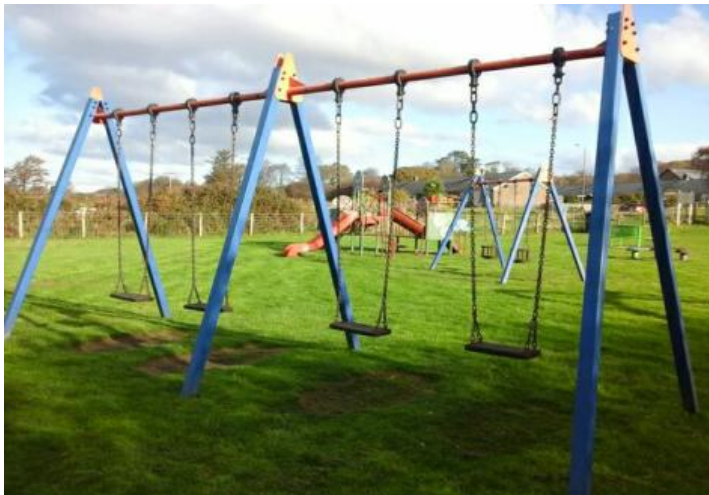
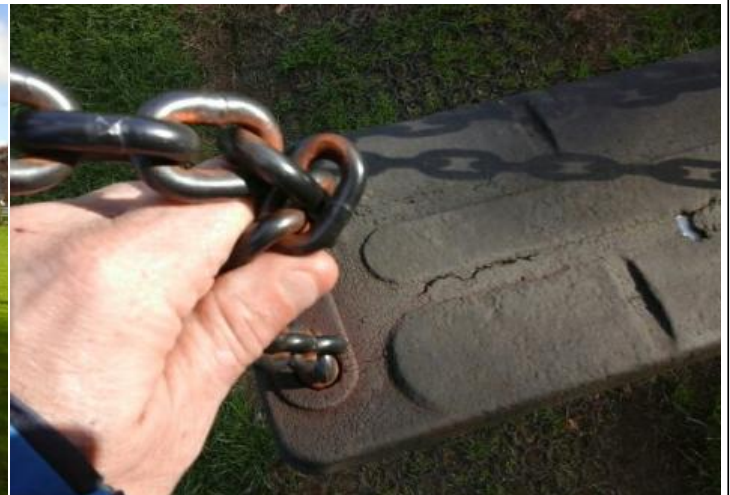
Item: Swings - 2 Bay 4 Seat (Flat)
Manufacturer: Park Leisure Ltd

Finding: There is some notable evidence of chain wear
Action: Monitor for any further deterioration and replace when 40% worn

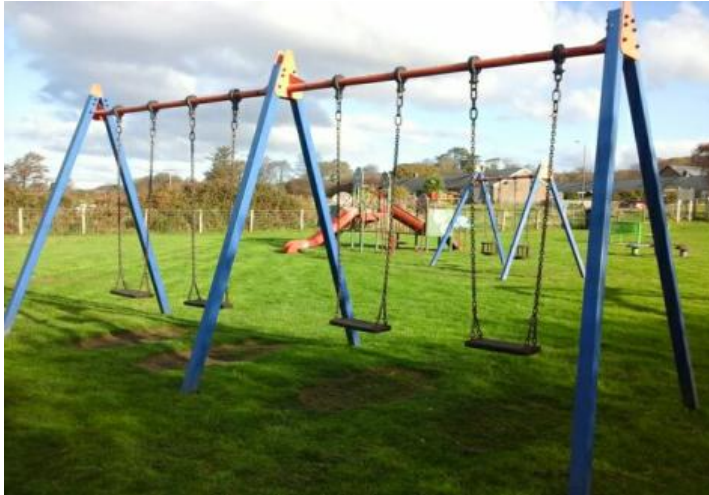
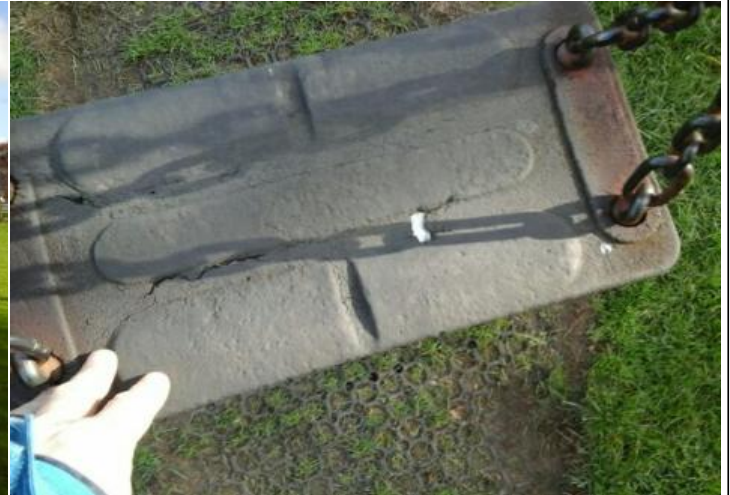
Item: Swings - 2 Bay 4 Seat (Flat)
Manufacturer: Park Leisure Ltd

Finding: The seat has minor damage or wear

Action: Monitor for any further deterioration and replace as required

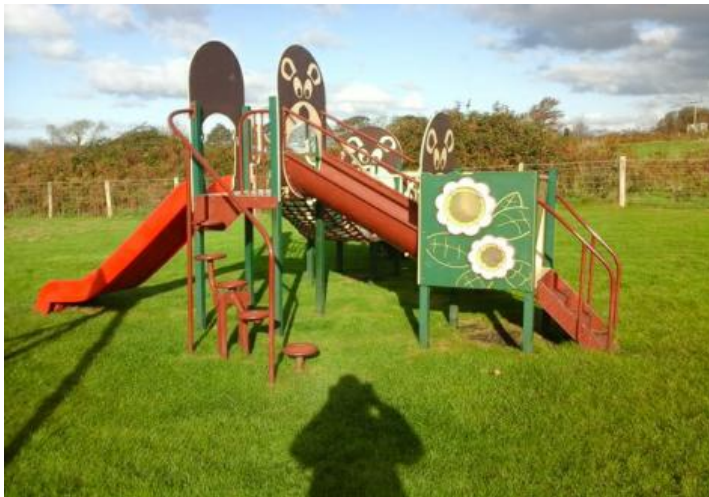
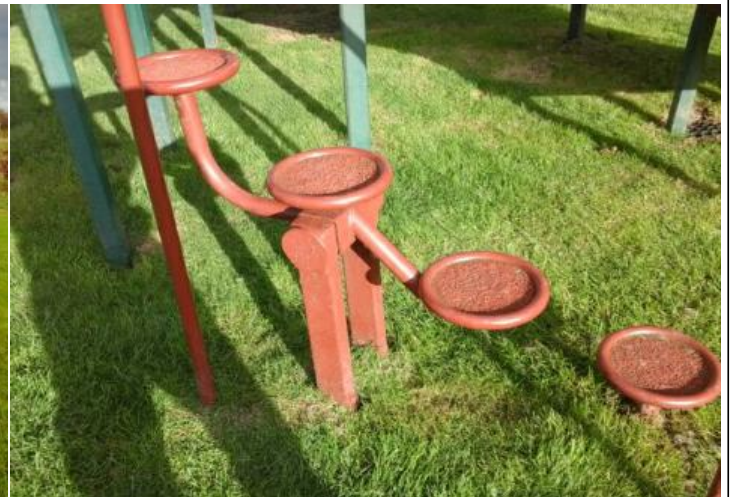
Item: Activity Equipment - Multi Play (Junior)
Manufacturer: Not Identified

Finding: There is wear to the torsion system

Action: Service item

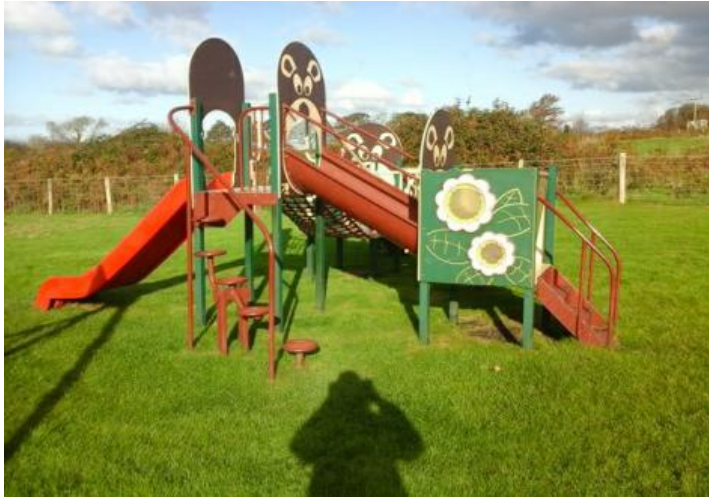
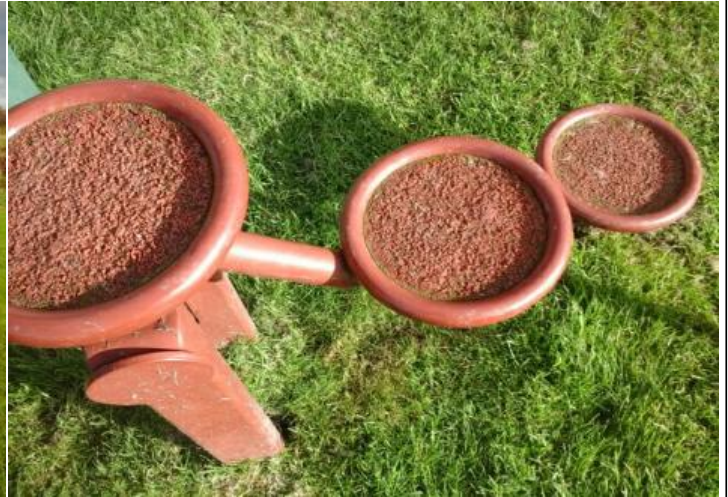
Item: Activity Equipment - Multi Play (Junior)
Manufacturer: Not Identified

Finding: Wetpour inlays are worn

Action: Repair

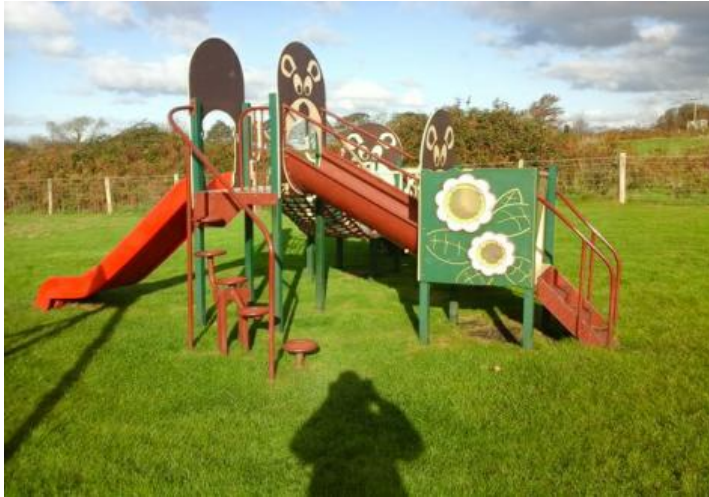
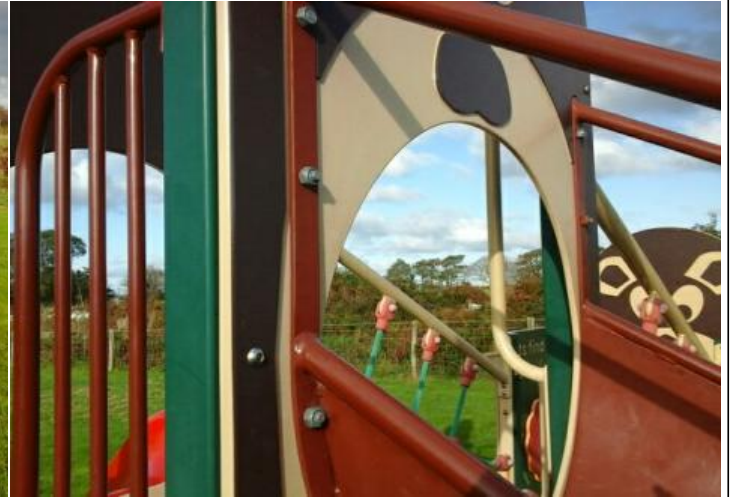
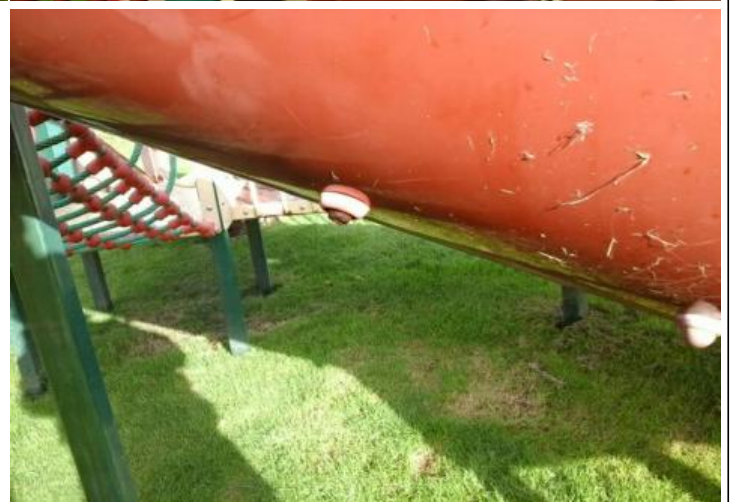
Item: Activity Equipment - Multi Play (Junior)
Manufacturer: Not Identified

Finding: There is/are bolt cap covers missing or damaged on the item

Action: Replace missing or damaged bolt cap covers

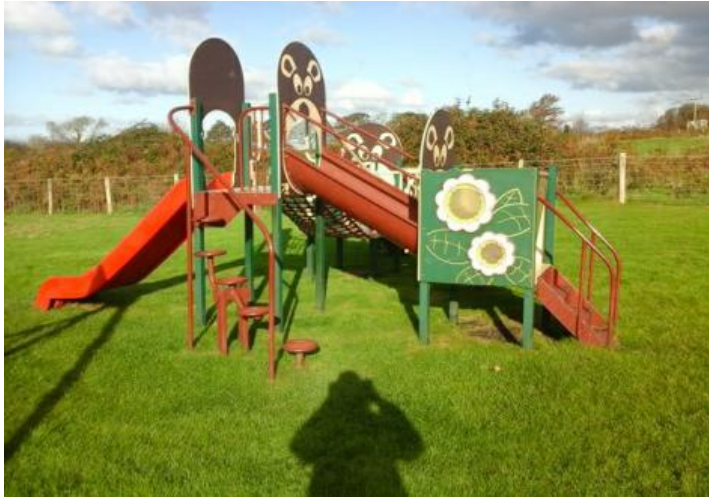
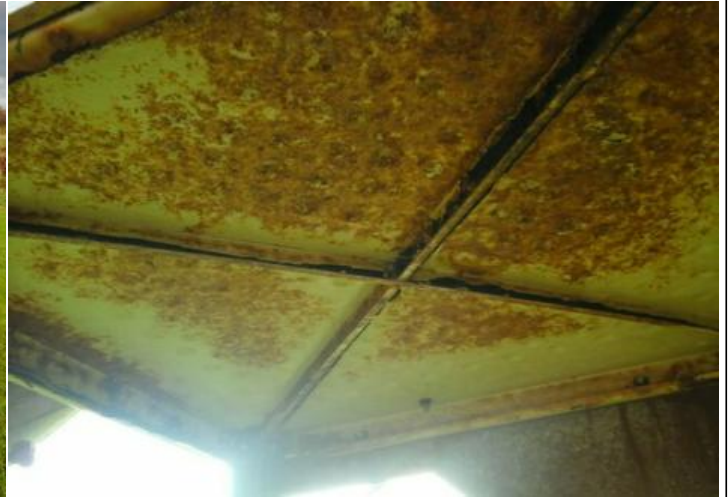
Item: Activity Equipment - Multi Play (Junior)
Manufacturer: Not Identified

Finding: There is surface corrosion present on the item

Action: Consider treating and repainting the item

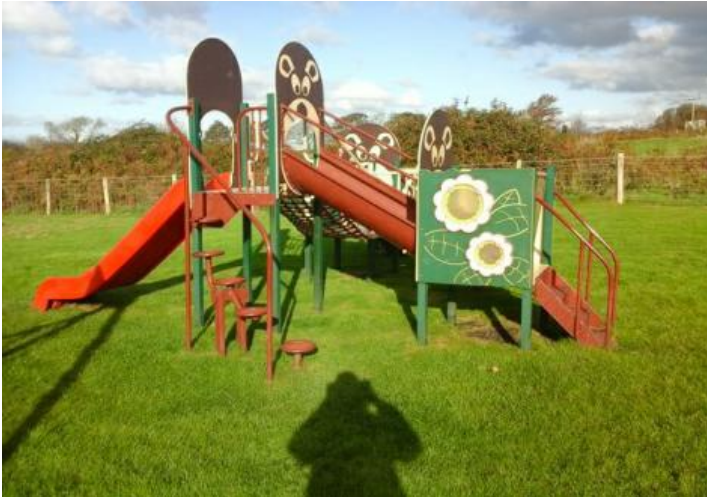
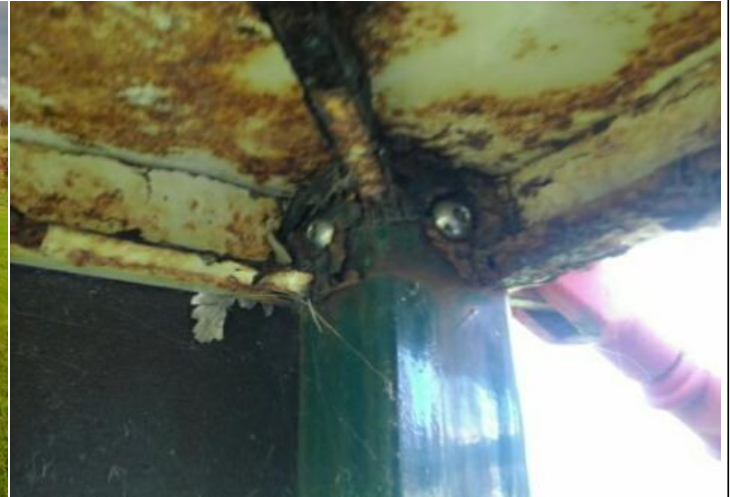
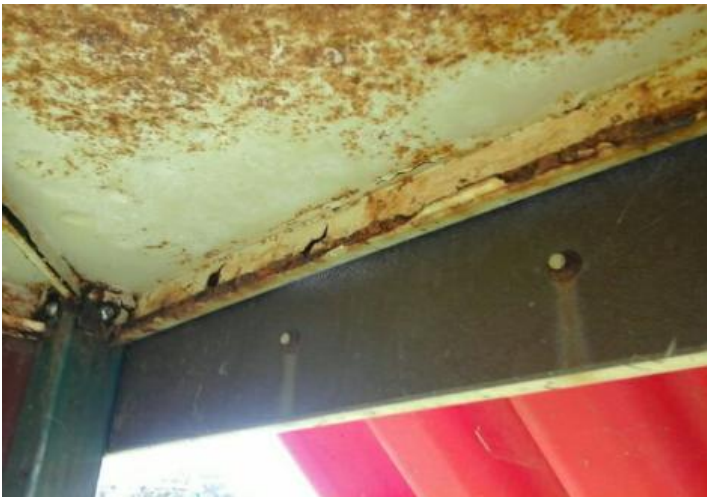
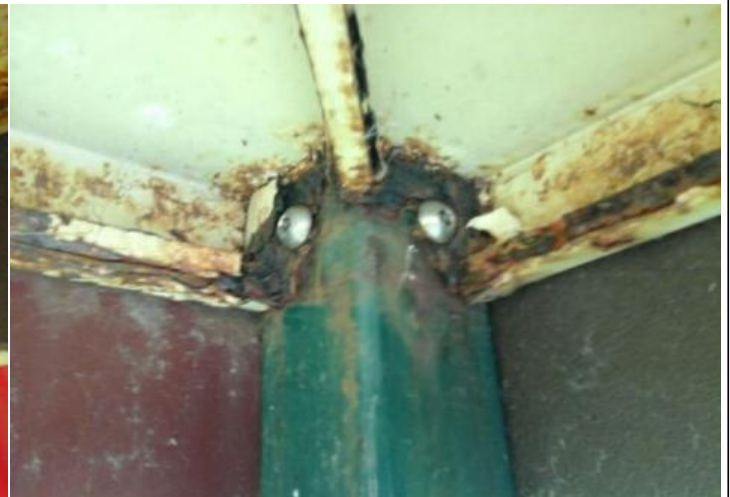
Item: Activity Equipment - Multi Play (Junior)
Manufacturer: Not Identified

Finding: There is heavy corrosion to the platforms fixing points

Action: Repair

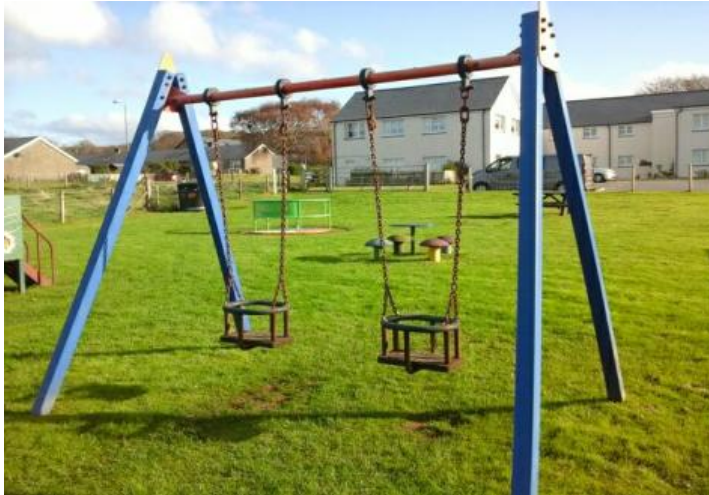
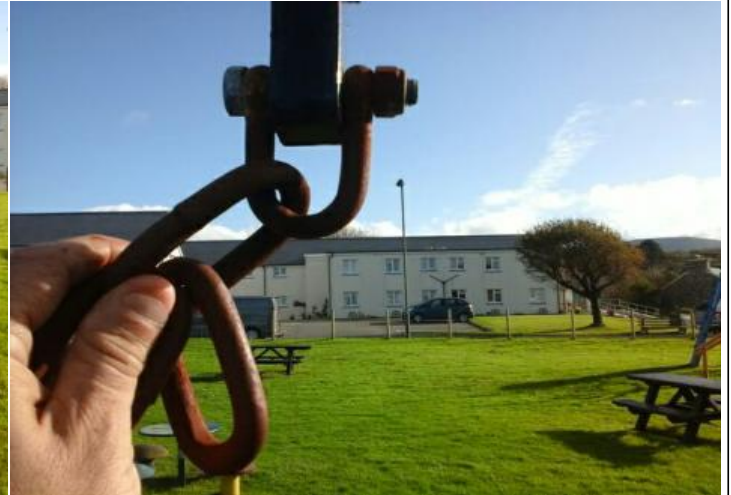
Item: Swings - 1 Bay 2 Seat (Cradle)
Manufacturer: Park Leisure Ltd

Finding: There is some wear to the shackles.

Action: Monitor for any further deterioration and replace when 40% worn

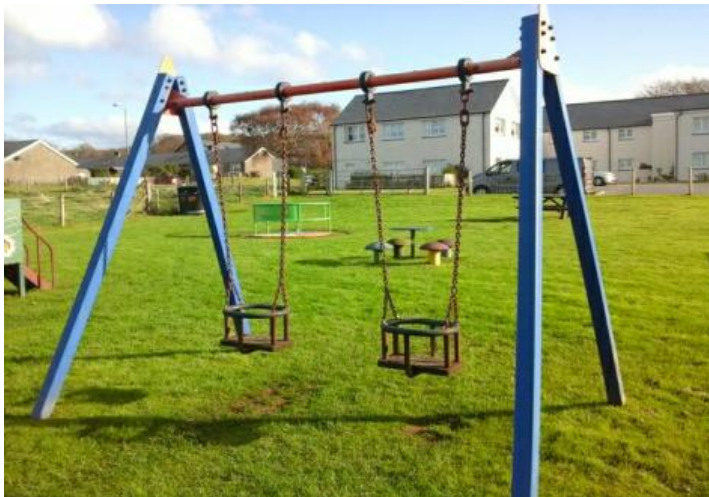
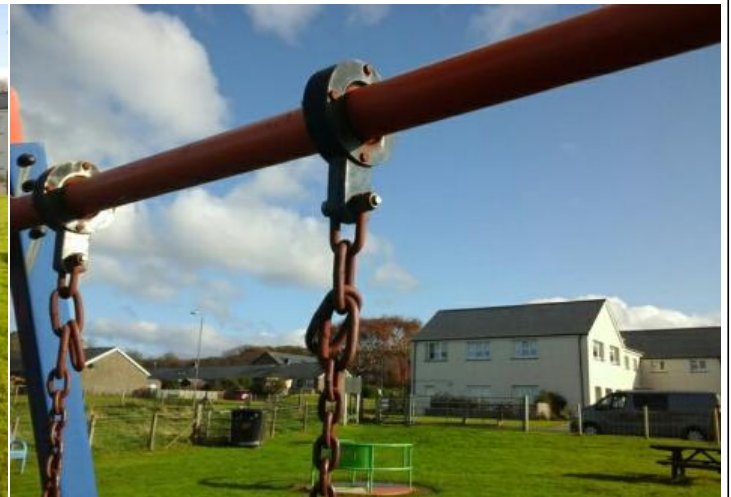
Item: Swings - 1 Bay 2 Seat (Cradle)
Manufacturer: Park Leisure Ltd

Finding: The shackles have been overtightened or seized transferring wear to the chain links below

Action: Loosen shackles to ensure free movement at the pivot

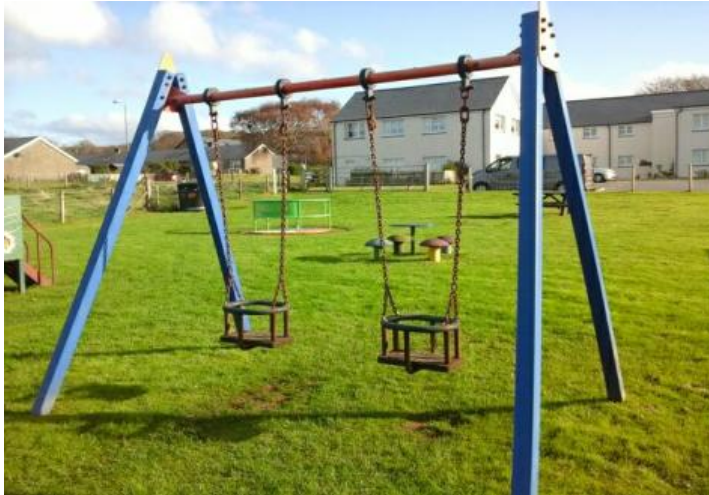
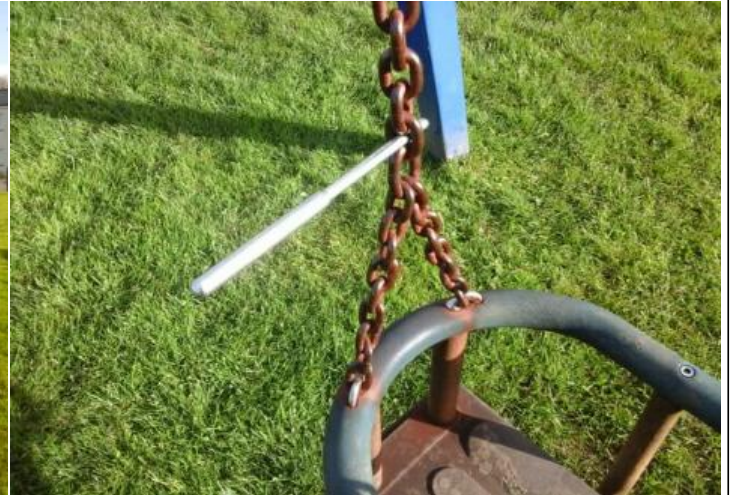
Item: Swings - 1 Bay 2 Seat (Cradle)
Manufacturer: Park Leisure Ltd

Finding: The chain openings are in excess of the 8.6mm as recommended by BS EN 1176 **Action:** Monitor - No remedial work recommended

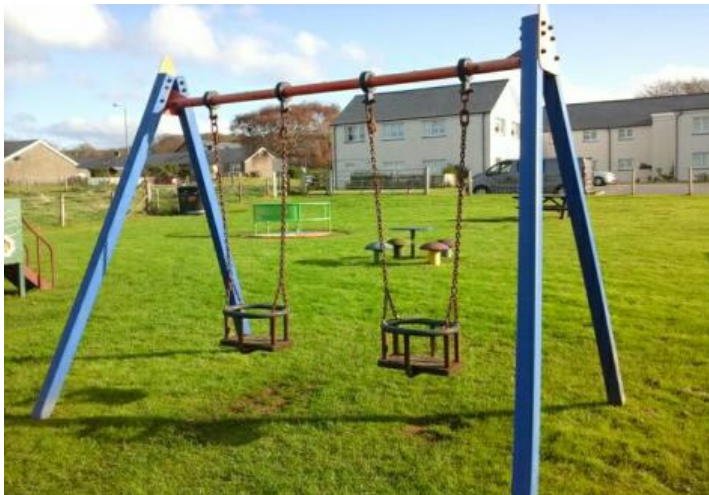
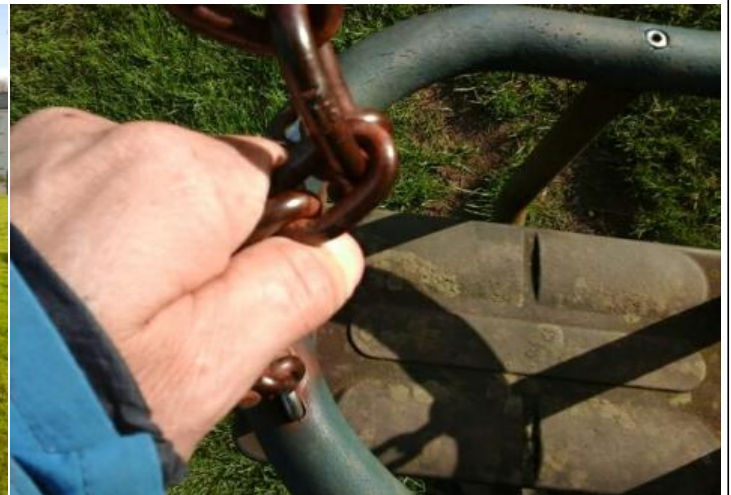
Item: Swings - 1 Bay 2 Seat (Cradle)
Manufacturer: Park Leisure Ltd

Finding: There is some notable evidence of chain wear **Action:** Monitor for any further deterioration and replace when 40% worn

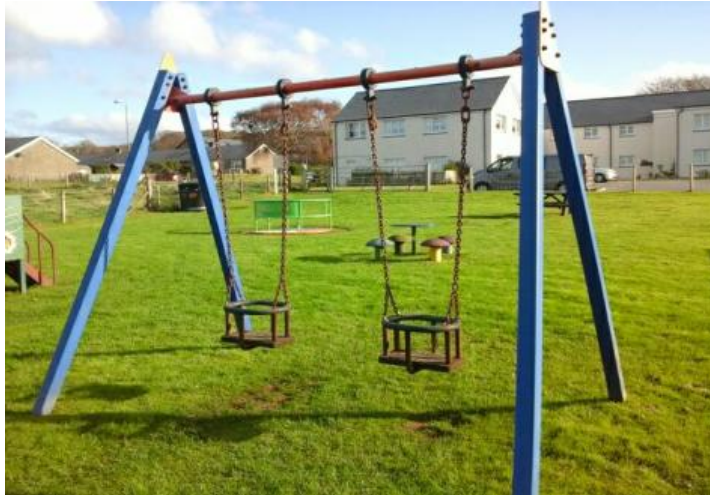
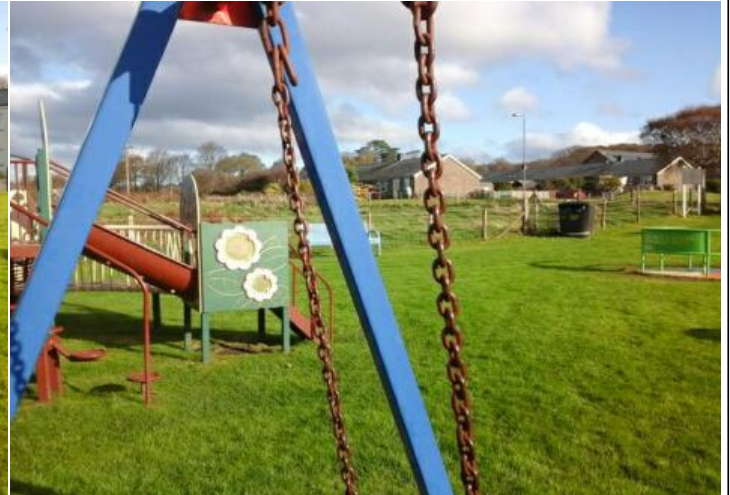
Item: Swings - 1 Bay 2 Seat (Cradle)
Manufacturer: Park Leisure Ltd

Finding: Chains have corroded

Action: Monitor and replace as required

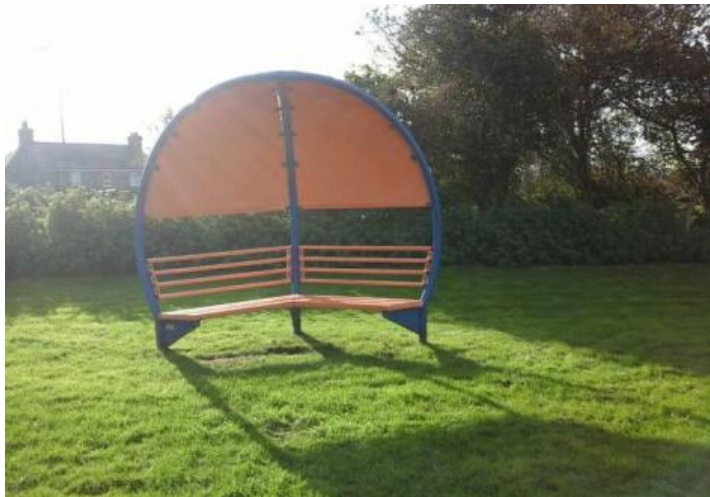
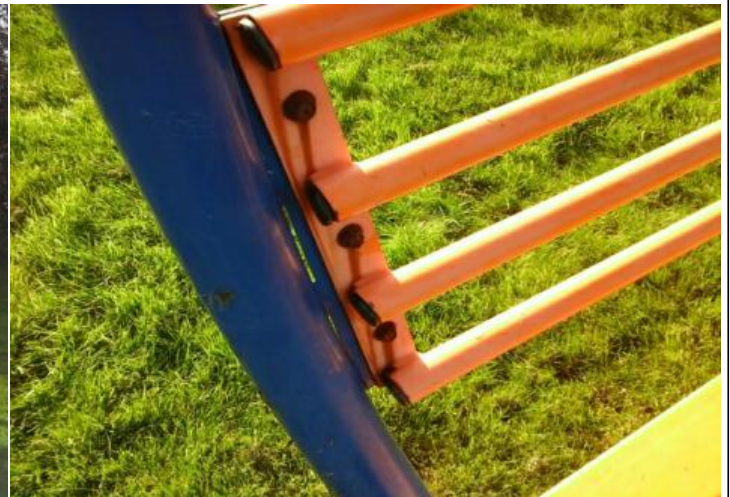
Item: Ancillary Items - Shelter
Manufacturer: Park Leisure Ltd

Finding: Fixings have corroded

Action: Replace

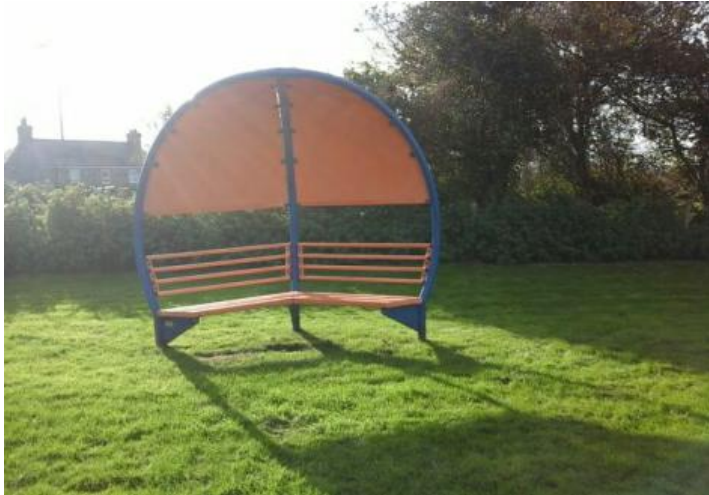
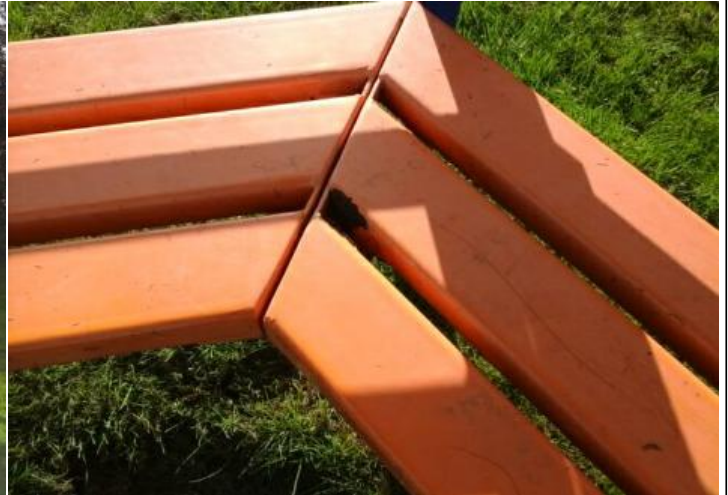
Item: Ancillary Items - Shelter
Manufacturer: Park Leisure Ltd

Finding: There is surface corrosion present on the item

Action: Consider treating and repainting the item

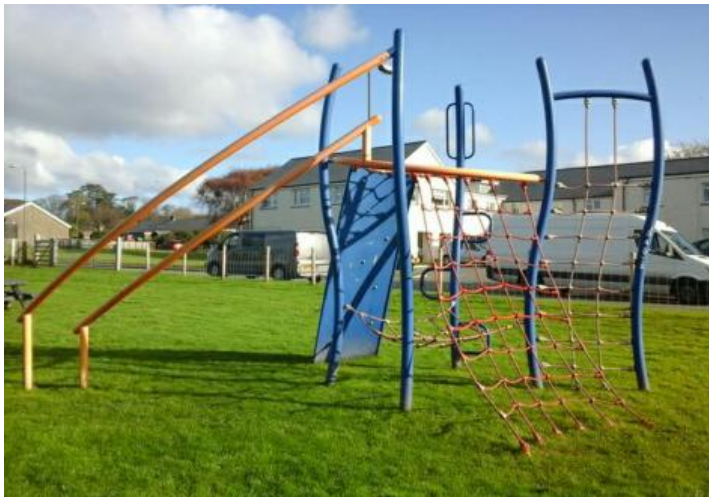
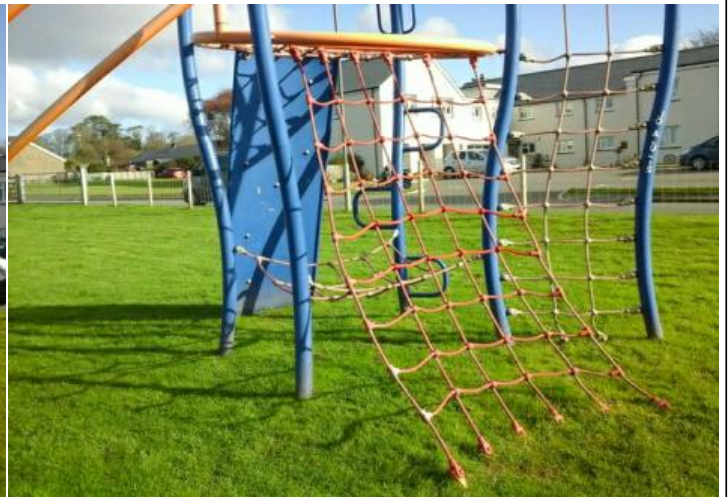
Item: Activity Equipment - Climbing Frame
Manufacturer: Park Leisure Ltd

Finding: The grass mats are silted up and the soil is compacted; this may have an effect on the impact absorbing properties of the surface

Action: Consider HIC testing impact absorbing properties to ensure the correct surface qualities are maintained for the equipment and replace as required

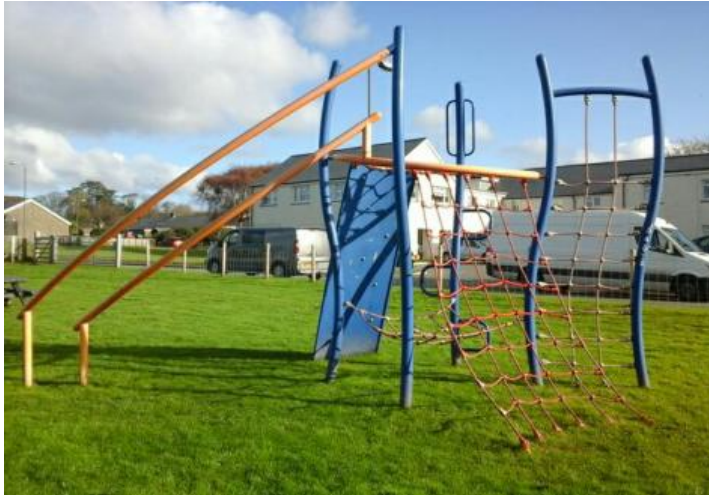
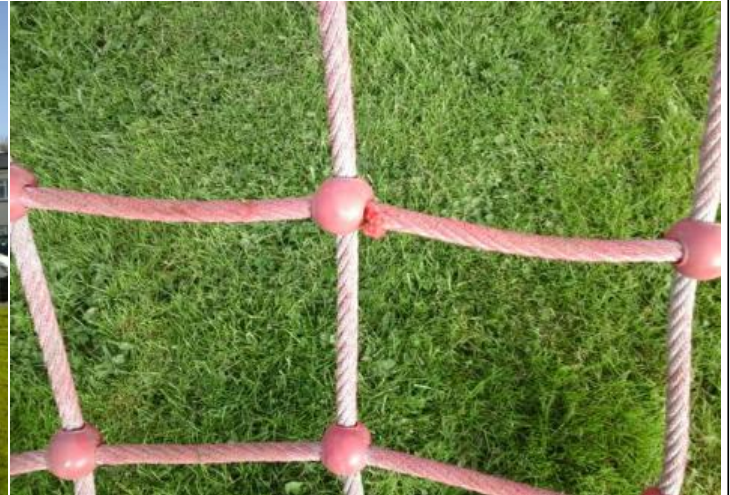
Item: Activity Equipment - Climbing Frame
Manufacturer: Park Leisure Ltd

Finding: The ropes/nets are worn/damaged in places

Action: Monitor for any further deterioration and repair or replace as required

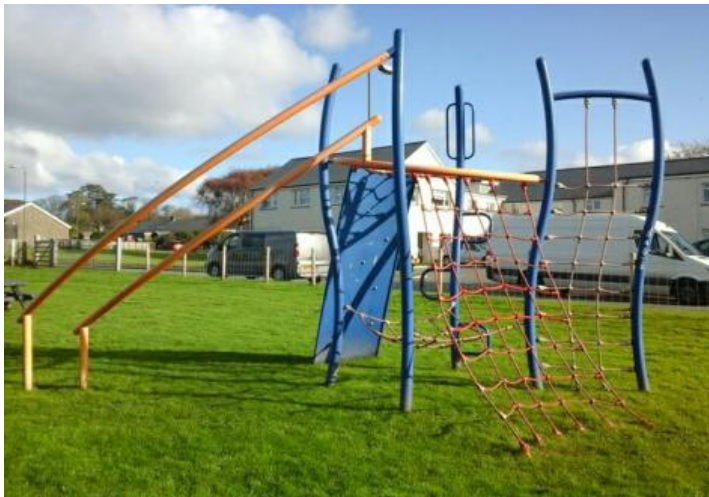
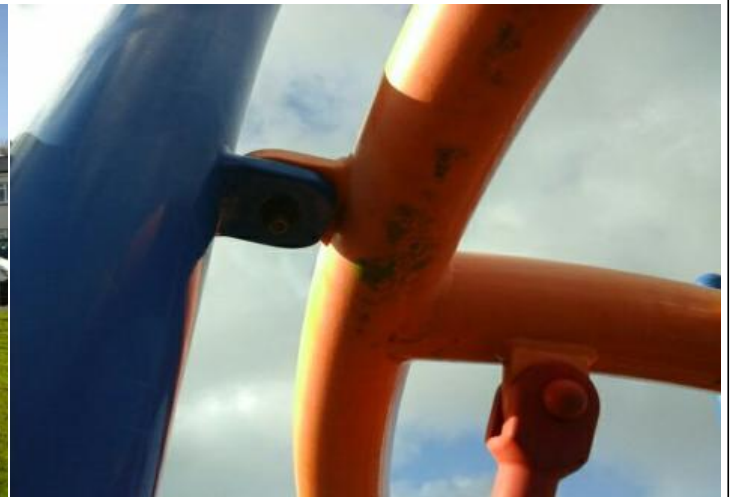
Item: Activity Equipment - Climbing Frame
Manufacturer: Park Leisure Ltd

Finding: The fixings are corroding

Action: Monitor for any further deterioration and replace as required

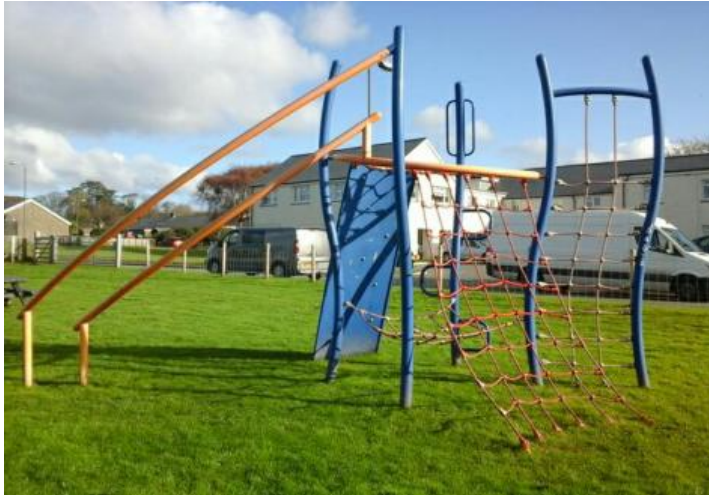
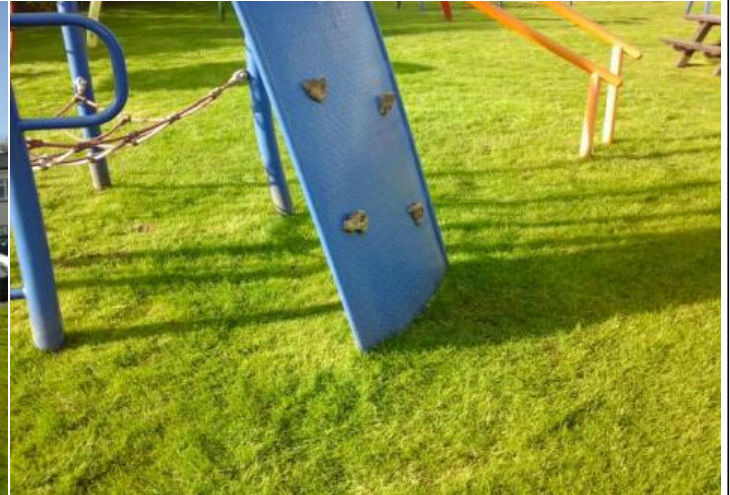
Item: Activity Equipment - Climbing Frame
Manufacturer: Park Leisure Ltd

Finding: The climb wall is slightly loose in its foundations

Action: Monitor for any further deterioration and repair as required

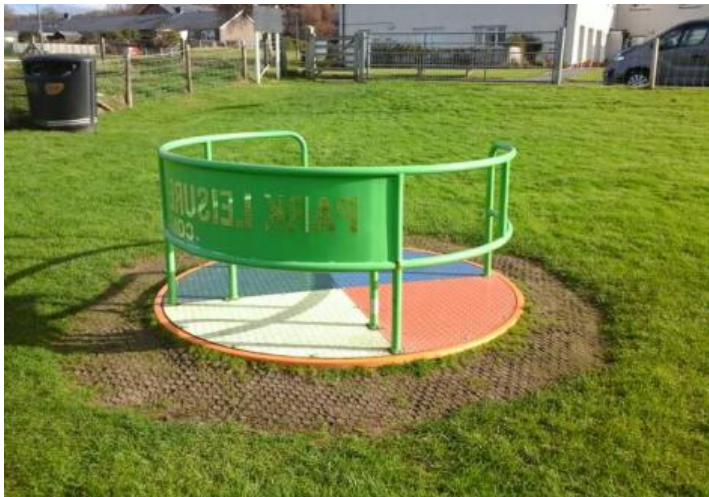
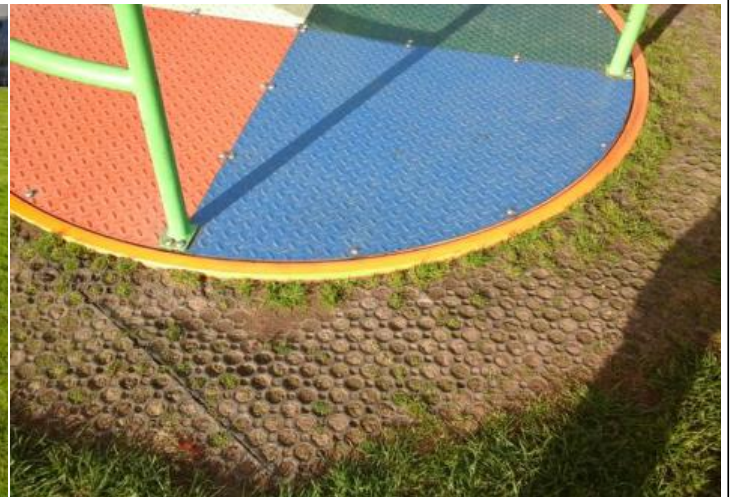
Item: Rotor Play - Roundabout
Manufacturer: Park Leisure Ltd

Finding: There are trip hazards present on the roundabout edge

Action: Reinstall surrounding surfaces to level to remove the trip points
