Annual Inspection

Dyffryn Ardudwy and Talybont Community Council

Pentre Uchaf Play Park

Inspection Ref: 956006

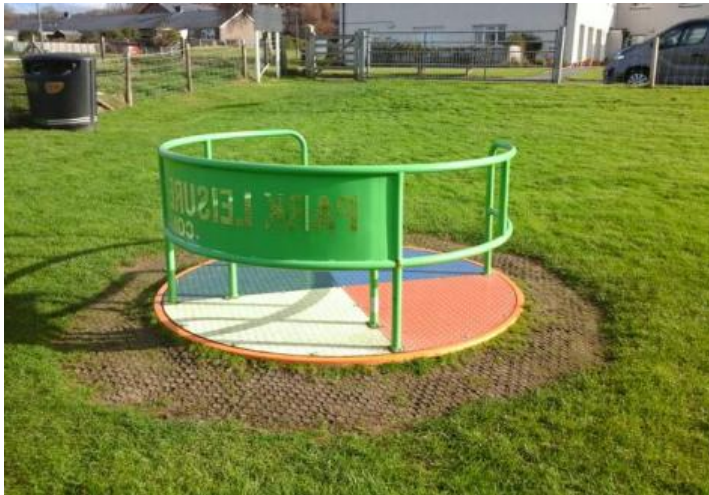
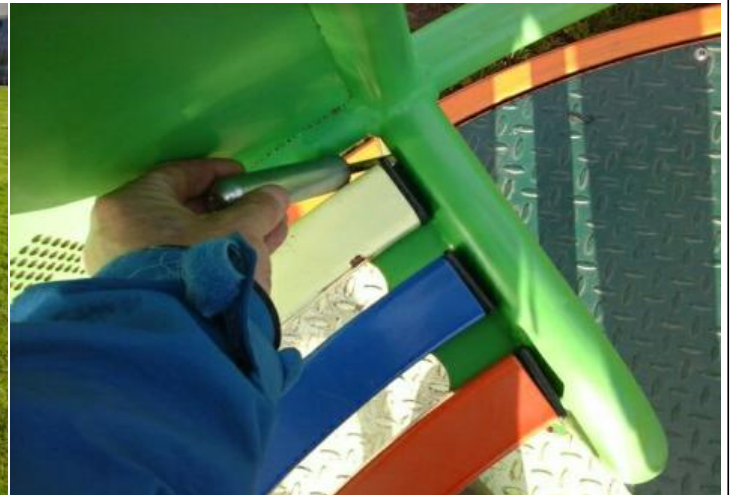
Item: Rotor Play - Roundabout
Manufacturer: Park Leisure Ltd

Finding: There is/are finger entrapment/s in the framework and the item fails to meet the requirements of BS EN 1176 Part 1 4.2.7.6 Entrapment of fingers

Action: Monitor - No remedial work recommended

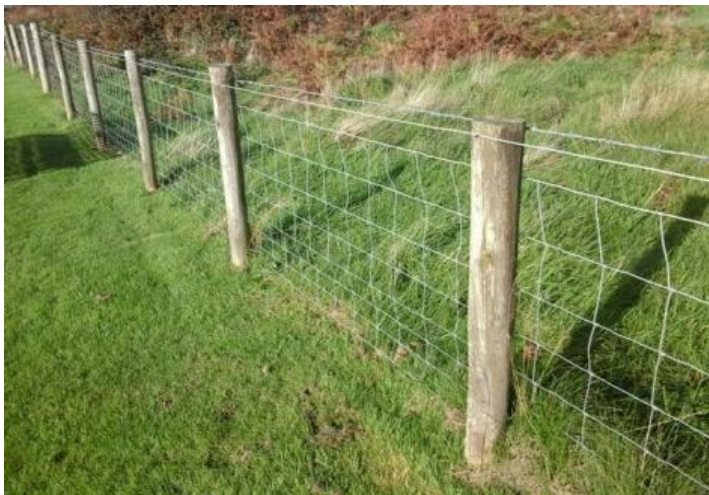
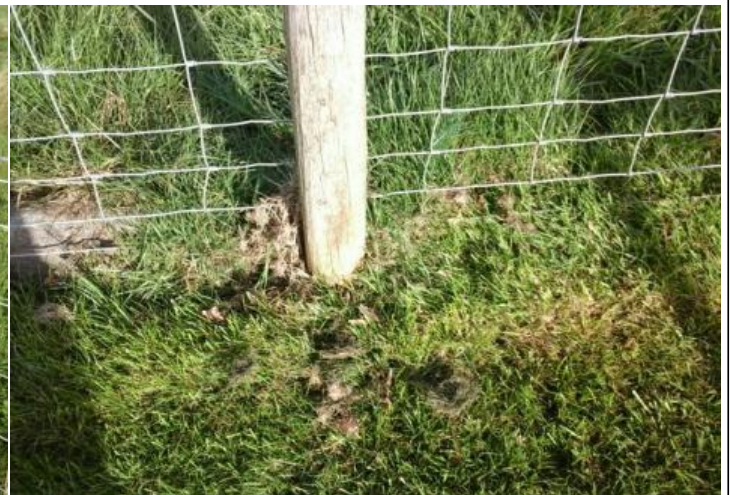
Item: Ancillary Items - Fence - Steel Mesh
Manufacturer: Owner/Operator

Finding: There are areas or parts of the timber on the structure that have rotted

Action: Replace all affected timbers

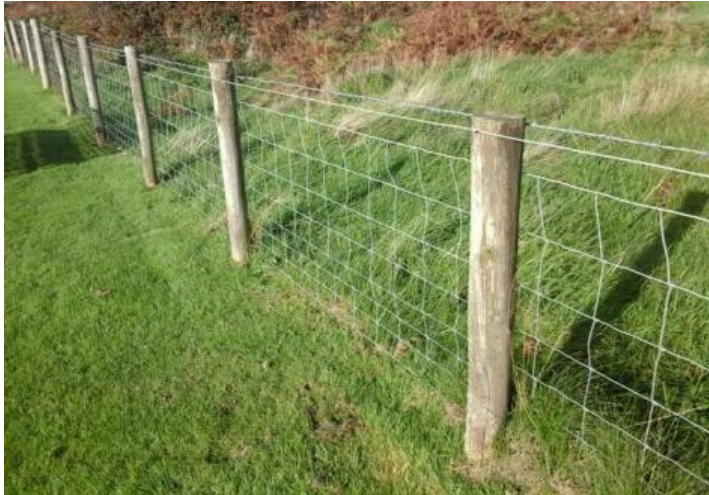
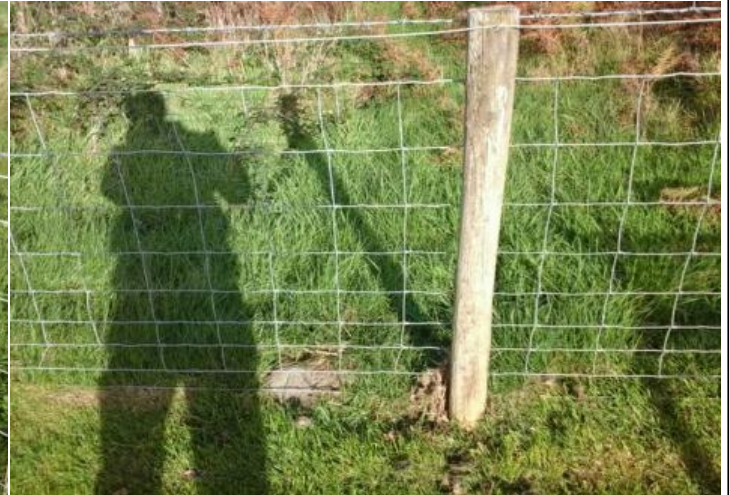
Item: Ancillary Items - Fence - Steel Mesh
Manufacturer: Owner/Operator

Finding: There are a number of loose posts around the fence

Action: Monitor for any further deterioration and reset as required

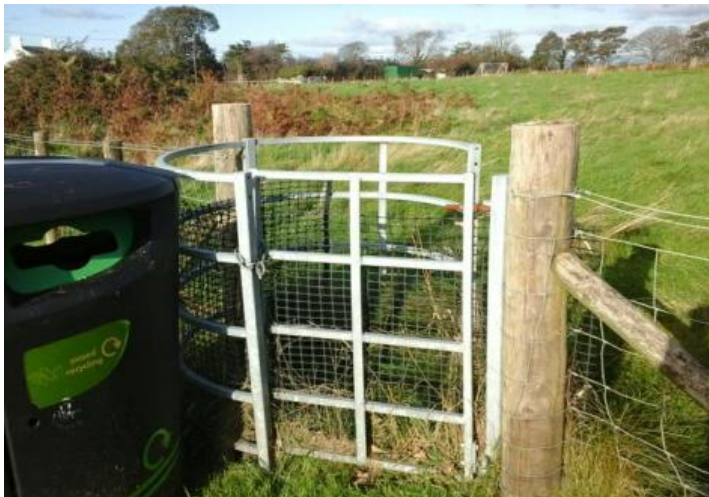
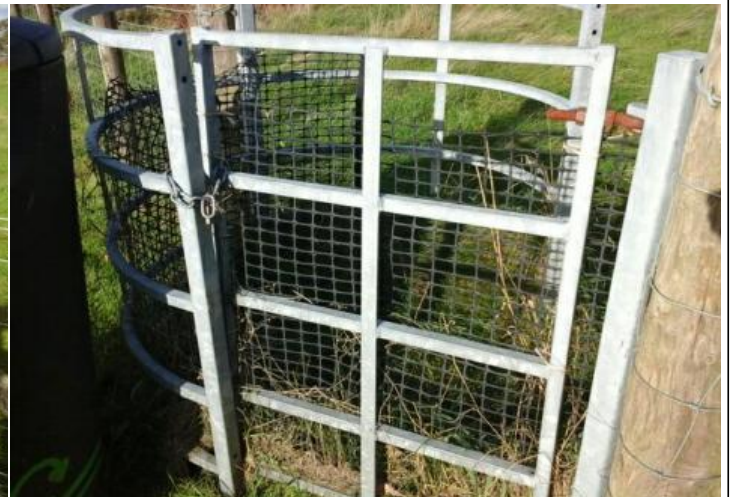
Item: Ancillary Items - Gate - Pedestrian
Manufacturer: Owner/Operator

Finding: The gate was locked at the time of inspection

Action: Check operation and finger clearances if reinstated
