## Annual Inspection

Dyffryn Ardudwy and Talybont Community Council

Pentre Uchaf Play Park

Annual Inspection - 21 November 2017 at 11:44 Inspector: Jon Dalton RPII Annual Inspector

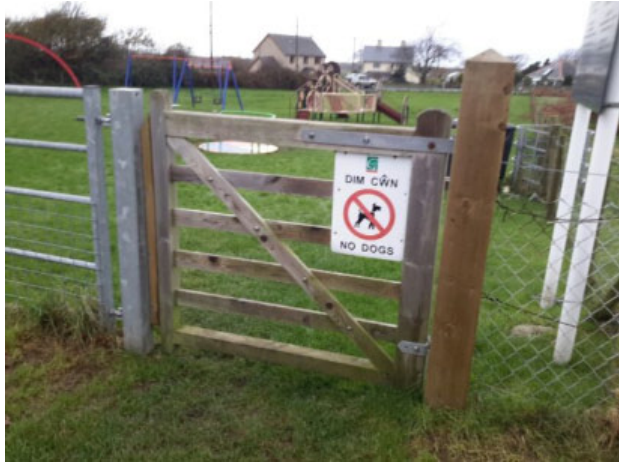
The opening between the gate and the post is less than 12mm and could trap users fingers - Adjust gate to ensure a 12mm opening all around

There are projecting bolt thread(s) present - Remove excess thread length and deburr or provide cap

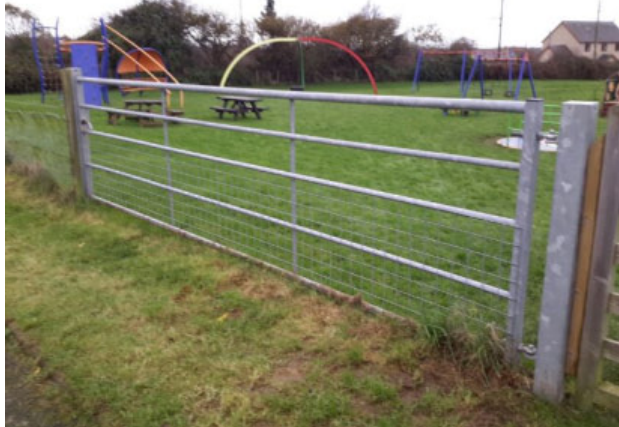
There is no padlock on the maintenance gate - Provide a padlock to secure the gate

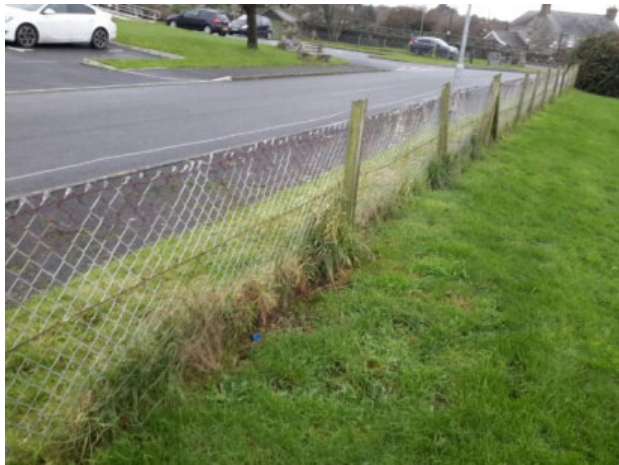
The timber on this item has severe rot - Remove and replace all affected timber sections

There are projecting wires - repair

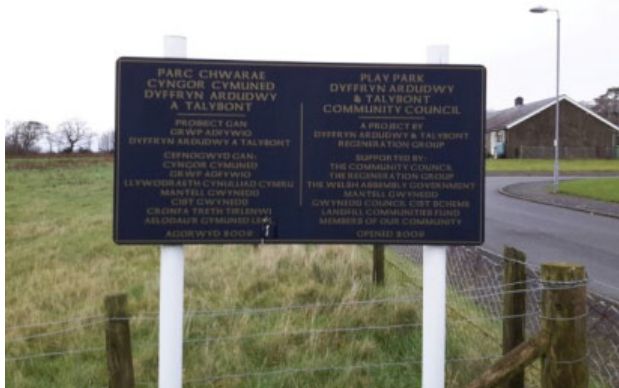
It is recommended that information signs with emergency contact details are installed at each entrance/exit point to the playground - Provide in accordance with the recommendations set out in BS EN 1176

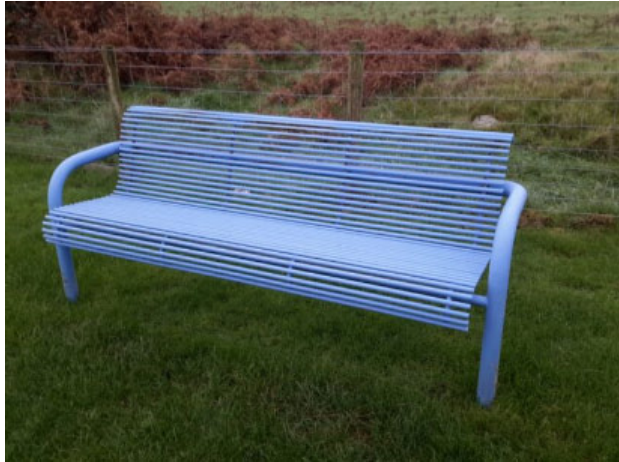
The paintwork on this item has been damaged or worn exposing the metal underneath which is rusting - Treat any rusting components and repaint

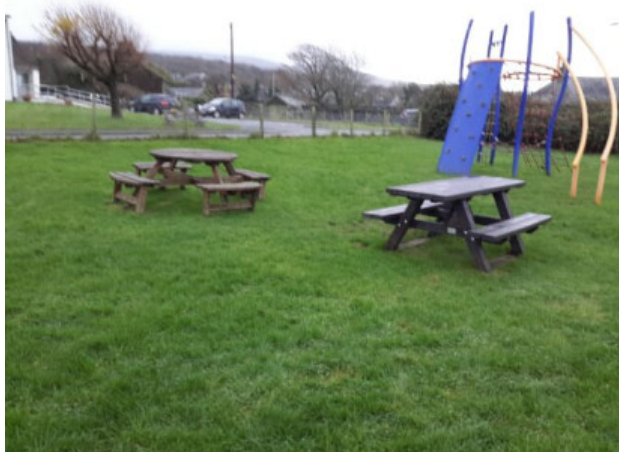
The table is not secured to the ground and there is some potential for the item to be moved within falling spaces of equipment - Secure the item to the ground

The timber on this item has severe rot - Remove and replace all affected timber sections

Fungus was found on site (see photos) - Identify fungus type and remove if poisonous; if classified as non-harmful leave on site

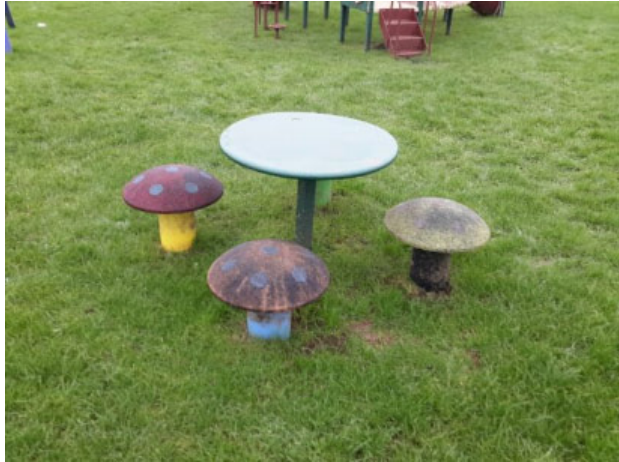
This item is satisfactory - no work required

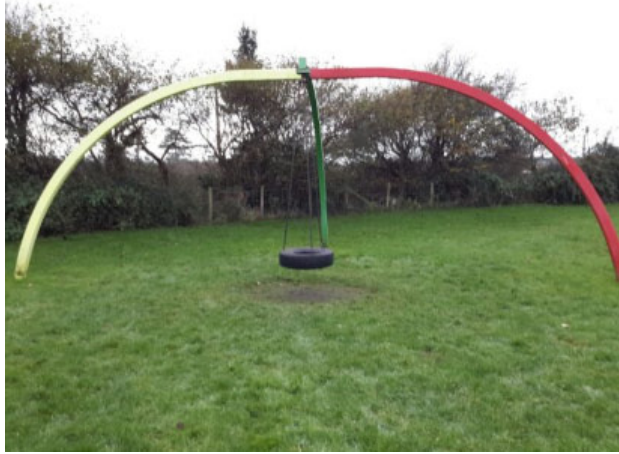
Swings of this design should have a secondary safety mechanism fitted unless the joint has been designed and tested specifically for the purpose. - Refer to manufacturer to establish if the joint is tested and approved for use on this item of equipment

The chain openings are in excess of the 8.6mm as recommended by BS EN 1176 - Monitor use

There is severe wear to the eyebolts - Replace

The grass mats are silted up and the soil is compacted; this may have an effect on the impact absorbing properties of the surface - Lift and relay mats or test impact absorbing properties to ensure the correct surface qualities are maintained for the equipment

The shackles are worn in excess of 40% and require renewing - Replace worn shackles

The tyre is full of water - Provide drainage holes

The paintwork on this item has been damaged or worn exposing the metal underneath which is rusting - Treat any rusting components and repaint

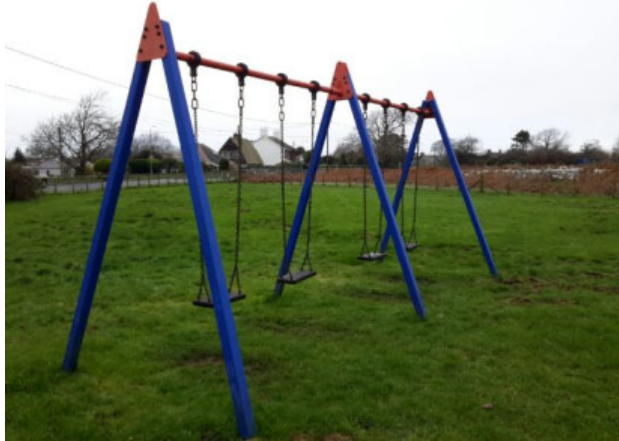
The grass mats are silted up and the soil is compacted; this may have an effect on the impact absorbing properties of the surface - Lift and relay mats or test impact absorbing properties to ensure the correct surface qualities are maintained for the equipment

There is some notable evidence of chain wear - Monitor for any further deterioration and replace when 40% worn

The chain openings are in excess of the 8.6mm as recommended by BS EN 1176 - Monitor use

The seat is severely damaged and requires replacing - Replace damaged seat

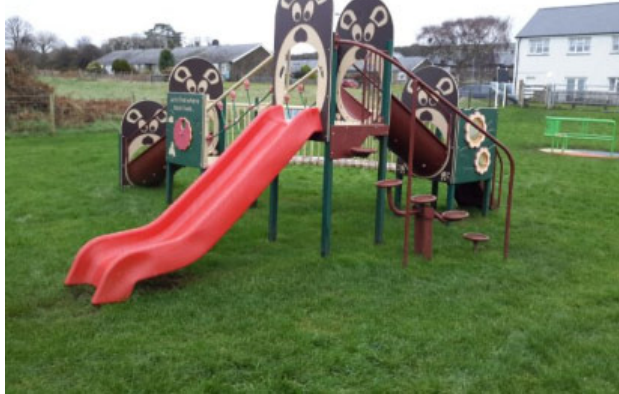
Wetpour inlays are worn - Repair

Rubber bearing worn on seesaw step - Replace

There is/are bolt cap covers missing or damaged on the item - Replace missing or damaged bolt cap covers

The paintwork on this item has been damaged or worn exposing the metal underneath which is rusting under the platforms - Treat any rusting components and repaint

The paintwork on this item has been damaged or worn exposing the metal underneath which is rusting - Treat any rusting components and repaint

There is algae or moss on the surface of the equipment - Clean and treat appropriately

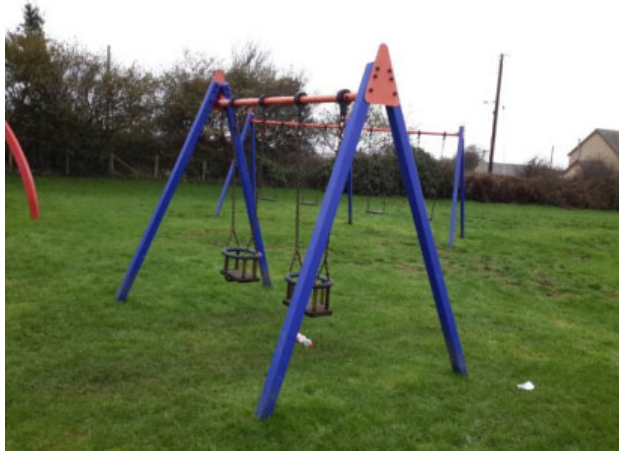
There is some notable evidence of chain wear - Monitor for any further deterioration and replace when 40% worn

Chains have corroded - Monitor and replace as required

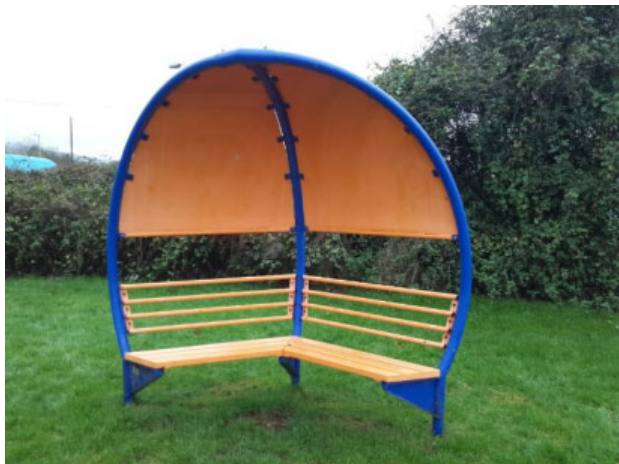
The surface has eroded in some areas - Reinstate the surface

Fixings have corroded - Replace

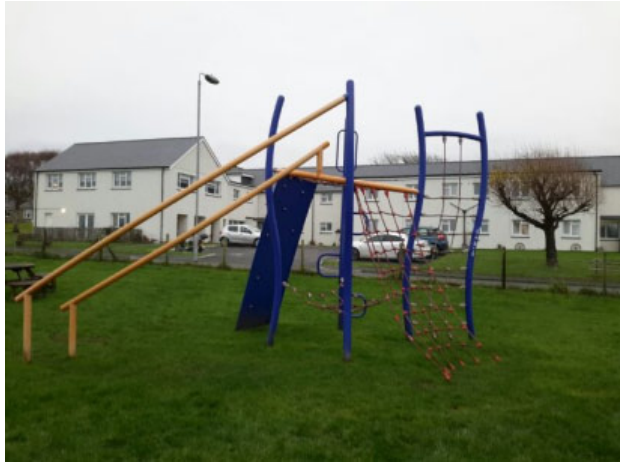
The grass mats are silted up and the soil is compacted; this may have an effect on the impact absorbing properties of the surface - Lift and relay mats or test impact absorbing properties to ensure the correct surface qualities are maintained for the equipment

The ropes/nets are worn/damaged in places - Monitor for any further deterioration and repair or replace as required

Net clamps are not secure - Secure

There is/are bolt cap covers missing or damaged on the item - Replace missing or damaged bolt cap covers

The paintwork on this item has been damaged or worn exposing the metal underneath which is rusting - Treat any rusting components and repaint

Climbing wall loose in ground at base - Re concrete

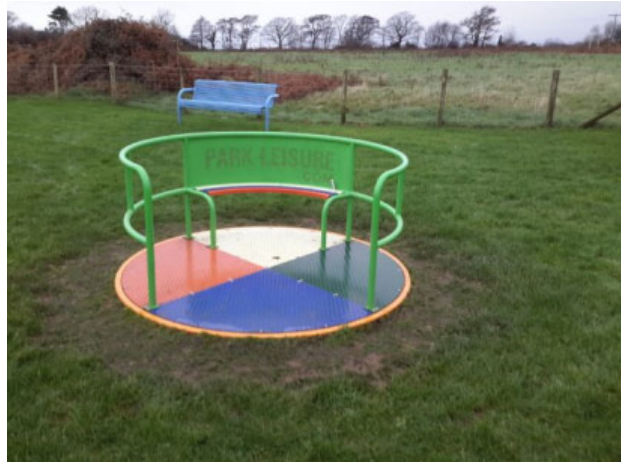
There is/are finger entrapment/s in the seat and the item fails to meet the requirements of BS EN 1176:2008 Part 1 4.2.7.6 Entrapment of fingers - Monitor use

The paintwork on this item has been damaged or worn exposing the metal underneath which is rusting - Treat any rusting components and repaint

The grass mats are silted up and the soil is compacted; this may have an effect on the impact absorbing properties of the surface - Lift and relay mats or test impact absorbing properties to ensure the correct surface qualities are maintained for the equipment

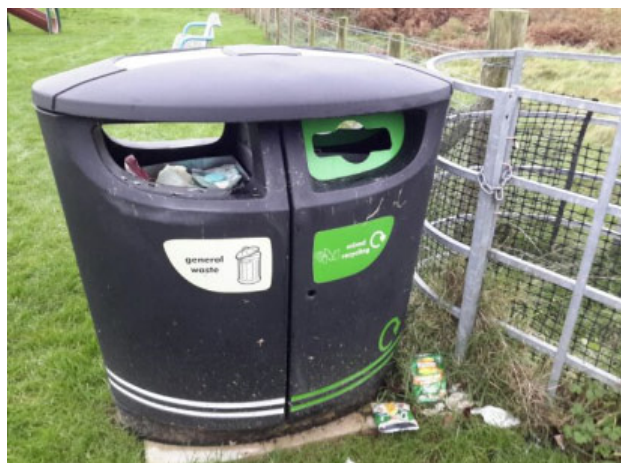
The bin is not securely fixed to the surface and there is some possibility of the item tipping or rolling over - Secure the bin to the ground

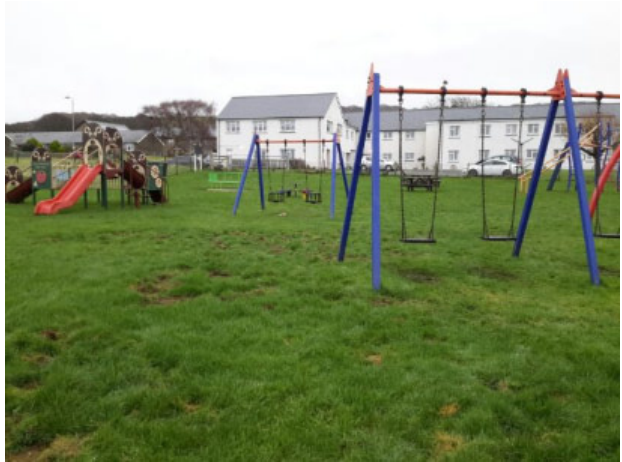
The ground is rutted and in poor condition - Reinststate to level

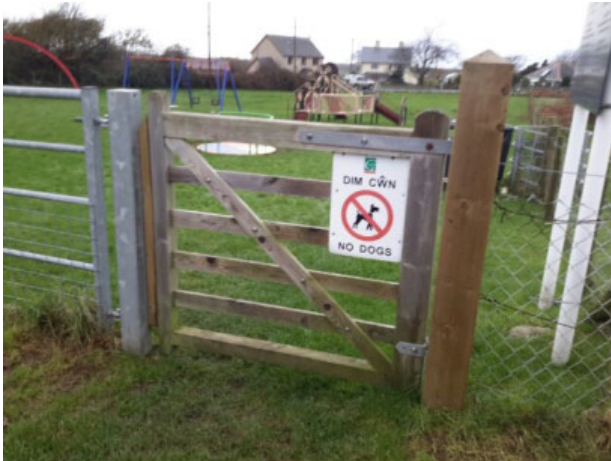
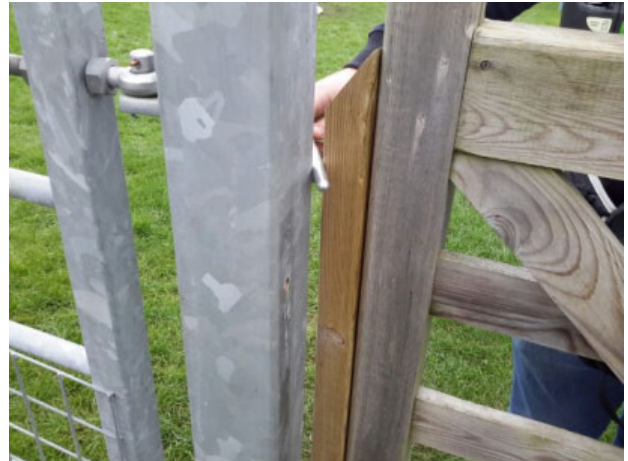
## 8 - Low Risk (Finding 1)

**Finding:** The opening between the gate and the post is less than 12mm and could trap users fingers  
**Action:** Adjust gate to ensure a 12mm opening all around

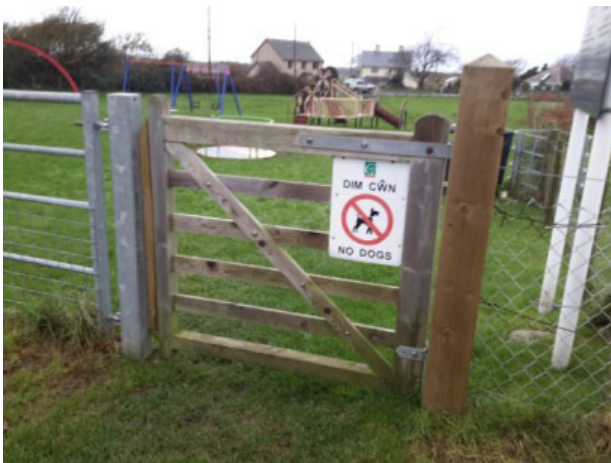
## 6 - Low Risk (Finding 2)

**Finding:** There are projecting bolt thread(s) present  
**Action:** Remove excess thread length and deburr or provide cap

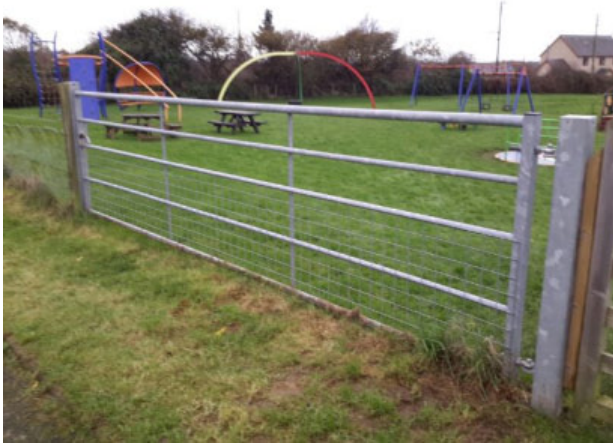
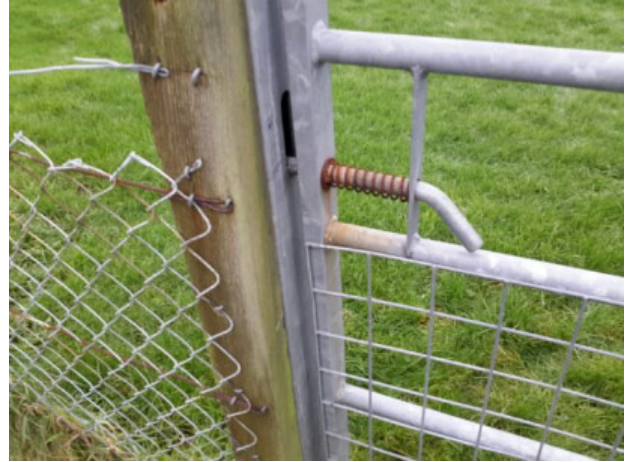
6 - Low Risk (Finding 1)

**Finding:** There is no padlock on the maintenance gate **Action:** Provide a padlock to secure the gate

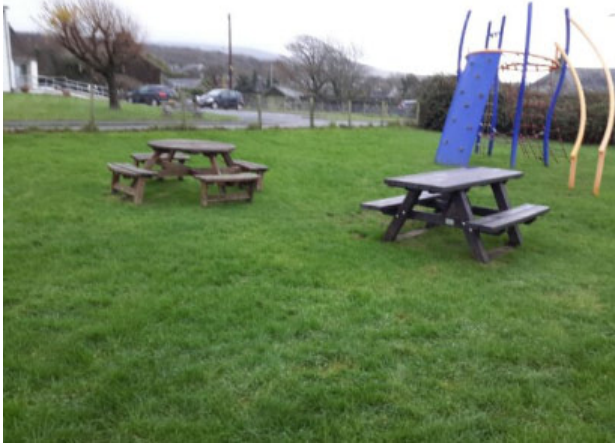
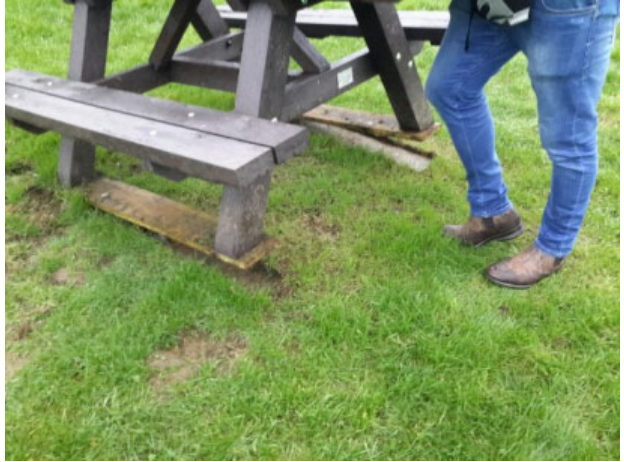
8 - Low Risk (Finding 1)

**Finding:** The table is not secured to the ground and there is some potential for the item to be moved within falling spaces of equipment

**Action:** Secure the item to the ground

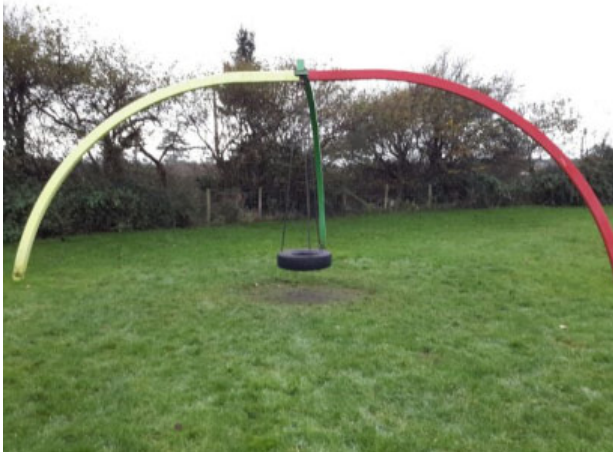
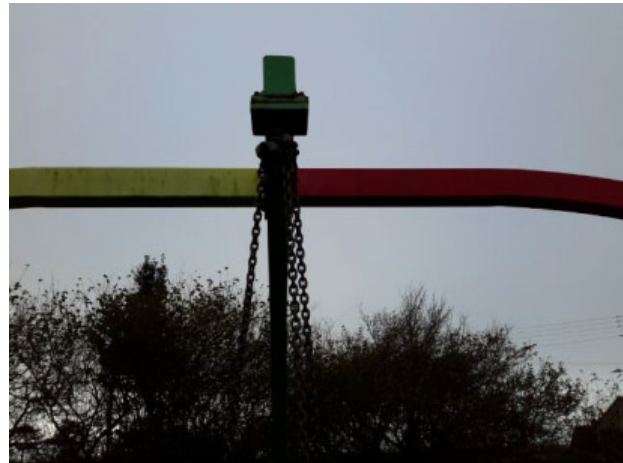
12 - Moderate Risk (Finding 1)

**Finding:** Swings of this design should have a secondary safety mechanism fitted unless the joint has been designed and tested specifically for the purpose.

**Action:** Refer to manufacturer to establish if the joint is tested and approved for use on this item of equipment

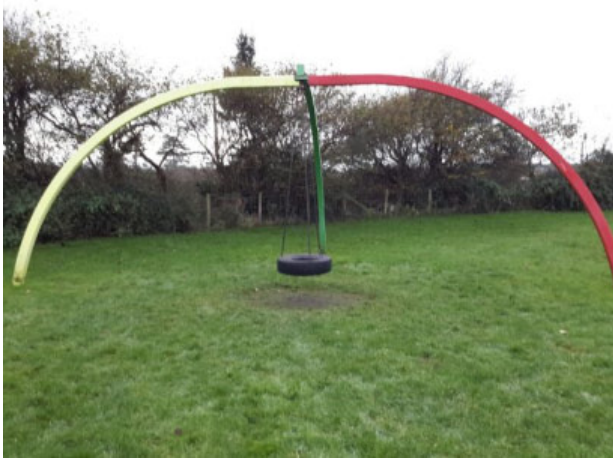
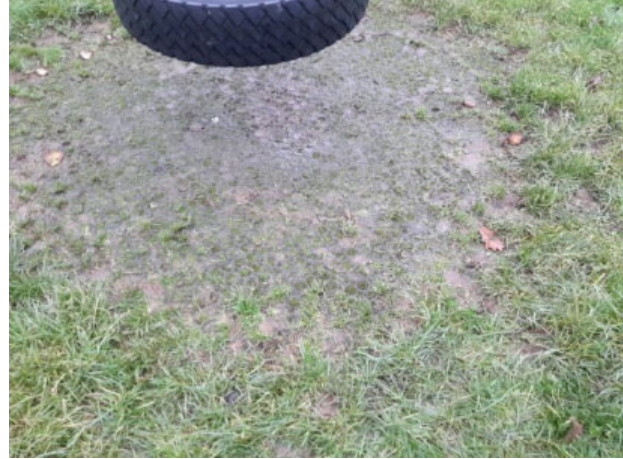
8 - Low Risk (Finding 4)

**Finding:** The grass mats are silted up and the soil is compacted; this may have an effect on the impact absorbing properties of the surface

**Action:** Lift and relay mats or test impact absorbing properties to ensure the correct surface qualities are maintained for the equipment

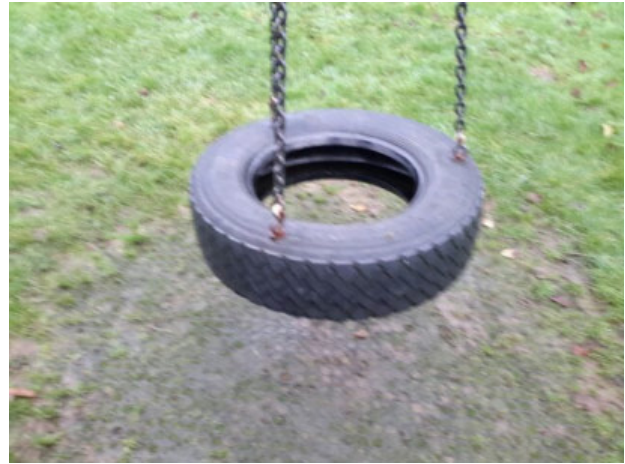
**Finding:** The tyre is full of water

**Action:** Provide drainage holes

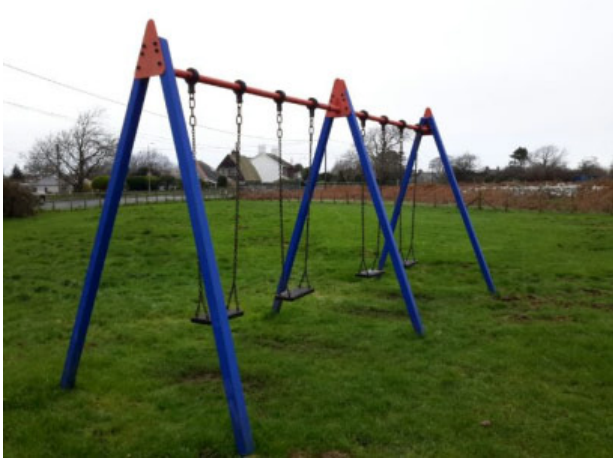
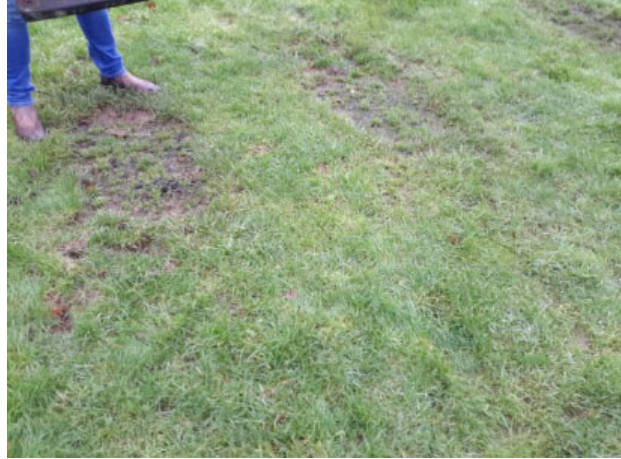
**Finding:** The grass mats are silted up and the soil is compacted; this may have an effect on the impact absorbing properties of the surface

**Action:** Lift and relay mats or test impact absorbing properties to ensure the correct surface qualities are maintained for the equipment

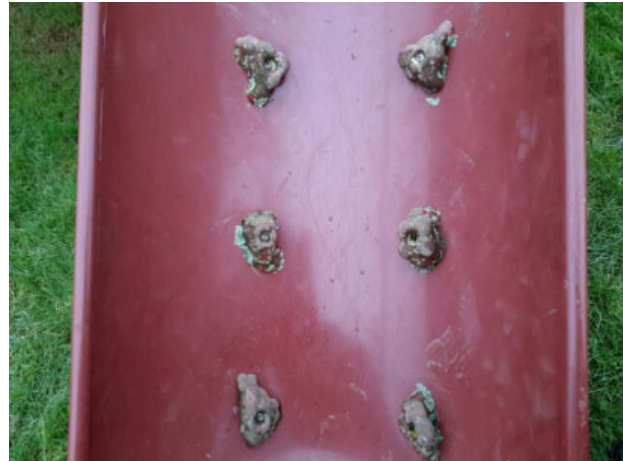
**Finding:** There is algae or moss on the surface of the equipment

**Action:** Clean and treat appropriately

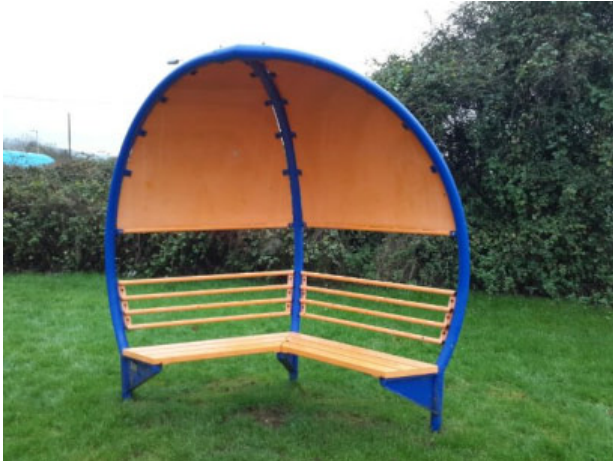
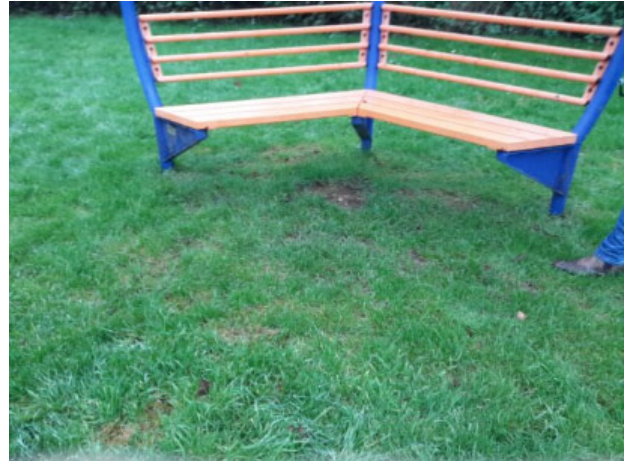
**Finding:** The surface has eroded in some areas

**Action:** Reinstate the surface

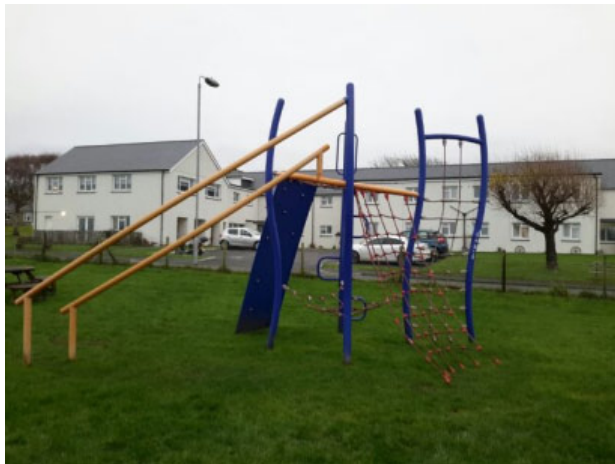
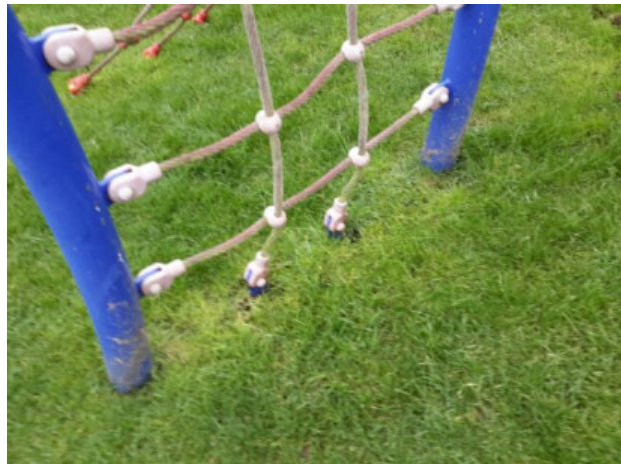
**Finding:** The grass mats are silted up and the soil is compacted; this may have an effect on the impact absorbing properties of the surface

**Action:** Lift and relay mats or test impact absorbing properties to ensure the correct surface qualities are maintained for the equipment

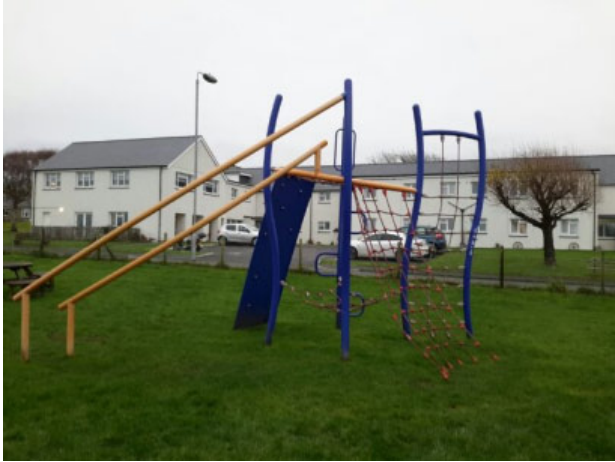
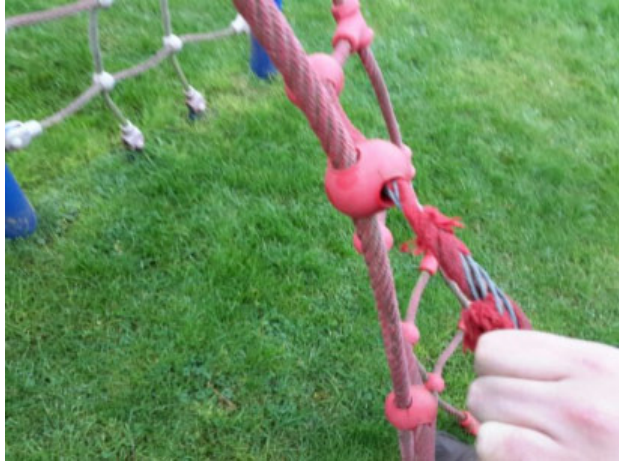
**Finding:** Net clamps are not secure

**Action:** Secure

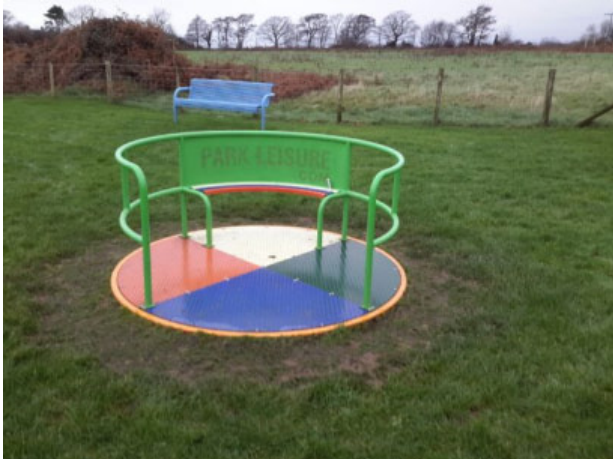
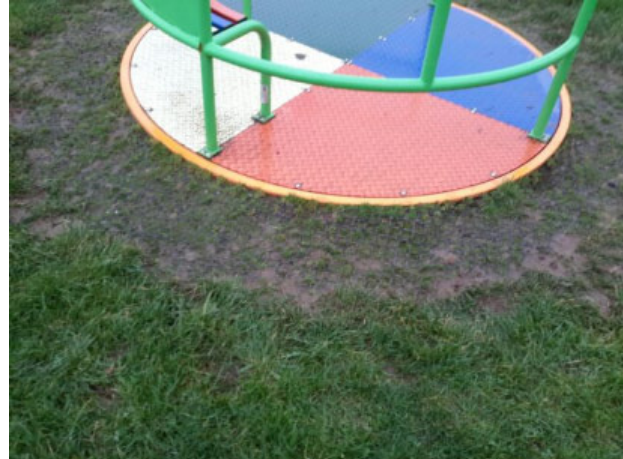
**Finding:** The grass mats are silted up and the soil is compacted; this may have an effect on the impact absorbing properties of the surface

**Action:** Lift and relay mats or test impact absorbing properties to ensure the correct surface qualities are maintained for the equipment

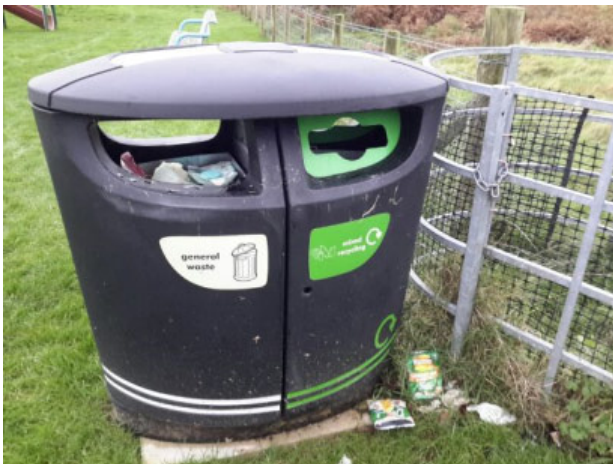
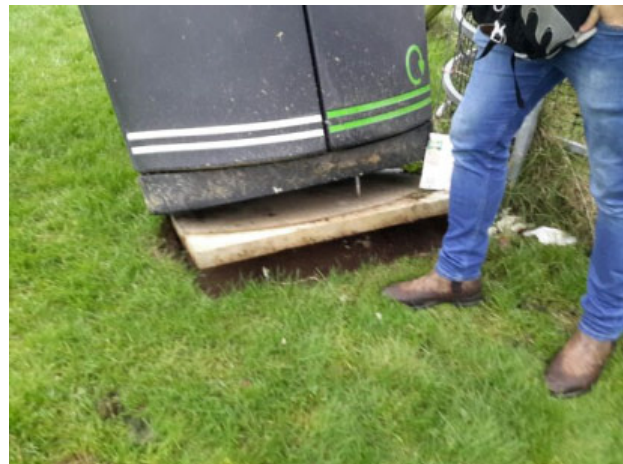
**Item:** Ancillary Items - Litter Bin  
**Manufacturer:** Not Identified

**Risk Level:** L - Low Risk  
**Surface:** Grass

**Finding:** The bin is not securely fixed to the surface and there is some possibility of the item tipping or rolling over

**Action:** Secure the bin to the ground
