Annual Inspection

Dyffryn Ardudwy and Talybont Community Council

Old Swings

Talybont, LL44 2HT

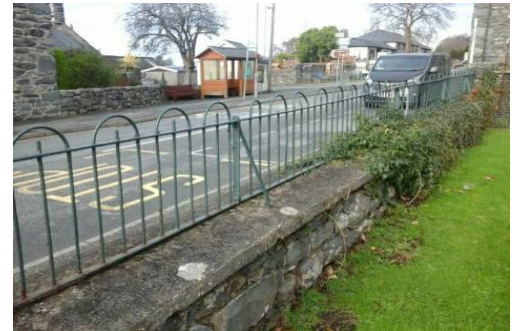
Item: Fence - Bow Top
Manufacturer: Owner/Operator
Surface Type: N/A
Equipment Compliance: N/A
Surface Area Compliance: N/A

There are a number of poles missing from the fence -
 Replace missing poles

There is surface corrosion present on the item - Consider
 treating and repainting the item

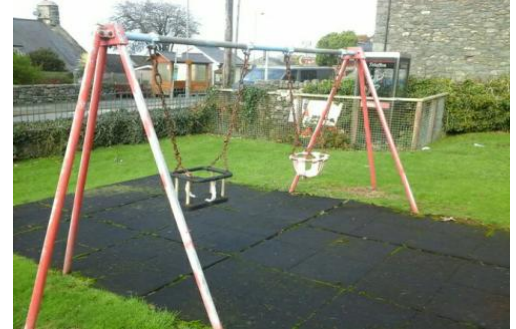
Item: 1 Bay 2 Seat (Cradle)
Manufacturer: GL Jones
Surface Type: Rubber Tiles
Equipment Compliance: No
Surface Area Compliance: No

There are significant gaps (over 30mm) between the surface and the edging or between the joints in the surface; these are large enough for a small foot to enter - Repair surfacing

There are trip hazards at the edges of the surface - Reinstate surrounding surface levels to remove the trip points

The chain openings are in excess of the 8.6mm as recommended by BS EN 1176 - Monitor use

The chain links are worn in excess of 40% and require renewing - Replace worn chains

There is some wear to the shackles. - Monitor for any further deterioration and replace when 40% worn

The seat has minor damage or wear - Monitor for any further deterioration and replace as required

The swing seat frame is severely corroded and requires replacement - Replace seat

The chains are heavily corroded - Replace chains

The surfacing width under each seat is less than 1.75 metres and fails the requirements of BS EN 1176 Part 2 - Monitor use

The shackles are corroding - Monitor for any further deterioration and repair as required

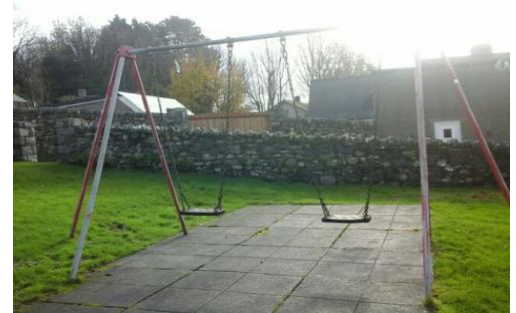
Item: 1 Bay 2 Seat (Flat)
Manufacturer: GL Jones
Surface Type: Rubber Tiles
Equipment Compliance: No
Surface Area Compliance: No

The bushes are showing signs of wear - Monitor for any further deterioration and replace as required

The shackles are corroding - Monitor for any further deterioration and repair as required

The chain openings are in excess of the 8.6mm as recommended by BS EN 1176 - Monitor use

The seat is severely damaged and requires replacing - Replace damaged seat

The seat eye bolts are worn - Replace bolts

The seats are too close to the frame as defined in BS EN 1176 Part 2; this is a low risk failure and no remedial action is required - Monitor use

There is some wear to the shackles. - Monitor for any further deterioration and replace when 40% worn

The chains are corroding - Monitor for any further deterioration and repair as required.

The chain links are worn in excess of 40% and require renewing - Replace worn chains

The seat fixings are corroded - Replace fixings

The surfacing width under each seat is less than 1.75 metres and fails the requirements of BS EN 1176 Part 2 - Monitor use

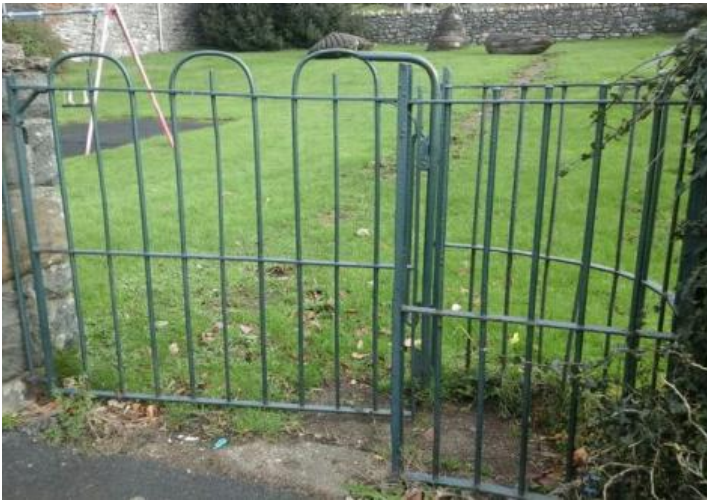
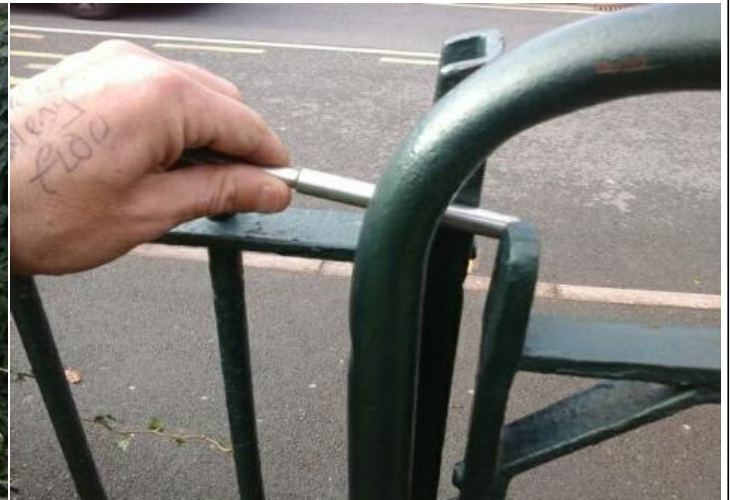
Item: Ancillary Items - Gate - Pedestrian
Manufacturer: Owner/Operator

Finding: The opening between the gate and the post is less than 12mm and could trap users fingers
Action: Adjust gate to ensure a 12mm opening all around

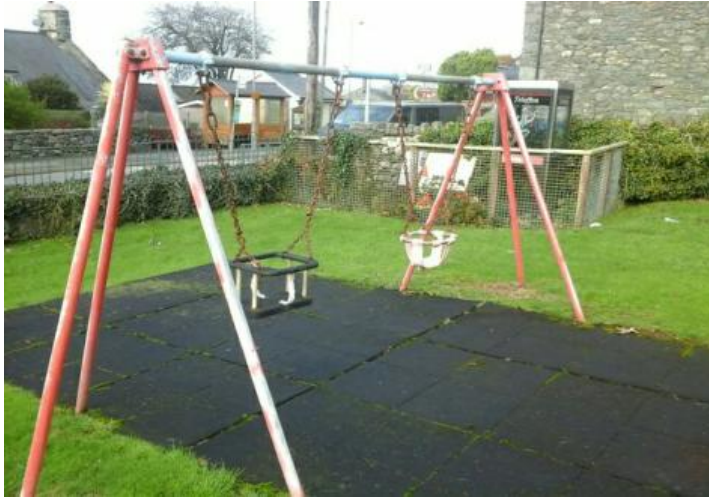
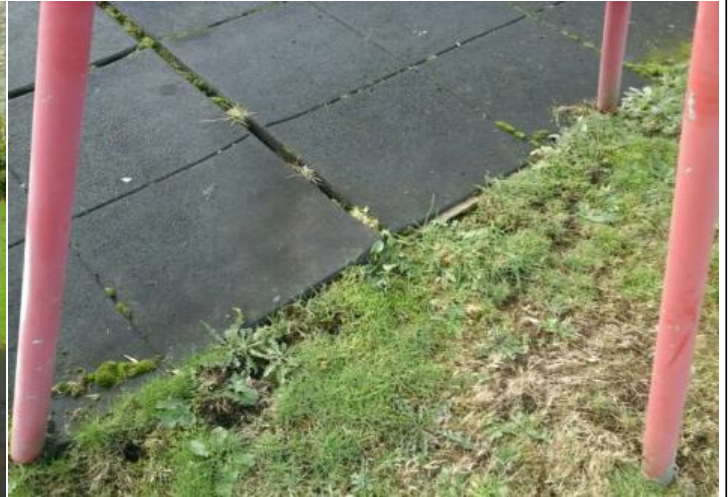
Item: Swings - 1 Bay 2 Seat (Cradle)
Manufacturer: GL Jones

Finding: The tiles can easily be lifted or are lifting along the edges of the area
Action: Lift and re-glue tiles to secure

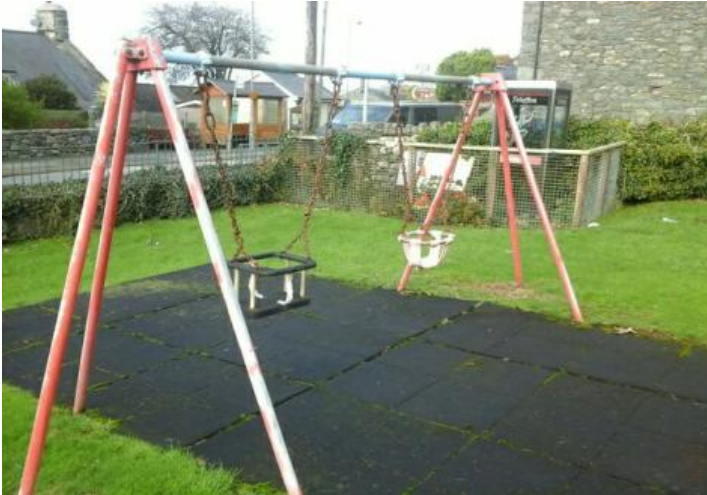
Item: Swings - 1 Bay 2 Seat (Cradle)
Manufacturer: GL Jones

Finding: The shackles are corroding

Action: Monitor for any further deterioration and repair as required

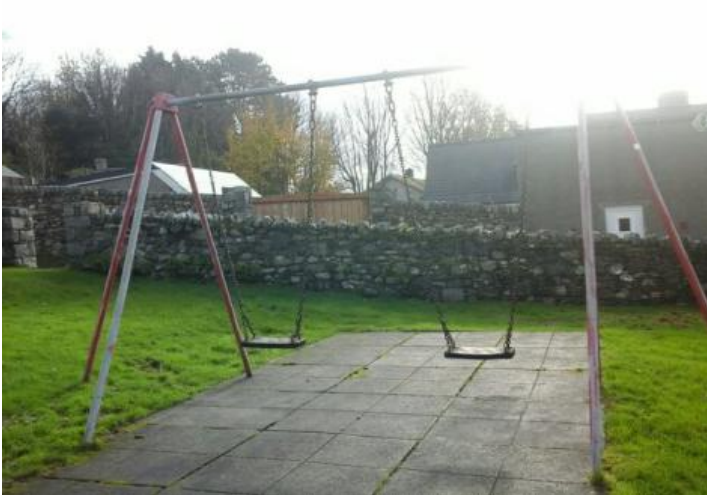
Item: Swings - 1 Bay 2 Seat (Flat)
Manufacturer: GL Jones

Finding: The chain links are worn in excess of 40% and require renewing

Action: Replace worn chains

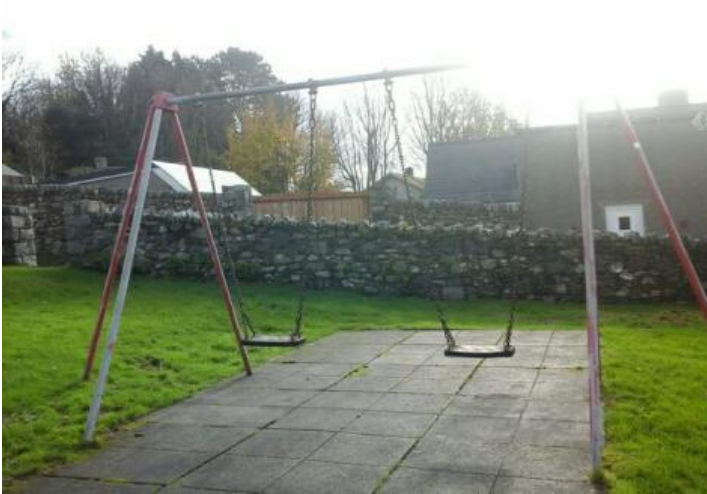
Item: Swings - 1 Bay 2 Seat (Flat)
Manufacturer: GL Jones

Finding: The seat is severely damaged and requires replacing

Action: Replace damaged seat

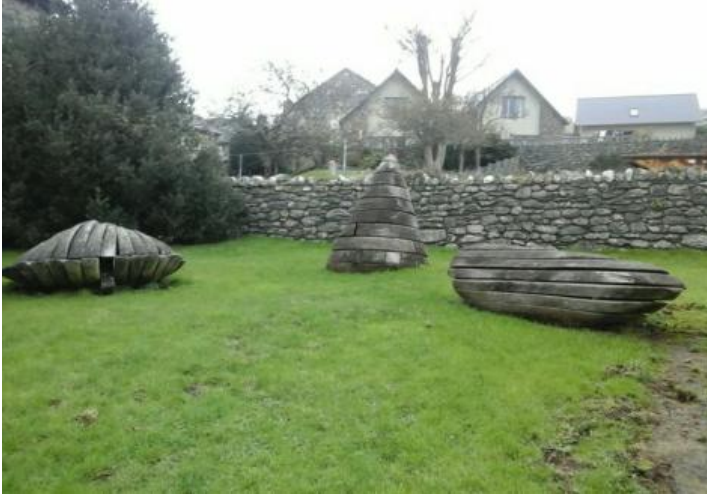
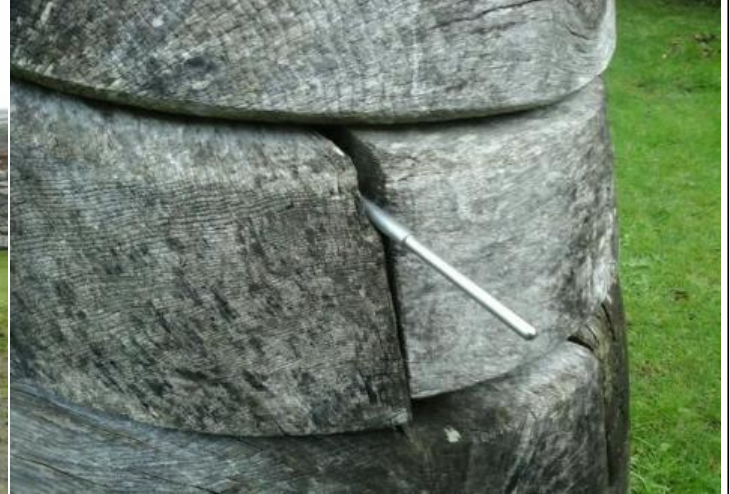
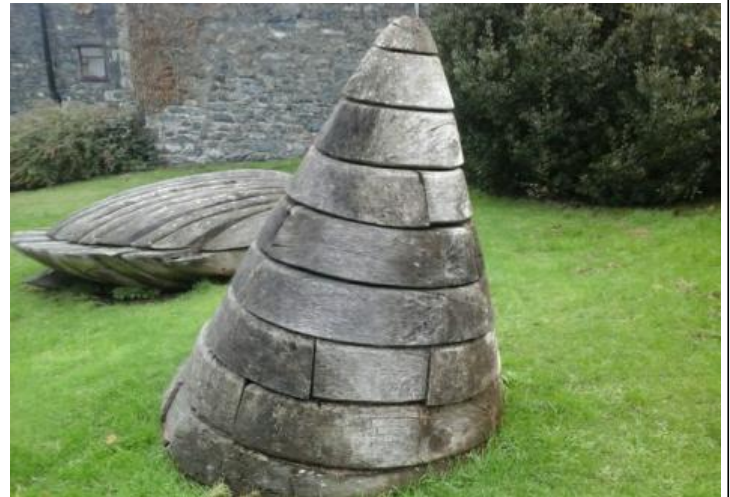
Item: Other - Sculpture
Manufacturer: Not Identified

Finding: There is a potential crush point between the rotating sections

Action: Adjust item to remove crush point
