Annual Inspection

Dyffryn Ardudwy and Talybont Community Council

Pentre Uchaf Play Park

Dyffrn Ardudwy, LL44 2HT

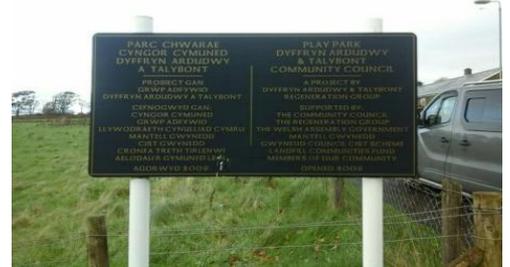
Item: Sign
Manufacturer: Owner/Operator
Surface Type: N/A
Equipment Compliance: N/A
Surface Area Compliance: N/A

It is recommended that information signs with emergency contact details are installed at each entrance/exit point to the playground - Provide in accordance with the recommendations set out in BS EN 1176

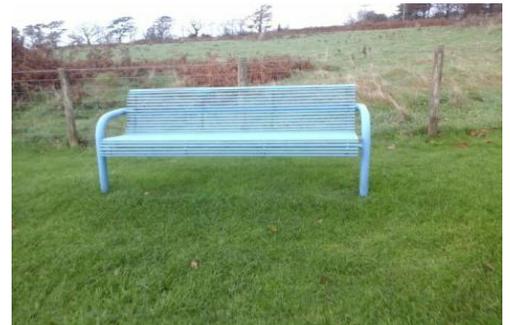
Item: Bench
Manufacturer: Lightmain Engineering
Surface Type: N/A
Equipment Compliance: N/A
Surface Area Compliance: N/A

There is surface corrosion present on the item - Consider treating and repainting the item

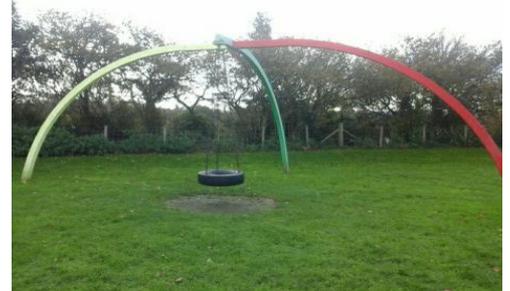
Item: Single Point Swing - Type 3
Manufacturer: Park Leisure Ltd
Surface Type: Grass Matrix Tiles
Equipment Compliance: No
Surface Area Compliance: Yes

The grass mats are silted up and the soil is compacted; this may have an effect on the impact absorbing properties of the surface - Consider HIC testing impact absorbing properties to ensure the correct surface qualities are maintained for the equipment and replace as required

The eye bolts are heavily worn, H.O. informed - Replace

The connecting links are in excess of 8.6mm and less than 12mm and fail the requirements of BS EN 1176 Part 1; clause 4.2.13, Chains - Monitor use

The seat has minor damage or wear - Monitor for any further deterioration and replace as required

There is some wear to the shackles. - Monitor for any further deterioration and replace when 40% worn

The chain openings are in excess of the 8.6mm as recommended by BS EN 1176 - Monitor use

The shackles have been overtightened or seized transferring wear to the chain links below - Loosen shackles to ensure free movement at the pivot

The shackles are worn in excess of 40% and require renewing - Replace worn shackles

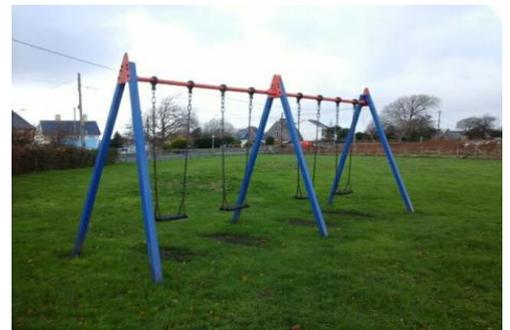
Item: 2 Bay 4 Seat (Flat)
Manufacturer: Park Leisure Ltd
Surface Type: Grass Matrix Tiles
Equipment Compliance: No
Surface Area Compliance: Yes

The shackles have been overtightened or seized transferring wear to the chain links below - Loosen shackles to ensure free movement at the pivot

The chain openings are in excess of the 8.6mm as recommended by BS EN 1176 - Monitor use

There is some notable evidence of chain wear - Monitor for any further deterioration and replace when 40% worn

The seat has minor damage or wear - Monitor for any further deterioration and replace as required

The swing seat connectors are loose - Tighten to secure

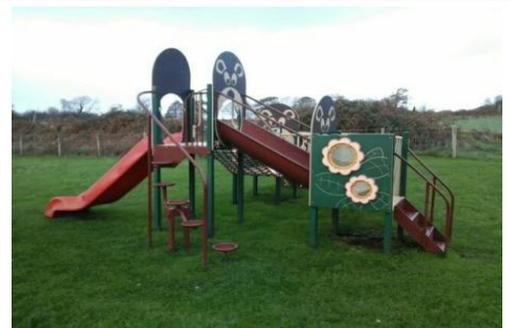
Item: Multi Play (Junior)
Manufacturer: Not Identified
Surface Type: Grass Matrix Tiles
Equipment Compliance: Yes
Surface Area Compliance: Yes

There is wear to the torsion system - Monitor for any further deterioration and repair as required.

There is surface corrosion present on the item - Consider treating and repainting the item

There is/are bolt cap covers missing or damaged on the item - Replace missing or damaged bolt cap covers

Wetpour inlays are worn - Repair

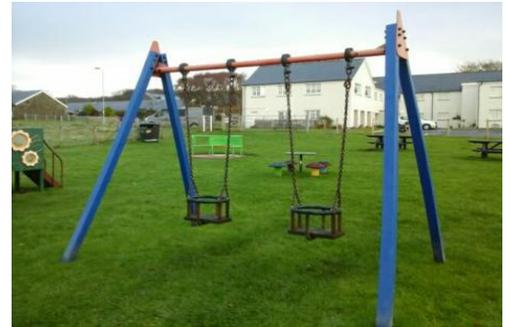
Item: 1 Bay 2 Seat (Cradle)
Manufacturer: Park Leisure Ltd
Surface Type: Grass
Equipment Compliance: Yes
Surface Area Compliance: Yes

The shackles have been overtightened or seized transferring wear to the chain links below - Loosen shackles to ensure free movement at the pivot

Chains have corroded - Monitor and replace as required

There is some notable evidence of chain wear - Monitor for any further deterioration and replace when 40% worn

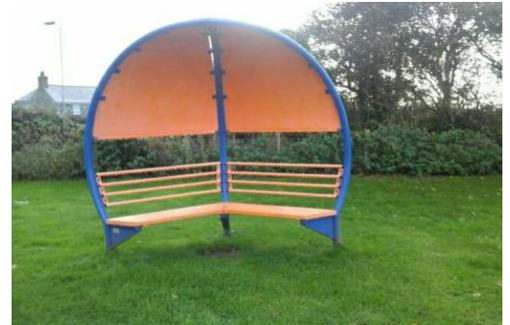
Item: Shelter
Manufacturer: Park Leisure Ltd
Surface Type: Grass
Equipment Compliance: N/A
Surface Area Compliance: N/A

Fixings have corroded - Replace

There is surface corrosion present on the item - Consider treating and repainting the item

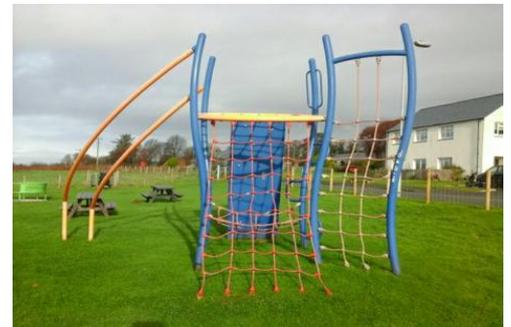
Item: Climbing Frame
Manufacturer: Park Leisure Ltd
Surface Type: Grass Matrix Tiles
Equipment Compliance: Yes
Surface Area Compliance: Yes

The rope has worn and there are sharp wire strands protruding - Replace rope or net

The ropes on this item have been taped and we are unable to fully assess the condition of the rope, ensure no wire strands are broken beneath the tape - Repair or replace as required

There is surface corrosion present on the item - Consider treating and repainting the item

The ropes/nets are worn/damaged in places - Monitor for any further deterioration and repair or replace as required

Climbing wall loose in ground at base - Re concrete

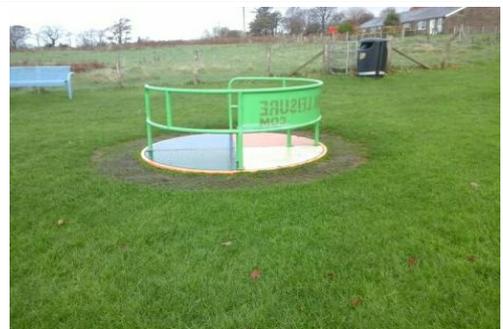
Item: Roundabout
Manufacturer: Park Leisure Ltd
Surface Type: Grass Matrix Tiles
Equipment Compliance: No
Surface Area Compliance: Yes

Finding 1
 The grass mats are silted up, the soil is compacted and the area will become very slippery when the soil is wet. - Reinstate as required

Finding 2
 There are trip hazards at the edges of the surface - Reinstate surrounding surface levels to remove the trip points

Finding 3
 There is/are finger entrapment/s in the framework and the item fails to meet the requirements of BS EN 1176 Part 1 4.2.7.6 Entrapment of fingers - Monitor use

Finding 4
 There is surface corrosion present on the item - Consider treating and repainting the item

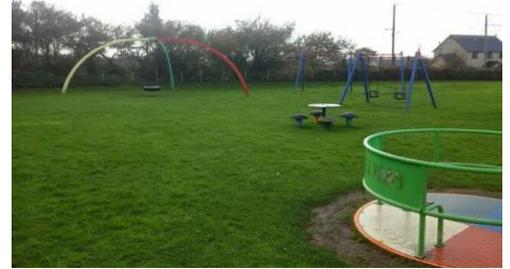
Item: Site General
Manufacturer: Owner/Operator
Surface Type: N/A
Equipment Compliance: N/A
Surface Area Compliance: N/A

There are a number of molehills within the area and these may present unforeseen hazards for users - Remove moles by appropriate means, reinstate surfaces to level and maintain the area

There are a number of loose posts around the fence - Monitor for any further deterioration and reset as required

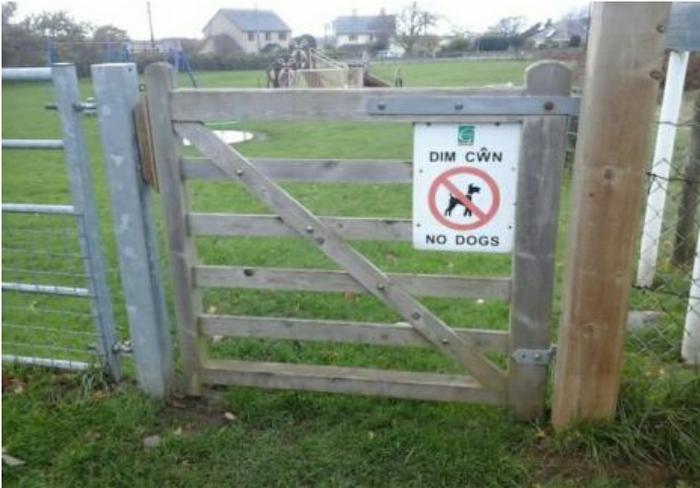
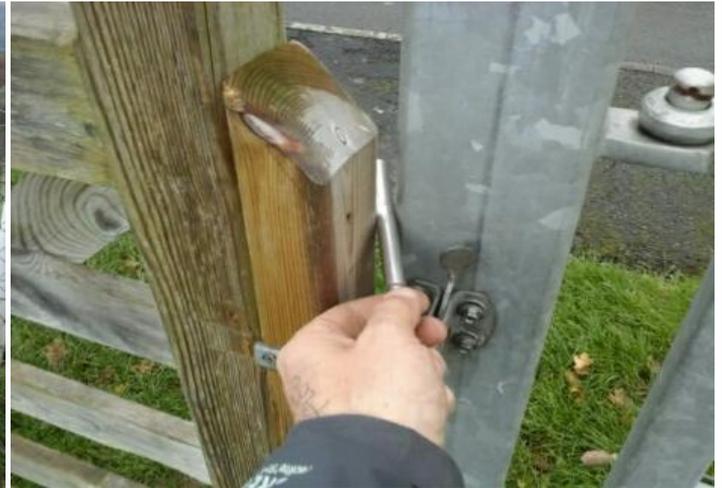
Item: Ancillary Items - Gate
Manufacturer: Owner/Operator

Finding: The opening between the gate and the post is less than 12mm and could trap users fingers
Action: Adjust gate to ensure a 12mm opening all around

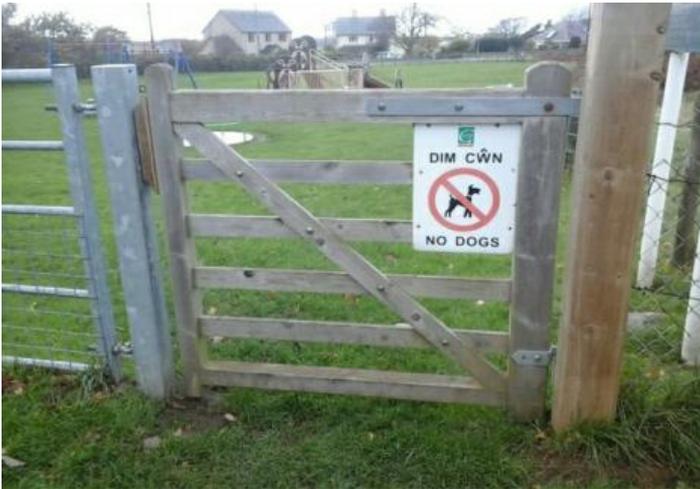
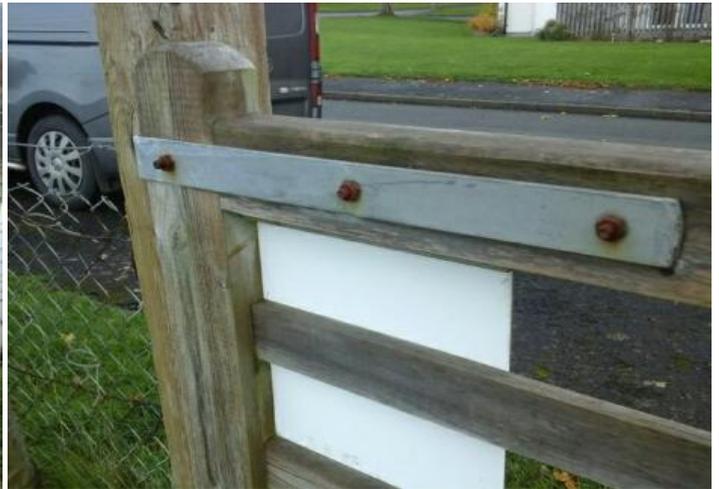
Item: Ancillary Items - Gate
Manufacturer: Owner/Operator

Finding: There are projecting bolt thread(s) present

Action: Remove excess thread length and deburr or provide cap

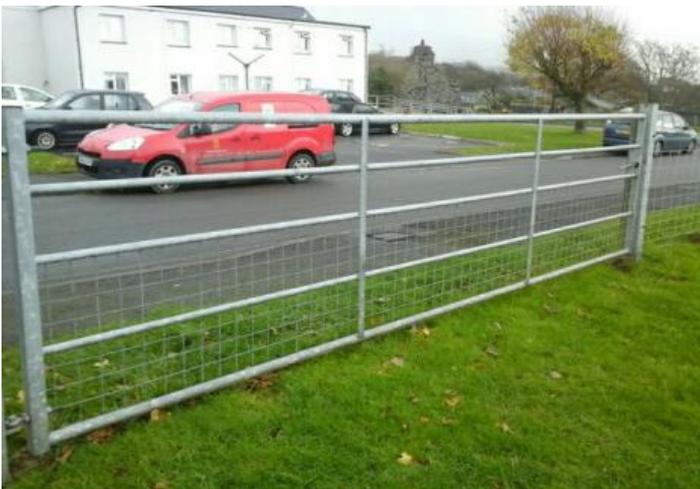
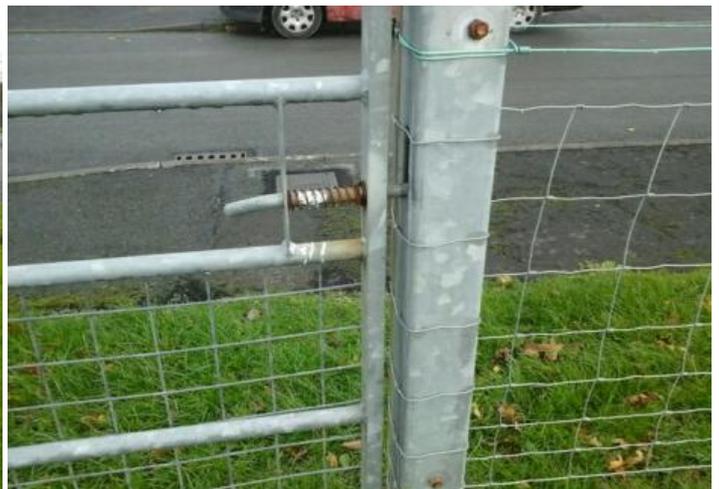
Item: Ancillary Items - Gate - Maintenance
Manufacturer: Owner/Operator

Finding: There is no padlock on the maintenance gate

Action: Provide a padlock to secure the gate

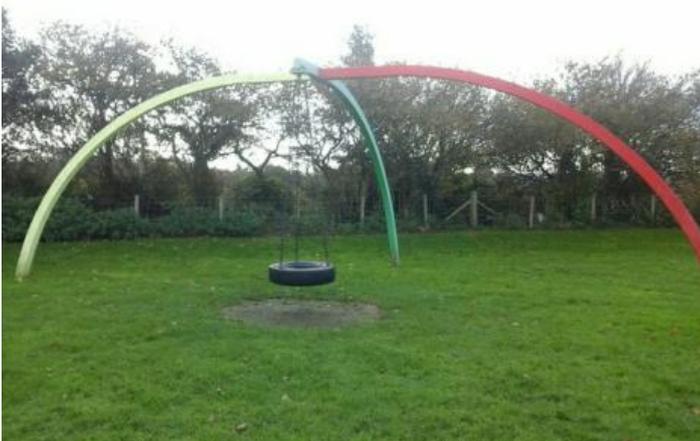
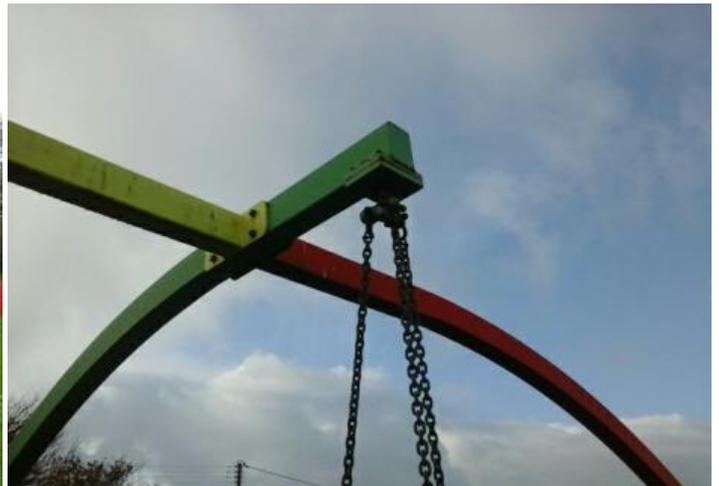
Item: Swings - Single Point Swing - Type 3
Manufacturer: Park Leisure Ltd

Finding: Swings of this design should have a secondary safety mechanism fitted unless the joint has been designed and tested specifically for the purpose.

Action: Refer to manufacturer to establish if the joint is tested and approved for use on this item of equipment

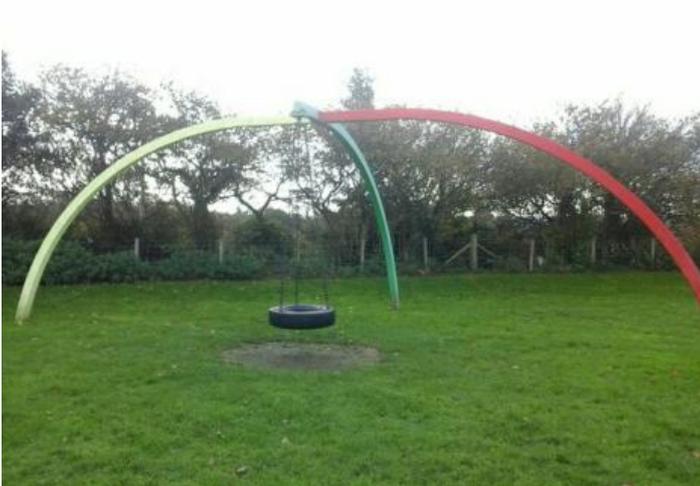
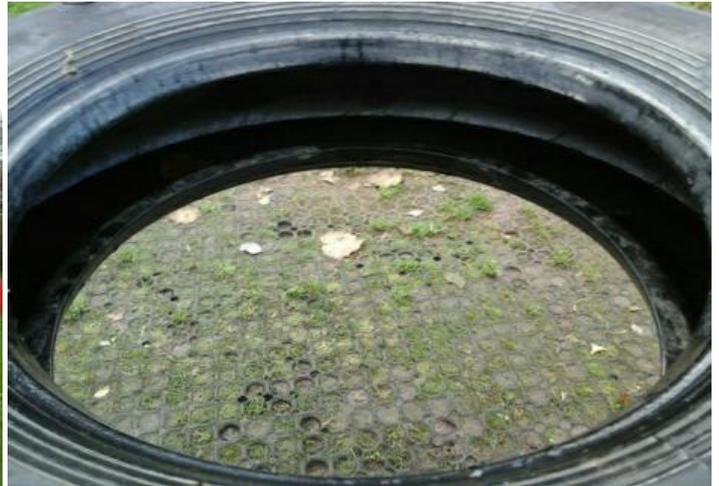
Item: Swings - Single Point Swing - Type 3
Manufacturer: Park Leisure Ltd

Finding: The tyre contains stagnant water

Action: Drill drainage holes

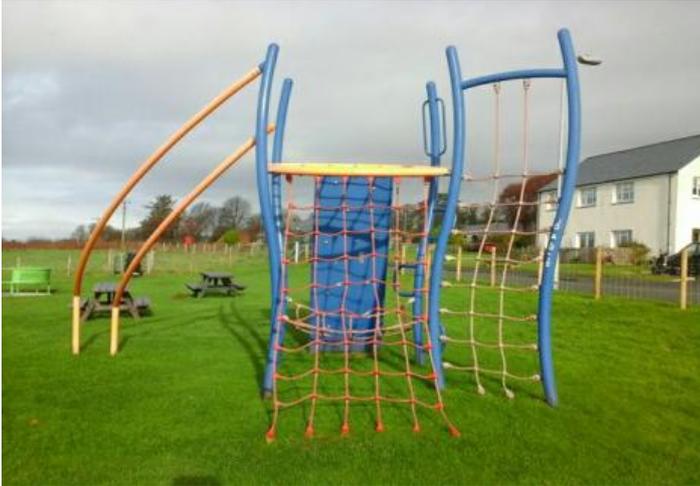
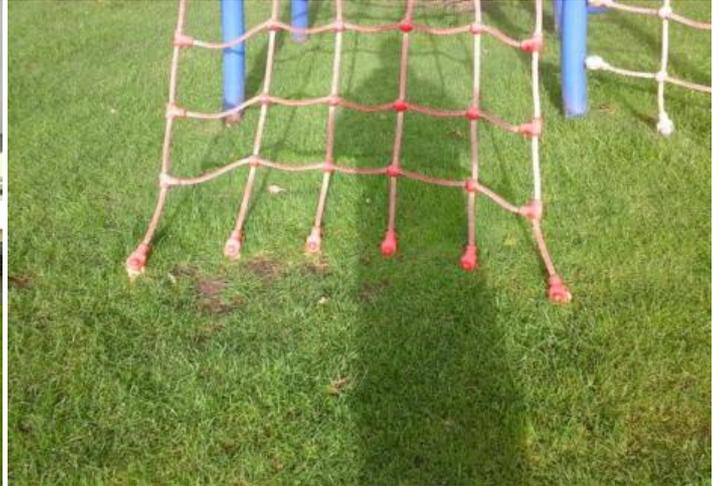
Item: Activity Equipment - Climbing Frame
Manufacturer: Park Leisure Ltd

Finding: The grass mats are silted up and the soil is compacted; this may have an effect on the impact absorbing properties of the surface

Action: Lift and relay mats or test impact absorbing properties to ensure the correct surface qualities are maintained for the equipment

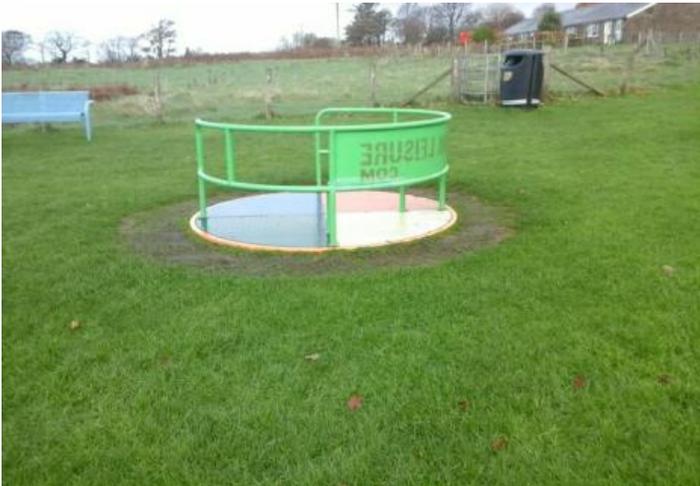
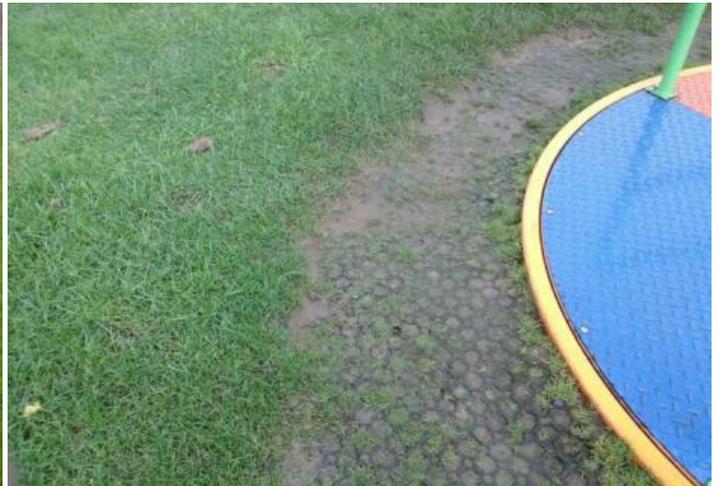
Item: Rotor Play - Roundabout
Manufacturer: Park Leisure Ltd

Finding: The grass mats are silted up, the soil is compacted and the area will become very slippery when the soil is wet.

Action: Reinstate as required

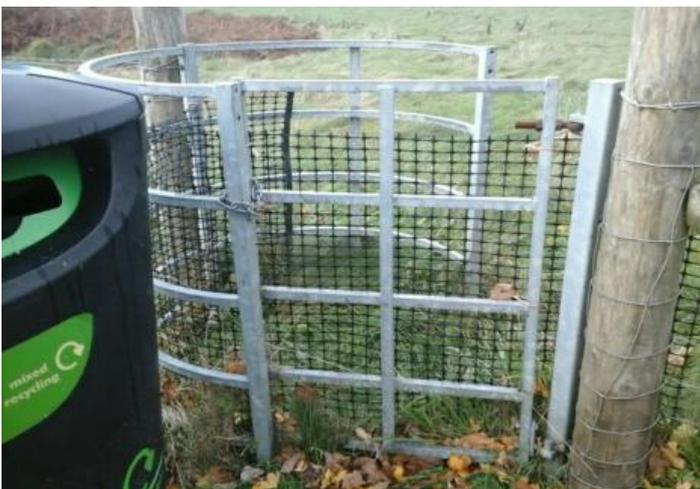
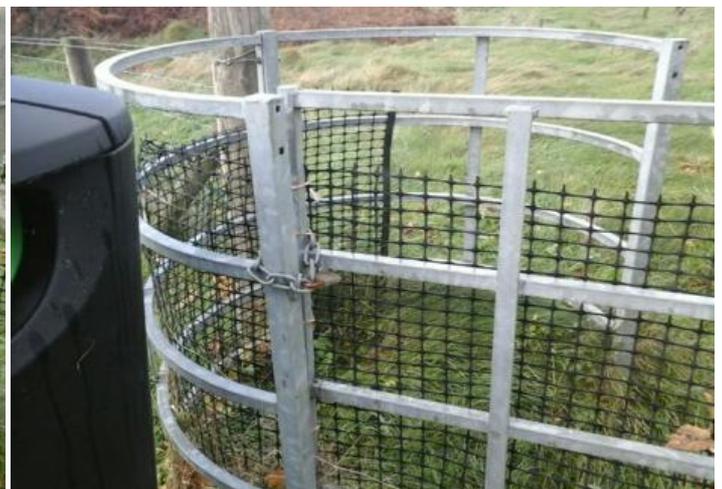
Item: Ancillary Items - Gate - Pedestrian
Manufacturer: Owner/Operator

Finding: The gate was locked at the time of the inspection

Action: Check operation and finger clearances if reinstated
