Annual Inspection

Dyffryn Ardudwy and Talybont Community Council

Pentre Uchaf Play Park

Inspection Ref: 956006

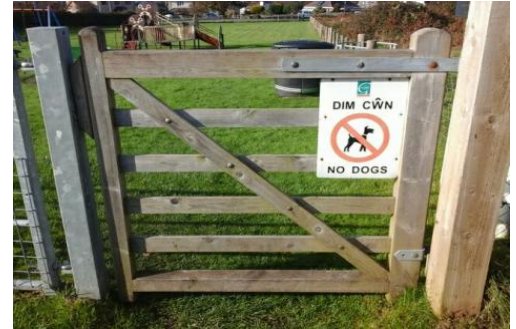
Item: Gate
Manufacturer: Owner/Operator
Surface Type: N/A
Equipment Compliance: N/A
Surface Area Compliance: N/A

8 - Low Risk

Total Findings: 2

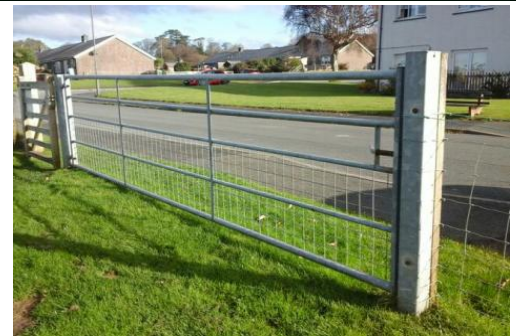
Item: Gate - Maintenance
Manufacturer: Owner/Operator
Surface Type: N/A
Equipment Compliance: N/A
Surface Area Compliance: N/A

6 - Low Risk

Total Findings: 1

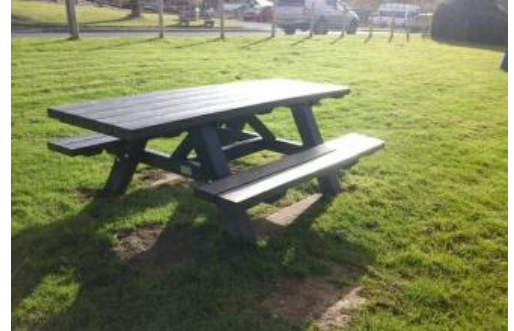
Item: Picnic Table
Manufacturer: Owner/Operator
Surface Type: N/A
Equipment Compliance: N/A
Surface Area Compliance: N/A

4 - Very Low Risk

Total Findings: 1

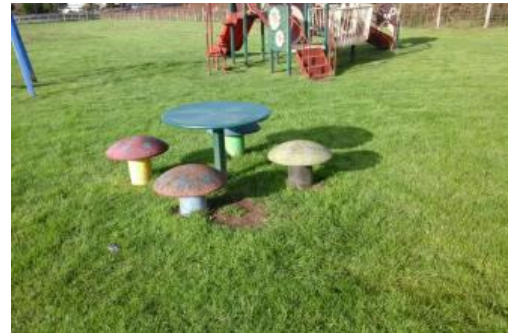
Item: Seating Area
Manufacturer: Park Leisure Ltd
Surface Type: N/A
Equipment Compliance: N/A
Surface Area Compliance: N/A

4 - Very Low Risk

Total Findings: 1

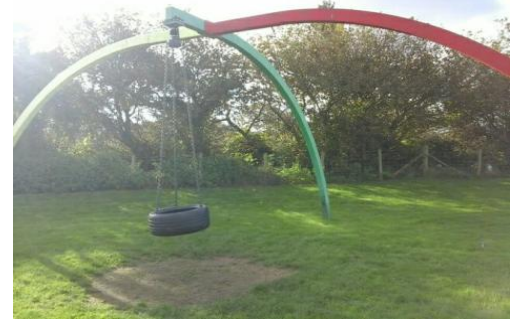
Item: Single Point Swing - Type 3
Manufacturer: Park Leisure Ltd
Surface Type: Grass Matrix Tiles
Equipment Compliance: Yes
Surface Area Compliance: Yes

8 - Low Risk

Total Findings: 1

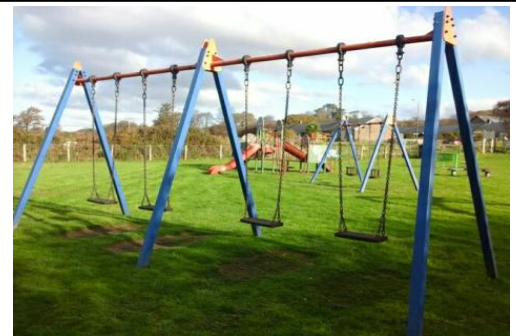
Item: 2 Bay 4 Seat (Flat)
Manufacturer: Park Leisure Ltd
Surface Type: Grass Matrix Tiles
Equipment Compliance: No
Surface Area Compliance: Yes

6 - Low Risk

Total Findings: 5

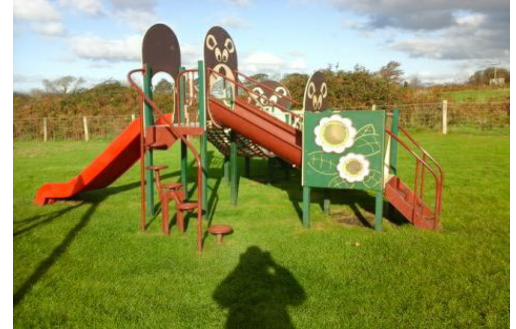
Item: Multi Play (Junior)
Manufacturer: Not Identified
Surface Type: Grass Matrix Tiles
Equipment Compliance: Yes
Surface Area Compliance: Yes

! 12 - Moderate Risk

Total Findings: 5

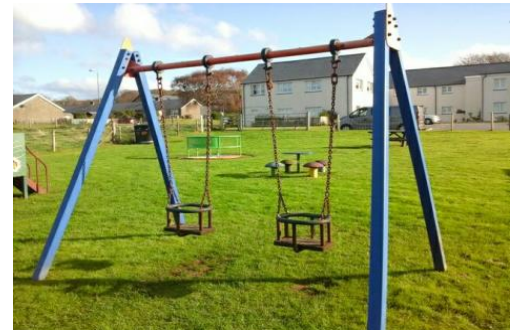
Item: 1 Bay 2 Seat (Cradle)
Manufacturer: Park Leisure Ltd
Surface Type: Grass
Equipment Compliance: No
Surface Area Compliance: Yes

i 6 - Low Risk

Total Findings: 5

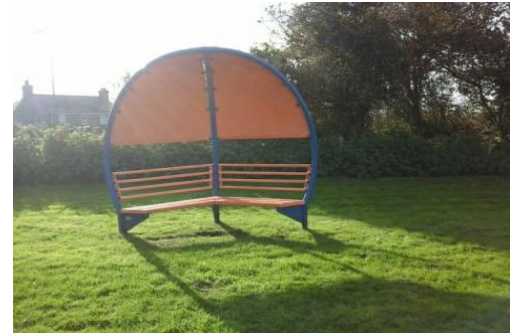
Item: Shelter
Manufacturer: Park Leisure Ltd
Surface Type: Grass
Equipment Compliance: N/A
Surface Area Compliance: N/A

6 - Low Risk

Total Findings: 2

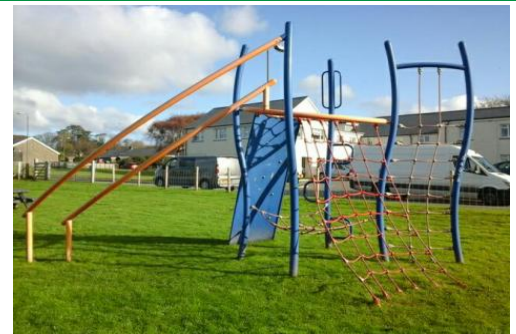
Item: Climbing Frame
Manufacturer: Park Leisure Ltd
Surface Type: Grass Matrix Tiles
Equipment Compliance: Yes
Surface Area Compliance: Yes

8 - Low Risk

Total Findings: 4

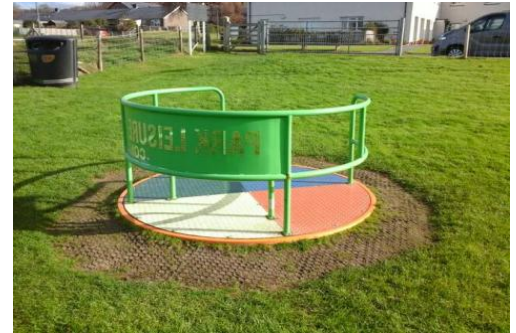
Item: Roundabout
Manufacturer: Park Leisure Ltd
Surface Type: Grass Matrix Tiles
Equipment Compliance: No
Surface Area Compliance: Yes

8 - Low Risk

Total Findings: 2

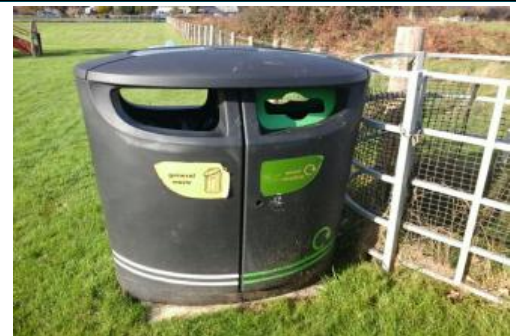
Item: Litter Bin
Manufacturer: Not Identified
Surface Type: Grass
Equipment Compliance: N/A
Surface Area Compliance: N/A

4 - Very Low Risk

Total Findings: 1

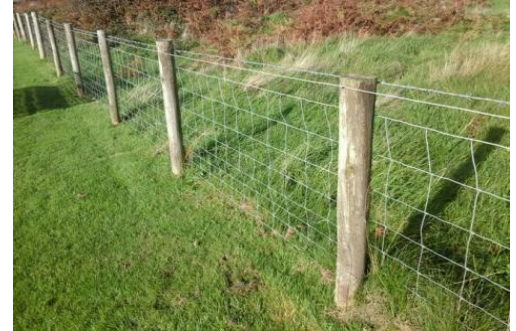
Item: Fence - Steel Mesh
Manufacturer: Owner/Operator
Surface Type: Grass
Equipment Compliance: N/A
Surface Area Compliance: N/A

8 - Low Risk

Total Findings: 2

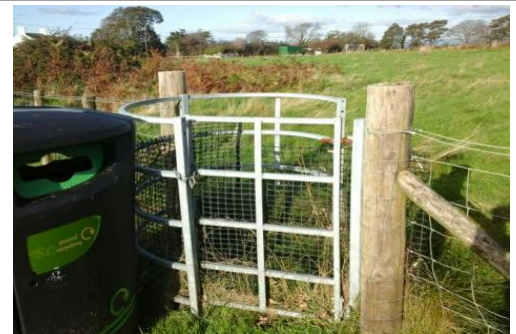
Item: Gate - Pedestrian
Manufacturer: Owner/Operator
Surface Type: Grass
Equipment Compliance: N/A
Surface Area Compliance: N/A

0 - Risk Assessment not Undertaken

Total Findings: 1
